## Assessing Compliance to Minimum Service Standards of Indonesian Toll Roads: An Examination of the Padaleunyi Toll Road

**Keywords:** Padaleunyi Toll Road; Compliance; Indonesian minimum service standards for toll roads; Cipularang toll road; Purbaleunyi toll road; Road conditions

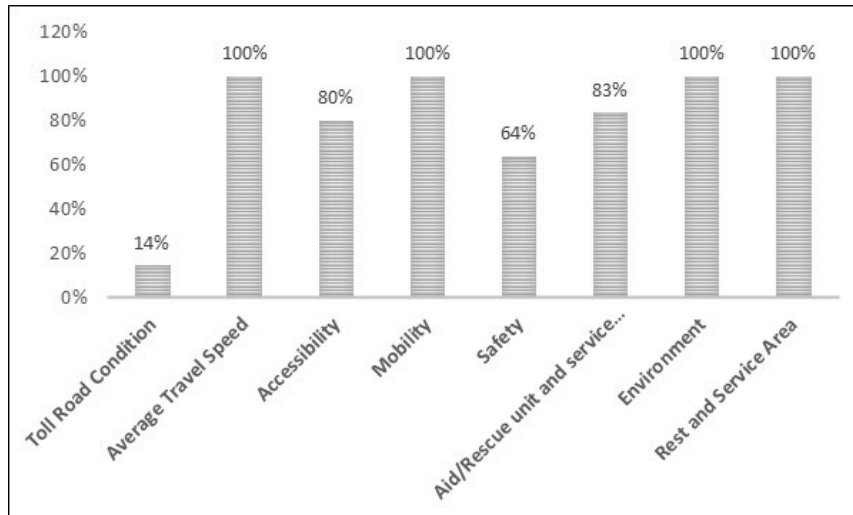
**Figure 1.** Percentage of criteria fulfillment

Figure 1 depicts the percentage of criteria fulfillment for the toll road minimum service standards in the Padaleunyi section. Among the eight criteria, only four met the standards in their entirety: average travel speed, mobility, environment, rest, and service area. The criterion with the lowest percentage of standard fulfillment was toll road conditions, meeting only 2 out of the 14 benchmarks. Comparison results with minimum service standards of toll roads for Toll roads condition as can be seen in Table 6 to Table 13. Thus, the achievement of minimum service

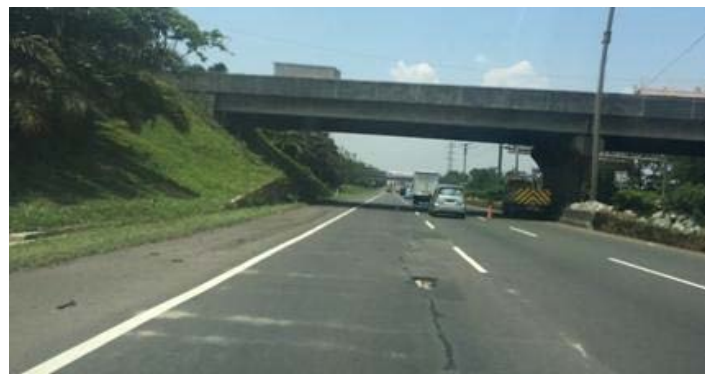
standards for toll road conditions reached a mere 14% of the expected level. Specifically, the only criteria that were met were the roughness and roughness of the main pavement. Conversely, the requirements of having no holes, rutting, and cracks on the main road pavement, as well as proper roadside conditions, were not fulfilled. Furthermore, improvements are needed in all drainage conditions. The median condition, encompassing the curb, median concrete barrier (MCB), guard rail, and wire rope, also fell short of meeting the standards. An example illustrating the presence of cracks and pothole damage on the main road and shoulder pavement is showcased in Figures 2-3.

The condition of the main line pavement exhibits variability, with some sections being overlaid and in excellent condition while others could benefit from further enhancement. The road surface has experienced significant wear and tear, despite the application of patches to many areas. Numerous cracks, grooves, longitudinal cracks, and holes are present, with longitudinal cracks being particularly common in the joint area between adjacent pavement layers. According to Wahidin [17], both newly built roads and newly restored roads (overlays) experience a decrease in structural function over time. Additionally, damage can occur due to the interaction of friction between vehicles and the road pavement, such as sudden braking at high speeds [17, 18]. Such damage weakens the asphalt pavement structure, leading to pavement deformation and the subsequent occurrence of pavement roughness. The presence of pavement roughness negatively impacts vehicle performance and traffic safety.

**Figure 2.** Longitudinal cracks and holes in the main line pavement at km 135

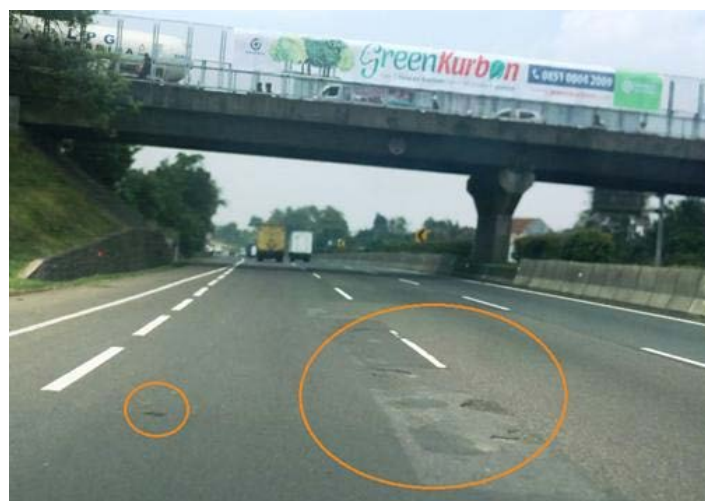
**Figure 3.** Damage at km 128

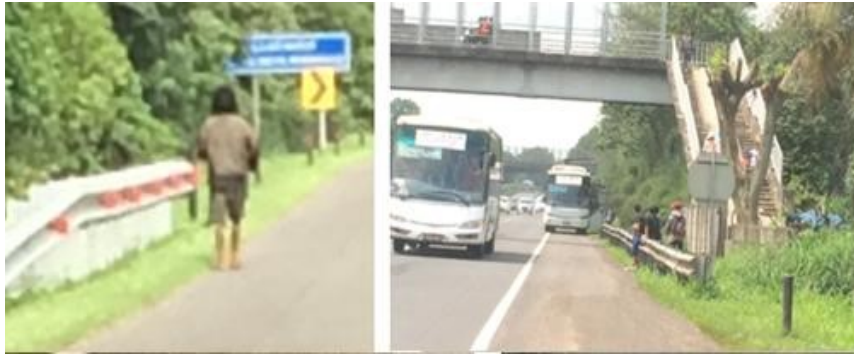
**Figure 4.** Absence of right-of-way fence
