Assessing Compliance to Minimum Service Standards of Indonesian Toll Roads: An Examination of the Padaleunyi Toll Road

Abstract: The primary objective of this study encompasses the evaluation of the Padaleunyi Toll Road's service performance, particularly in relation to Indonesia's established minimum service standards for toll roads. Given that the Padaleunyi Toll Road currently stands at mid-life in terms of its service duration, it is crucial to undertake this assessment to predict its remaining useful life. Criteria for measuring minimum service standards' fulfillment were diversified to cover the conditions of the toll road, average vehicular speed, accessibility, mobility, safety parameters, availability of rescue units and service assistance, environmental impact, and features of rest and service areas. The employed research methodology was based on the guidelines provided by Regulation 16/PRT/M/2014 from the Indonesian Ministry of Public Works. Findings indicate a compliance level of 66.04% to the minimum service standards, with the poorest indicator being the condition of the toll roads at a mere 14%. This study hopes to contribute by offering comprehensive insights into

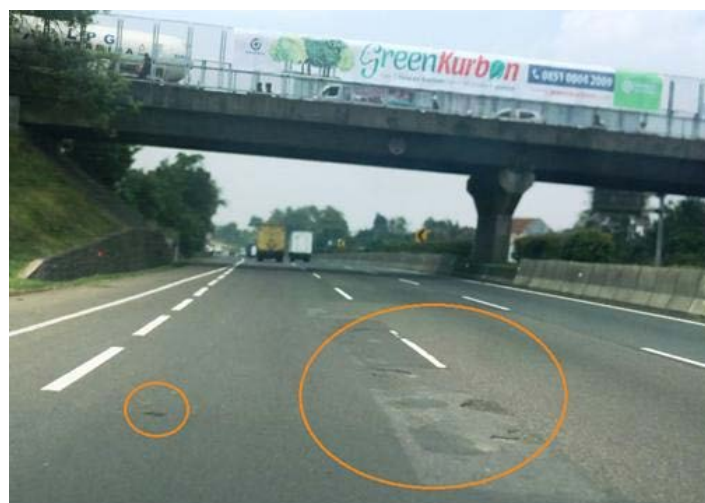
standards for toll road conditions reached a mere 14% of the expected level. Specifically, the only criteria that were met were the roughness and roughness of the main pavement. Conversely, the requirements of having no holes, rutting, and cracks on the main road pavement, as well as proper roadside conditions, were not fulfilled. Furthermore, improvements are needed in all drainage conditions. The median condition, encompassing the curb, median concrete barrier (MCB), guard rail, and wire rope, also fell short of meeting the standards. An example illustrating the presence of cracks and pothole damage on the main road and shoulder pavement is showcased in Figures 2-3.

Figure 3. Damage at km 128
