## Assessing Compliance to Minimum Service Standards of Indonesian Toll Roads: An Examination of the Padaleunyi Toll Road

**Abstract:** The primary objective of this study encompasses the evaluation of the Padaleunyi Toll Road's service performance, particularly in relation to Indonesia's established minimum service standards for toll roads. Given that the Padaleunyi Toll Road currently stands at mid-life in terms of its service duration, it is crucial to undertake this assessment to predict its remaining useful life. Criteria for measuring minimum service standards' fulfillment were diversified to cover the conditions of the toll road, average vehicular speed, accessibility, mobility, safety parameters, availability of rescue units and service assistance, environmental impact, and features of rest and service areas. The employed research methodology was based on the guidelines provided by Regulation 16/PRT/M/2014 from the Indonesian Ministry of Public Works. Findings indicate a compliance level of 66.04% to the minimum service standards, with the poorest indicator being the condition of the toll roads at a mere 14%. This study hopes to contribute by offering comprehensive insight

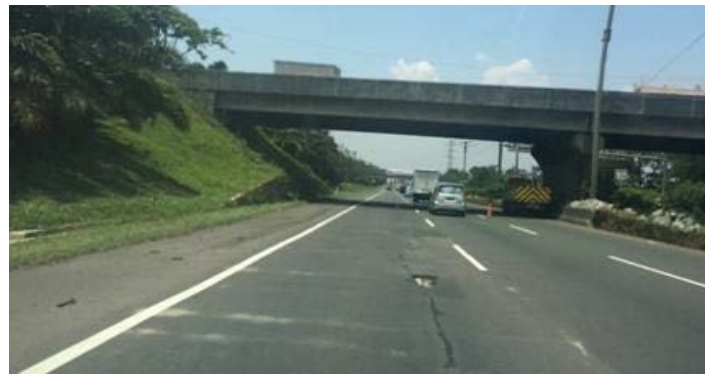
standards for toll road conditions reached a mere 14% of the expected level. Specifically, the only criteria that were met were the roughness and roughness of the main pavement. Conversely, the requirements of having no holes, rutting, and cracks on the main road pavement, as well as proper roadside conditions, were not fulfilled. Furthermore, improvements are needed in all drainage conditions. The median condition, encompassing the curb, median concrete barrier (MCB), guard rail, and wire rope, also fell short of meeting the standards. An example illustrating the presence of cracks and pothole damage on the main road and shoulder pavement is showcased in Figures 2-3.

The condition of the main line pavement exhibits variability, with some sections being overlaid and in excellent condition while others could benefit from further enhancement. The road surface has experienced significant wear and tear, despite the application of patches to many areas. Numerous cracks, grooves, longitudinal cracks, and holes are present, with longitudinal cracks being particularly common in the joint area between adjacent pavement layers. According to Wahidin [17], both newly built roads and newly restored roads (overlays) experience a decrease in structural function over time. Additionally, damage can occur due to the interaction of friction between vehicles and the road pavement, such as sudden braking at high speeds [17, 18]. Such damage weakens the asphalt pavement structure, leading to pavement deformation and the subsequent occurrence of pavement roughness. The presence of pavement roughness negatively impacts vehicle performance and traffic safety.

**Figure 2.** Longitudinal cracks and holes in the main line pavement at km 135

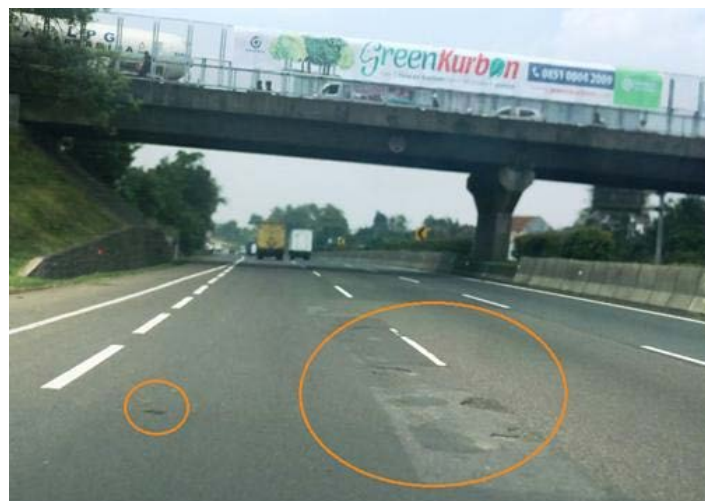
**Figure 3.** Damage at km 128
