1.4.160. H450 GTOLS Re-implementation. (S26)

1.4.164. From the potential accident route matrix above, identified by RAF CAM in Jun 11, 4 months before ZK515's accident, it can be seen in the Accident Point (on the day) section that the identified factors were very close to predicting what happened in this accident. In this respect, the predicted accident factors can be matched against the entry conditions for ZK515's accident:

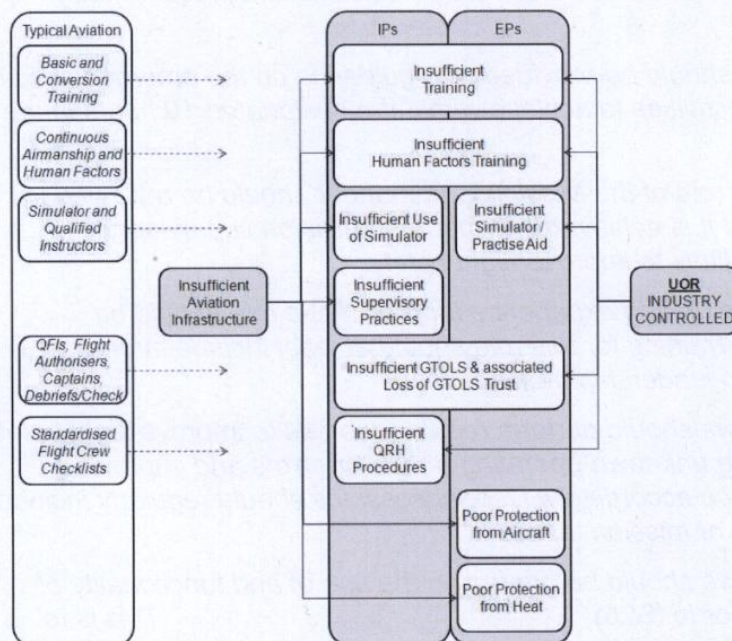
Figure 15 - Summary of identified factors

The identified factors may influence the likelihood a H450 crew would enter a hazardous scenario and the likelihood that crew may fail to recover from that scenario, should these factors not be addressed. A summary of the factors raised are provided in Figure 15.

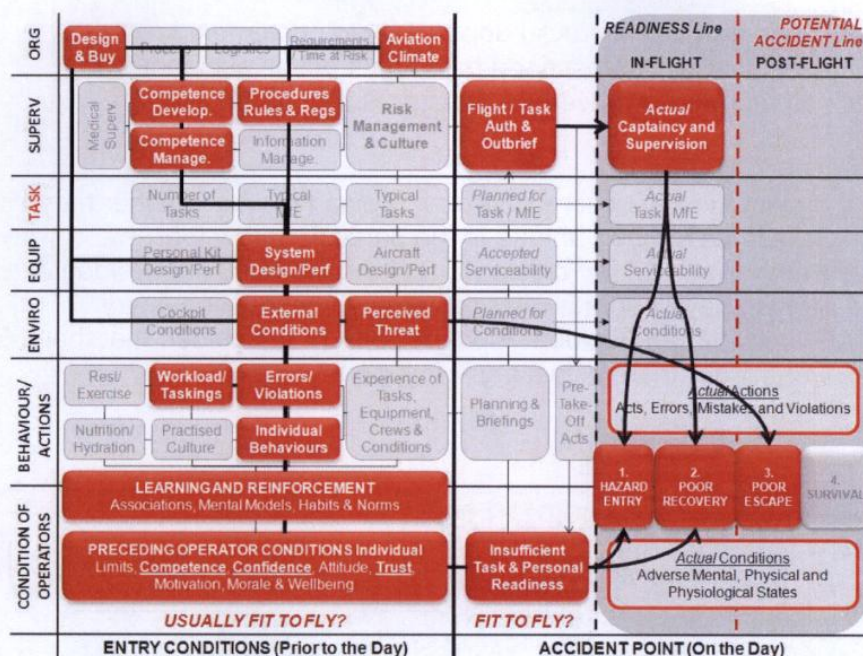
Figure 16 - Identified factors on the Accident Route Matrix - showing potential accident route in Jun 11

These factors have been highlighted on RAF CAM's Accident Route Matrix in Figure 16 to illustrate a potential route to another H450 incident or accident.

Therefore, the Panel observed that a crucial opportunity to implement key actions that could have prevented or lessened the impact of this accident was missed due to a lack of importance placed on the Jun 11 RAF CAM Human Factors report.

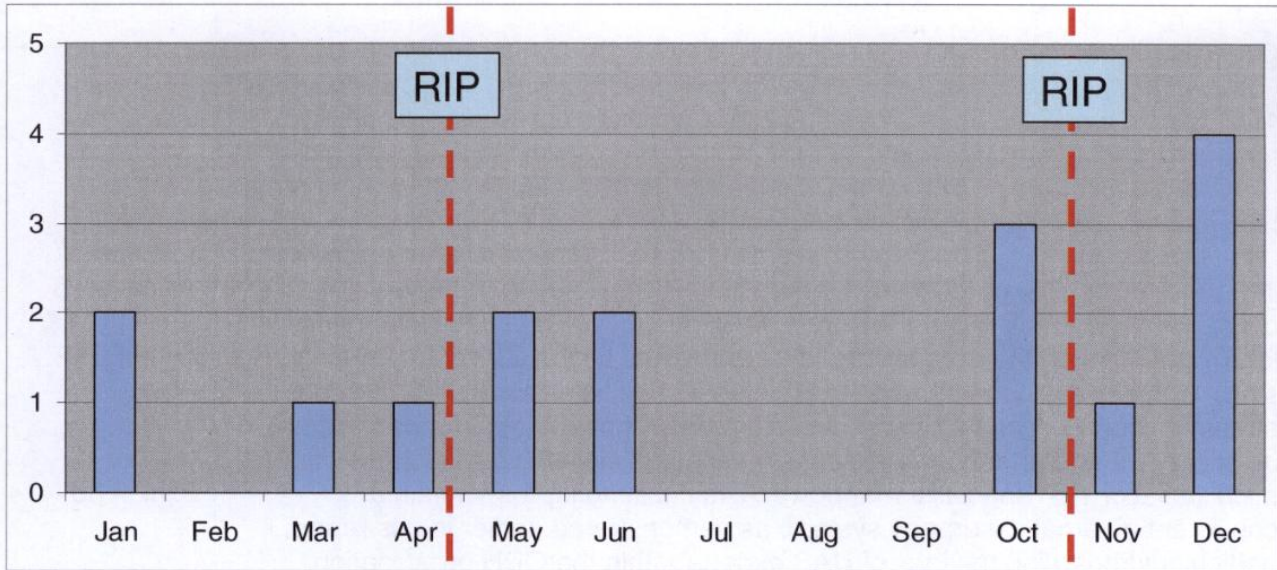
Figure 18 - Graph showing when H450 incidents have occurred over the last 5 years

1.4.170. The requirement to maintain flying currency for a large pool of H450 pilots with no live flying in the UK and only one simulator is extremely difficult; the system is flawed as pilots on the Bty most recently returned from Theatre are not maintaining the 1 Arty Bde FOB currency requirements. Once promoted past Sgt, a H450 pilot would not expect to be employed in this role again, so flying experience is mainly limited to Bdr and LBdr. The Panel believes that consideration should be given to modernising the structure of a UAS Regt to contain a smaller, centralised pool of UAS operators with a larger rank range and within a specialised aviation Career Employment Group (CEG). This approach would focus the operational experience within the Regt and decrease the training burden which at present is inefficient; roulement of a Bty every 6 months is not an efficient or intrinsically safe way to conduct flying operations. Figure 18 below shows that over the last 5 years, the majority of incidents are concentrated either side of the Bty changeover period 'Relief-in-Place' (RIP), when the outgoing Bty is likely to be suffering from skill fade and the new Bty is inexperienced. The Panel believes a UAS Regt should comprise of more typical aviation squadron structure consisting of a pool of pilots who can rotate through for shorter periods (for example 2-3 months) to maintain the pool of experience and currency in theatre. This would avoid the lengthy ThQ process every 6 months and prevent skill fade between tours. The transport and subsistence savings from continuous refresher training in (S26) is also thought to be worthy of investigation.
