ADVANCE RECONNAISSANCE REPORT

Venue Security Assessment & Operational Documentation

MISSION REFERENCE	DR-2025-1215-DEMO
VENUE	Leisure Complex & Hotel
LOCATION	United Kingdom
DATE OF ADVANCE	15 December 2025
PREPARED BY	DetailRecon AI Analysis
CLASSIFICATION	CONFIDENTIAL

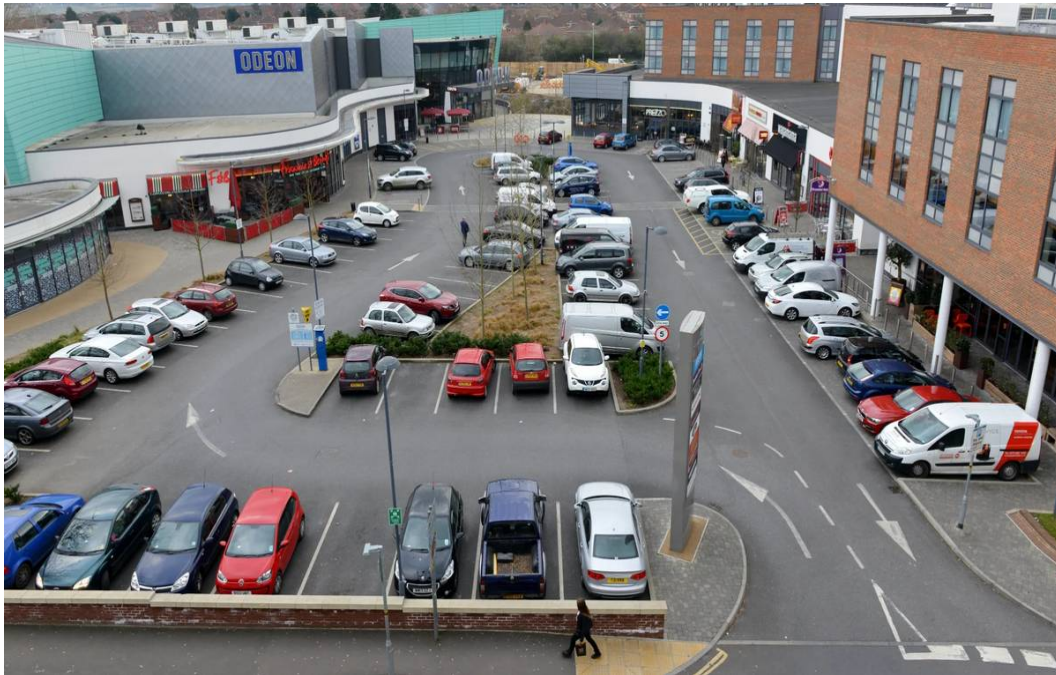
PHOTO 1: EXTERIOR - Vehicle Approach & Car Park Overview

RISK LEVEL: MEDIUM

Surface-level car park serving retail/leisure complex. Primary vehicle approach from south. Odeon cinema and multiple F&B; outlets visible.

- Open car park layout provides good situational awareness
- Multiple retail/F&B; establishments create variable foot traffic patterns
- 5 MPH speed limit signage indicates controlled vehicle movement
- Civilian pedestrian visible - public access area, no perimeter control

OPERATIONAL NOTE: High public exposure. Recommend covert arrival via service road if available.

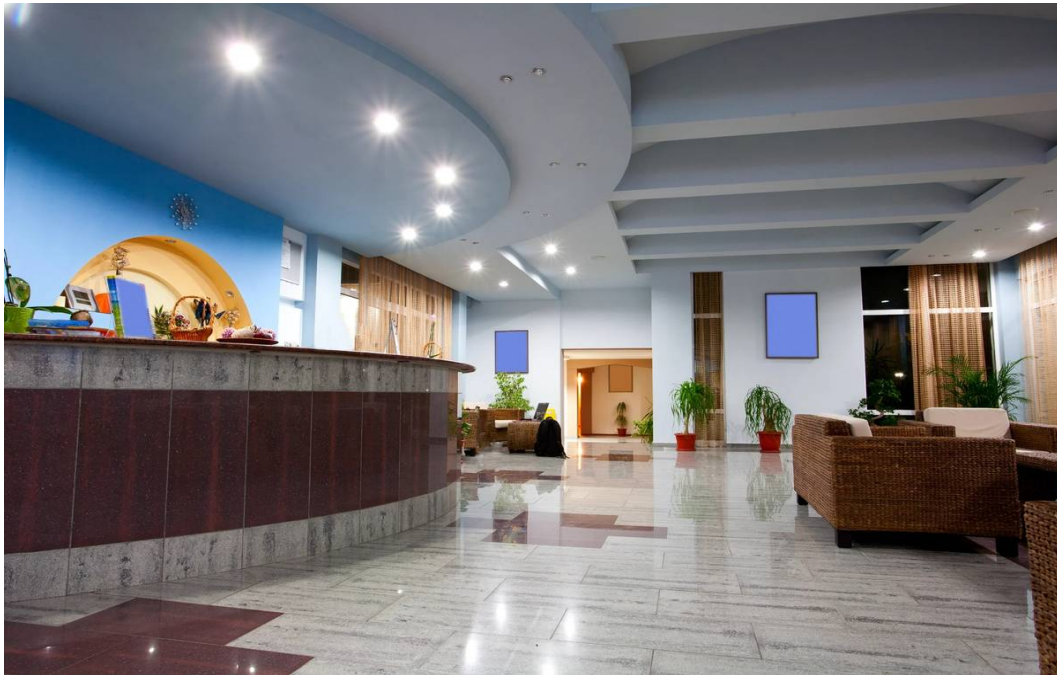
PHOTO 2: INTERIOR - Main Reception & Lobby Area**RISK LEVEL: LOW**

Hotel reception lobby. Curved reception desk with clear sightlines. Marble flooring, high ceilings with recessed lighting.

- Open plan lobby - good visibility from all angles
- Reception desk positioned centrally with 270° coverage
- Secondary corridor visible rear of frame - potential alternate route
- Floor-to-ceiling windows (right) - consider external observation risk
- Seating areas provide holding positions for advance team

OPERATIONAL NOTE: Good defensive layout. Recommend advance liaison with front desk manager.

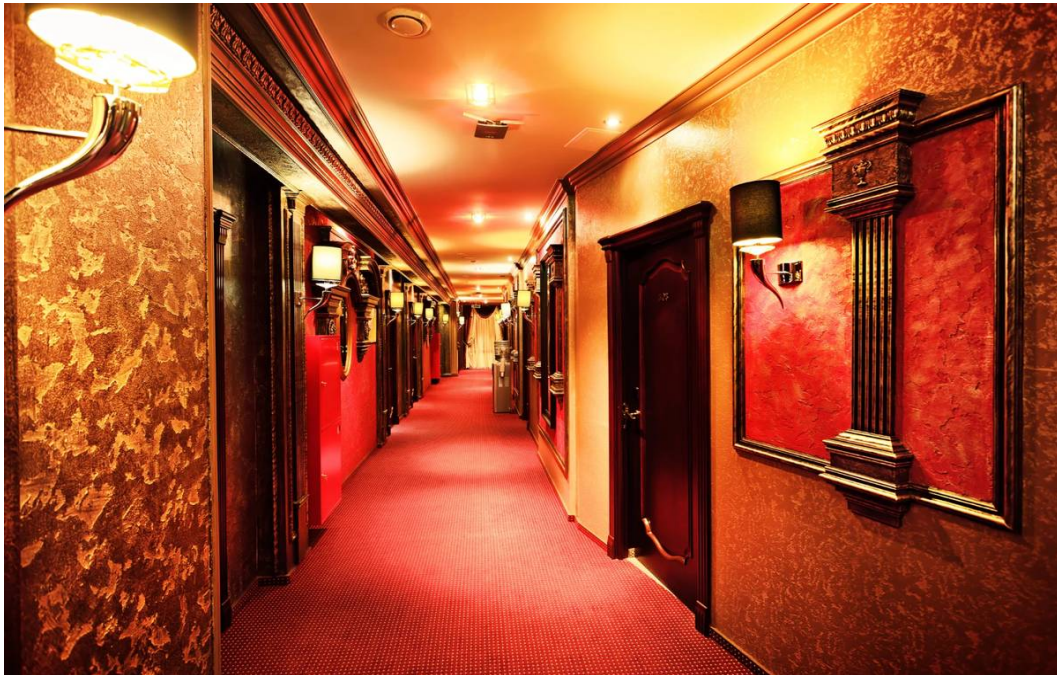
PHOTO 3: INTERIOR - Guest Corridor (Executive Floor)**RISK LEVEL: LOW**

Executive floor corridor. Ornate decor with red carpet, wood panelling, and period lighting fixtures.

- Single-point access corridor - excellent for access control
- Limited natural light - good for discretion, poor for threat identification
- Multiple room doors visible - verify Principal's room positioning
- Ceiling-mounted smoke detector - confirm no CCTV coverage
- Alcoves between doors provide limited concealment positions

OPERATIONAL NOTE: Controllable environment. Station CP at corridor entrance during Principal occupancy.

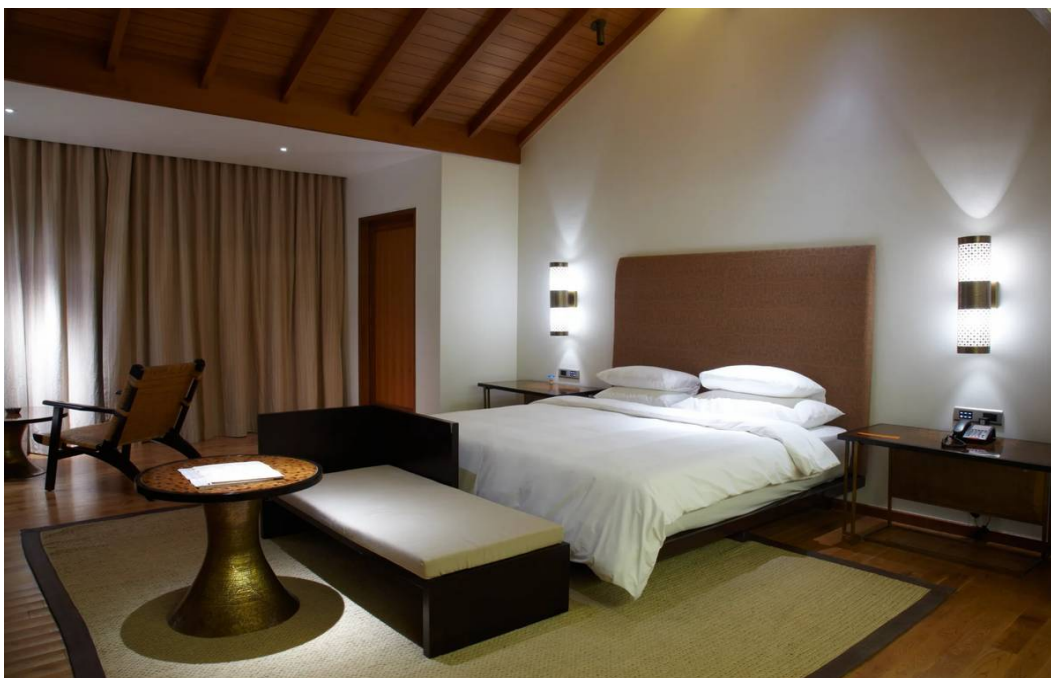
PHOTO 4: INTERIOR - Principal Suite (Bedroom)**RISK LEVEL: LOW**

Executive suite bedroom. Vaulted wooden ceiling, king bed configuration, single entry point visible.

- Single visible entry/exit point - confirm connecting door status
- Full-length curtains on left - verify window type and egress potential
- Bedside telephone for internal communications
- No visible safe - enquire re: in-room secure storage
- Room orientation requires confirmation of adjacent occupancies

OPERATIONAL NOTE: Standard executive configuration. Request adjacent rooms remain unoccupied if possible.

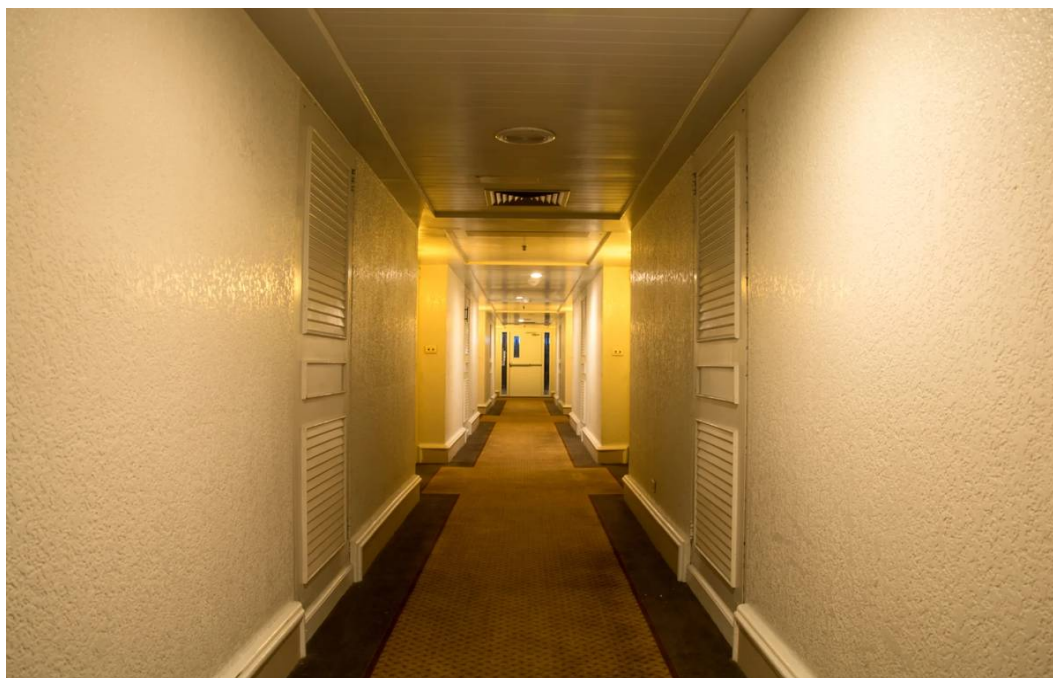
PHOTO 5: INTERIOR - Service Corridor (Staff Access)**RISK LEVEL: MEDIUM**

Staff/service corridor. Utility access with louvered panels indicating plant/storage rooms.

- Back-of-house access route - lower public exposure
- Louvered panels suggest utility/plant rooms - verify access control
- Fire exit visible at corridor terminus
- Minimal lighting - consider torch for emergency egress
- Textured walls suggest older building section

OPERATIONAL NOTE: Viable alternate egress route. Verify fire exit alarm status and external egress point.

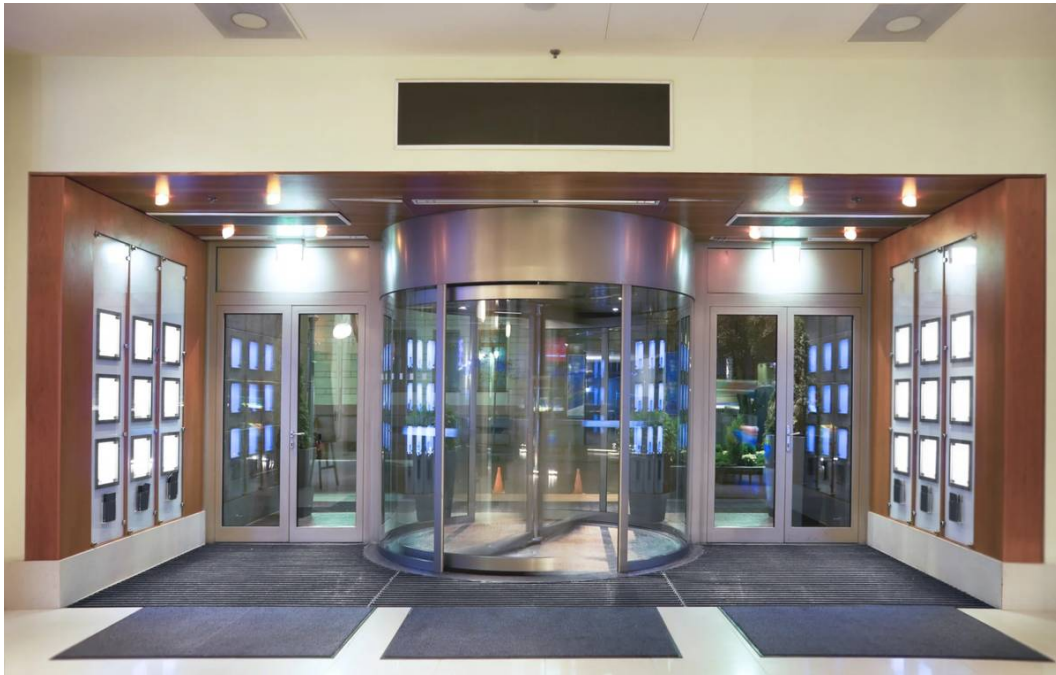
PHOTO 6: EXTERIOR - Primary Entrance (Main Door)**RISK LEVEL: MEDIUM**

Hotel main entrance. Revolving door with flanking manual doors. Display cases visible.

- Revolving door may impede rapid entry/exit - use side doors
- Glass frontage provides visibility but also exposure risk
- Floor mats indicate wet weather slip hazard
- Display cases flanking entrance - verify contents and access
- Air curtain unit above door - interior environment controlled

OPERATIONAL NOTE: Primary arrival point. Coordinate with doorman for VIP protocol. Consider porte-cochère if available.
