Design Optimization Proposal for Enhanced Robotic Arm Responsiveness

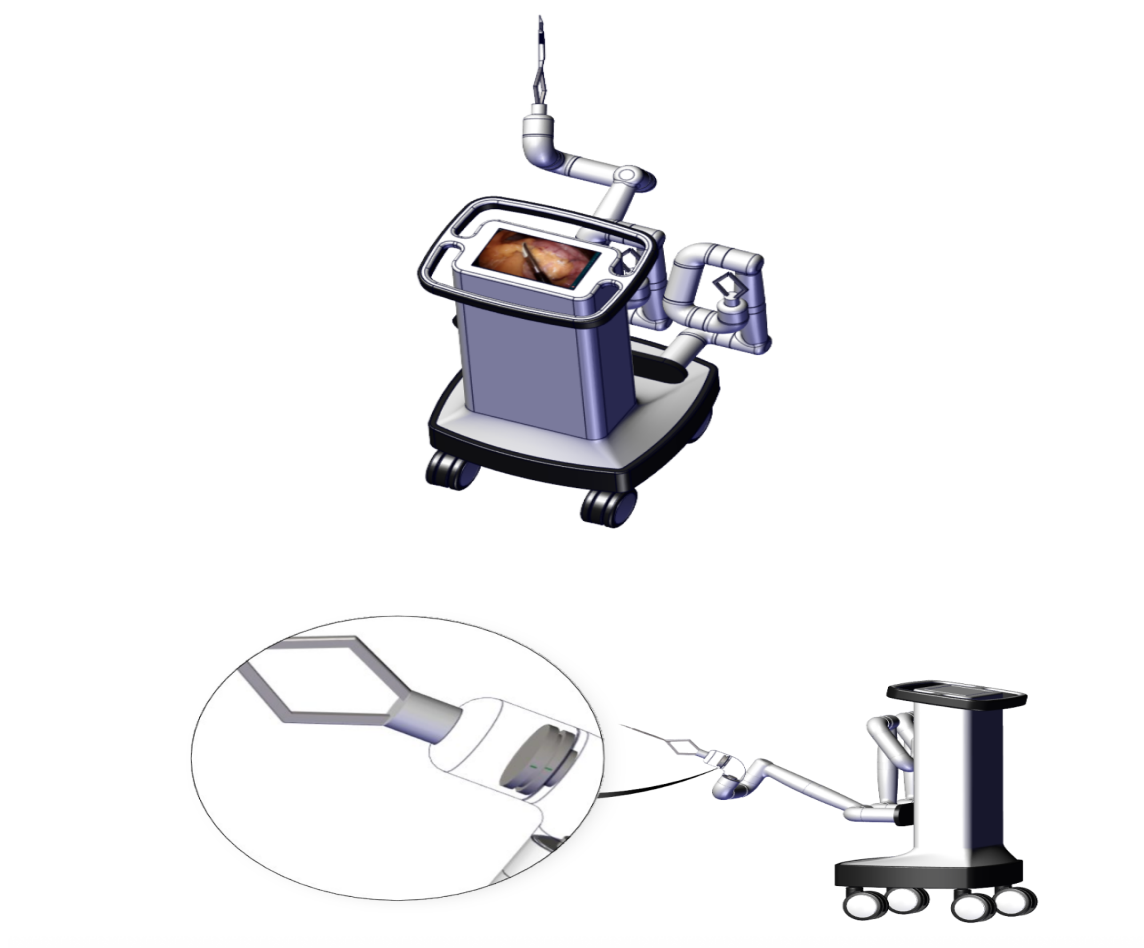
Visual Example 1: Current Sensor Misalignment vs. Proposed Realignment

- **Description:** Diagnostic images, indicate that the feedback sensors on the joint are misaligned.
- **Impact:** This misalignment causes a delay in the feedback loop, forcing the control system to work with outdated information and contributing to the overall response time lag.

- *Brief Description* : This annotation would show the current misaligned sensor. A "Before" arrow would point to the sensor's incorrect angle, and an "After" arrow would show it repositioned for an optimal data path.

- **Proposal:** Perform a full recalibration and realignment of the sensors at the 'rotate_joint'.
- **Justification:** This resolves the 'Sensor Misalignment' issue, eliminating the feedback delay and ensuring the control unit receives accurate, real-time position data.

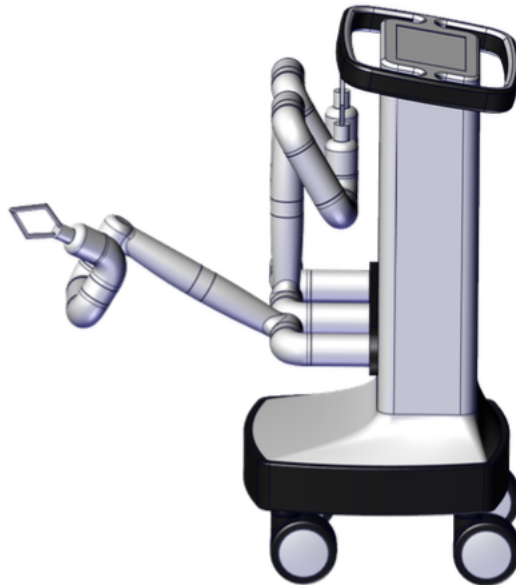
Visual Example 2: Actuator Upgrade Impact

- **Description:** Diagnostic images (Q2, Q4) show that the actuators at the rotate_joint are under excessive strain.
- **Impact:** This strain causes the motor to perform sub-optimally, leading to increased response times (latency) and reduced component lifespan (durability).

- *Brief Description*: This annotation would highlight the 'rotate_joint' actuator. A "Before" label would indicate "High Strain Area." An "After" label would point to the same joint, now marked "Reinforced Joint" and "High Efficiency Actuator."

- **Proposal:** Replace the current actuator with a lightweight, high-efficiency model. Simultaneously, reinforce the joint structure with stronger, lightweight composite materials.
- **Justification:** This directly addresses the 'Actuator Strain' by reducing load (lighter materials) and increasing power (new actuator). This will improve both responsiveness and durability.
