TECHNICAL DATA

REPORT DATE: 20 June 2011
REPORTED BY: I. Christopher
Complaint No.: 100223
REPORT N°: 11-171.0-IC
NOTEBOOK Ref.: 206-22

COMPLAINT: **100223** - Customer is experiencing issues with liner cracking breaking once laminated to their substrate and spooled.

PRODUCT: 154979: UP5040 6" x 1080ft
5 mil Reinforced Transfer Acrylic Adhesive on 76# Polycoated Kraft Liner

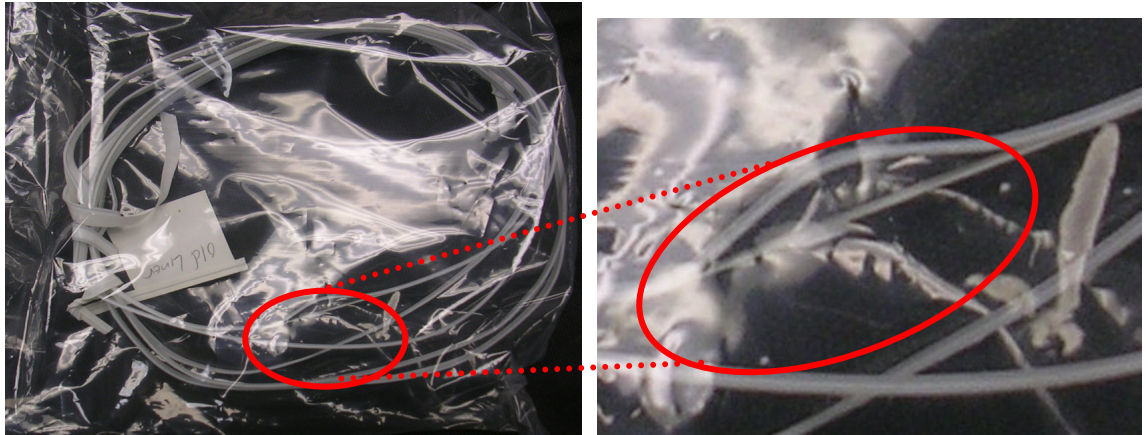
IMAGE 1:

UP5040	No Material Issues have been observed.
Supplied Product	Tension levels being induced into the UP5040 during the lamination process. This is causing the product to relieve internal tension by: a) Adhesive delamination from liner causing the customer substrate to bulge b) Liner breaking to relieve the tension

Older Liner

A) Multiple areas in which substrate & adhesive delaminated from liner.

- Bedford Industries to reduce/monitor tension of materials before and after lamination.
- Use of **ULTRA 6500** in place of **UP5040**. The proposed product was designed specifically for application in which the liner can see excessive stretch. **The adhesive system used in Ultra 6500 is not identical to that used in UP5040, but has a high degree of similarity in most application areas and in product performance.*

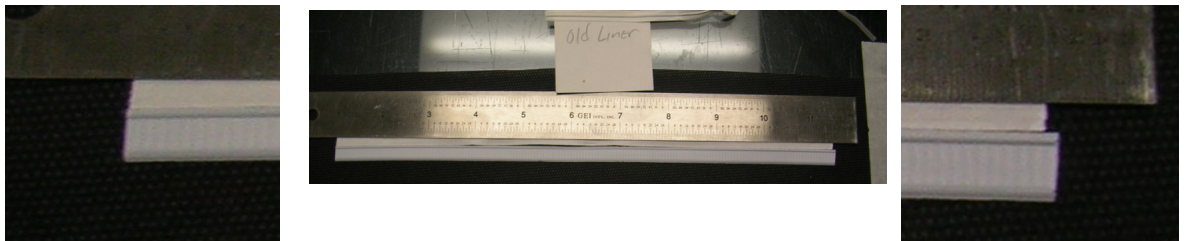
IMAGE 2:

Master Roll:	Nothing abnormal in review of lot history.
Liner:	Nothing abnormal in review of lot history used in comparison to prior lots of liner.
Design Changes:	Materials Used: No changes in base raw materials or components used. Any Changes: Release system nomenclature from liner supplier – no change to release chemistry or components used.
"Old Liner"	
Visual:	Material shipped to Windsor showed signs of liner/adhesive delamination in supplied format. Multiple sites within sample showed this.
Analytical:	Measurement of a cut section of final product and liner once removed, resulted with the liner being 0.45% shorter than the substrate.
"New Liner"	
Visual:	Material shipped to Windsor showed signs of liner/adhesive delamination in supplied format along with several areas in which the liner split in the machine direction. Multiple sites within sample showed this.
Analytical:	Measurement of a cut section of final product and liner once removed, resulted with the liner being 0.77% shorter than the substrate.

Older Liner

A) Test sample of Liner Length v. Bonded Part Length

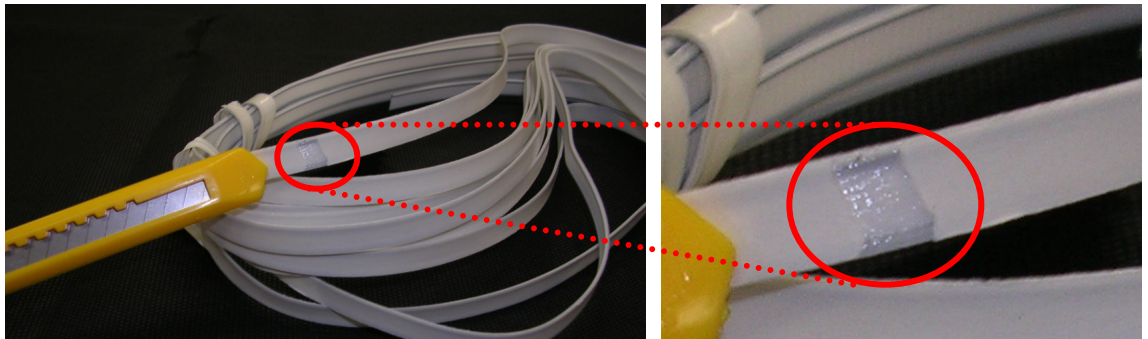
IMAGE 3:

Newer Liner

A) Image of point of break in liner on final part assembly.
