# TECHNICAL AUDIT REPORT

Location of intervention: Wind farm "  
Source de Sèves », 50490 ? Vaudrimesnil.

Mission completed on 11/12/2024

Mission type: Technical audit of a wind farm.

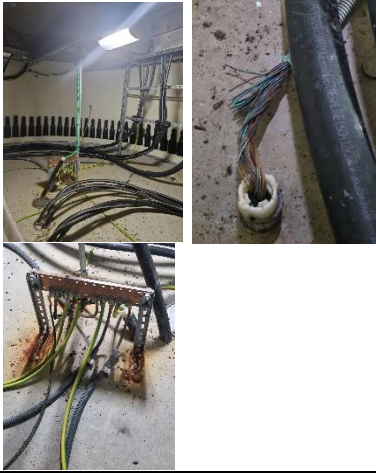
Description	Status	Observations	of Images
of the Fondation	of cleanliness	of a serious condition	caused by a corroded and damaged earth cable  EDPR Comment: A specific inspection will be carried out during the year (QAQC Foundation)

- Clean the foundation
- and a review of the stickers displaying important information
- replace the grounding cables in the foundation

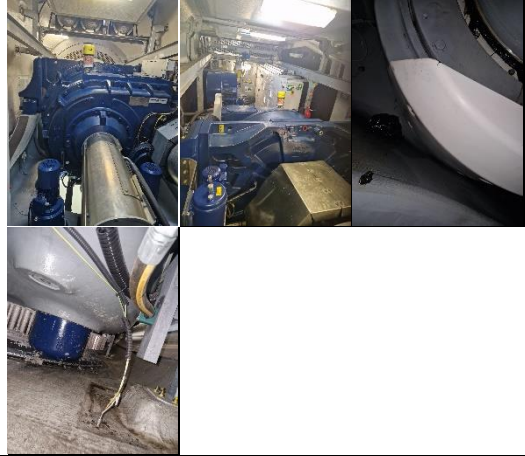
Description	Status	Observations	of Images
of Nacelle	of cleanliness/ General	Deteriorated condition	Slight grease overflow under the slow tree  Comment EDPR: The necessary cleaning will be carried out by SGRE during the next maintenance.

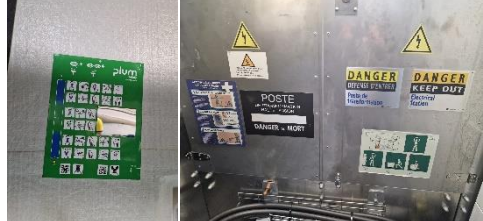
Nacelle	Evacuator - ResQ	- Degraded Condition	The case is slightly damaged, dirty  Comment from EDPR: EDPR will look to change the box

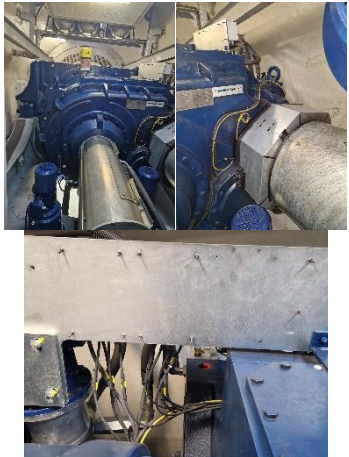
Description	Status	Observations	of Images
of the General Condition	of cleanliness, of the presence of hoods and screens, electrical and mechanical risks and mechanical	and degraded state	<p>the entire gearbox is very correct. However, the layout and and the dispersion of electrical cables need to be reconsidered. In this conception, there is a risk of wear of electrical cables. The installation of ducts would avoid this risk and improve optimization of space</p> <p>Comment by EDPR: The repair will be carried out if certain components are damaged, but the arrangement will not be affected</p>

- Find a better layout for the arrangement of the electrical cables of the gear box, it is recommended to install ducts to optimize space.
- the leak

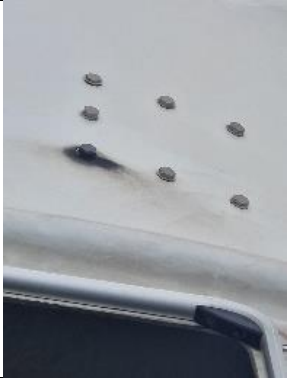
of the roof: Description	Condition	Observations	of Images
of the General Condition	of Access	of Deteriorated State	<p>a screw is damaged and the roof is slightly dented at the level of the access hatch</p> <p>Comment by EDPR: The repair will be carried out by SGRE during the next maintenance</p>

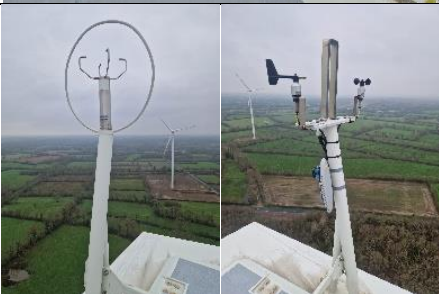
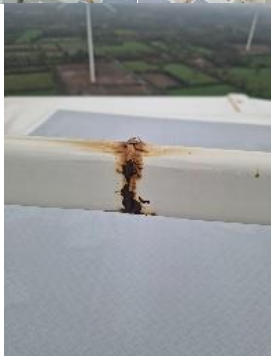
weather mast	in a degraded state	<p>with a rust trace on the part connecting the 2 meteorological masts.</p> <p>Comment from EDPR: EDPR will verify how to manage this issue</p>

the mast at the level of the corroded part

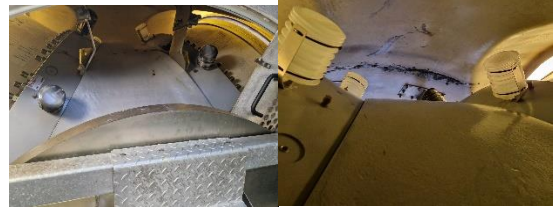
HUB	Access	Degraded state	<p>A bit of grease present at the entrance</p> <p>Comment from EDPR: Cleaning will be carried out by SGRE during the next maintenance.</p>

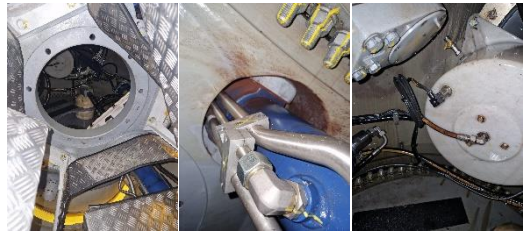
in a degraded state	<p>with dust and oil presence that can accelerate the degradation of flexible materials</p> <p>EDPR Comment: The cleaning will be carried out by SGRE during the next maintenance.</p>
