TECHNICAL AUDIT REPORT

Location of intervention : Wind farm "Source of Sèves», 50490 – Vaudrimesnil.	Mission completed on 11/12/2024 There is no text to translate. Names of Auditors: AUVRAY Pierre-SOCOTEC
Name of the Accompanying Person: Enzo GERLELIX	
Case Number: 2412H0270000001There is no text to translate. Intervention Number: H0270241200000000329There is no text to translate. Nature of the mission: Technical audit of a wind farm.

Name of the park :	Source of Sèves
Operating Company :	EDPR
Geographic coordinates:	<input type="checkbox"/> Latitude : 49° 9' 26.3" <input type="checkbox"/> Longitude : -1° 26' 43.6"
Location :	Vaudrimesnil 50490 – Saint-Sauveur-Villages
Composition of the park:	5 Wind Turbines & 1 Power Distribution Line

Audited Turbine VDN 2

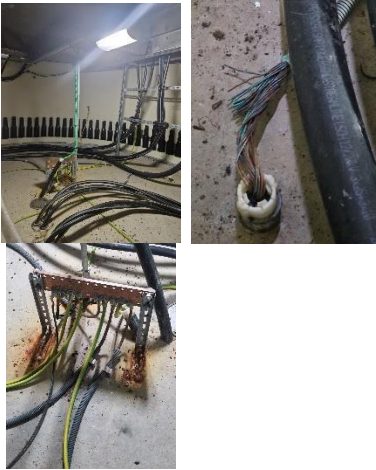
Description	State	Observations	Images
Foundation	State of cleanliness	Critical condition	Rusty and damaged earth cable <i>EDPR Comment: OneThere is no text to translate.A specific inspection will be carried out during the year (QAQC Foundation)</i>

-There is no text to translate.Replace the ground cables in the foundationThere is no text to translate.**Tour** :There is no text to translate.-There is no text to translate.Clean the last section

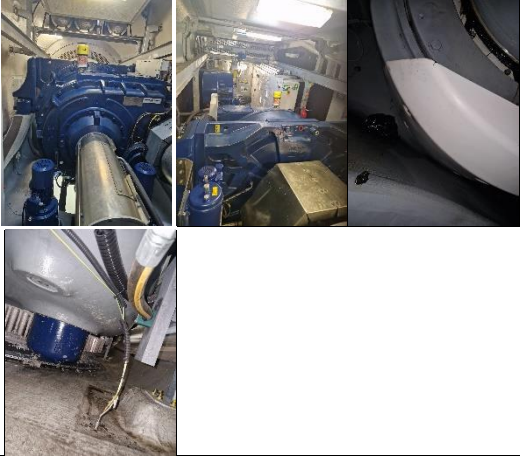
Description	State	Observations	Images	
Nacelle	State of Cleanliness/ General	Degraded state	Slight oil spill under the slow tree. <i>EDPR Comment: The necessary cleaning will be carried out by SGRE during the next maintenance.</i>

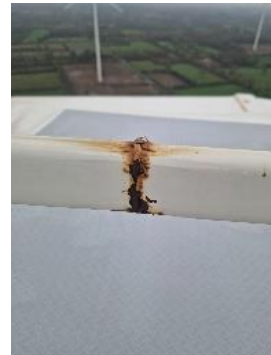
General Condition	Anchor points	Normal state	No defect was found during the audit.	
	Weather mast	Degraded state	<p>Rust trace on the part connecting the 2 weather masts.</p> <p><i>EDPR Comment: EDPR will check how to manage this issue.</i></p>

There is no text to translate.Fix the leak. -There is no text to translate.**Roof** :There is no text to translate.-There is no text to translate.Clean and repaint the mast at the level of the corroded part

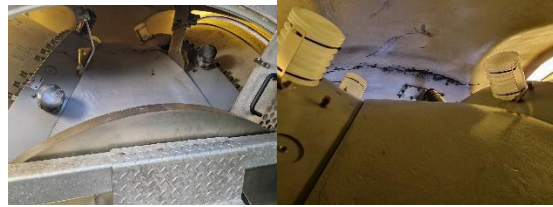
HUB	Access	Degraded state	A bit of grease present at the entrance <i>EDPR Comment: The necessary cleaning will be carried out by SGRE during the next maintenance.</i>

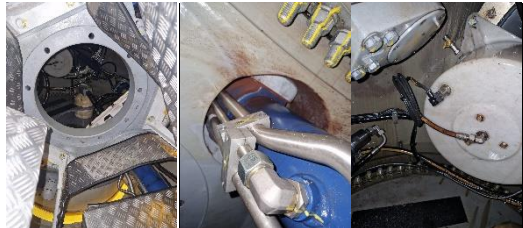
Interior	Degraded state	Presence of dust and oil There is no text to translate.that can accelerate the degradation of flexibles <i>EDPR Comment: The necessary cleaning will be carried out by SGRE during the next maintenance.</i>
