TECHNICAL AUDIT REPORT

Location of intervention: Wind farm "
Source of Sèves, 50490 ? Vaudrimesnil.

Case number: 2412H0270000001 Intervention number: H0270241200000000329
Nature of the mission: Technical audit of a wind farm.

Identification:	VDN 2
Manufacturer:	Siemens Gamesa
Model:	SG97 T120
Power (W):	2 MW
Tower height (m):	120 m
Rotor (m):	97 m
Maintainer:	SGRE

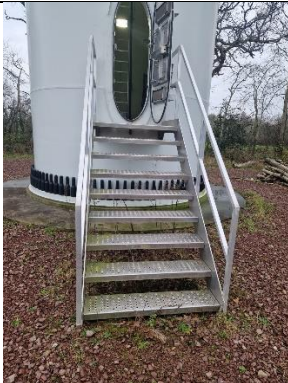
Access	Visual inspection of foundations, search for cracks and deterioration, bolting.	Degraded condition	<p>Foam has appeared, making the foundation slippery.</p> <p>EDPR Comment: The inspection will be carried out during the next maintenance by SGRE</p>

- Clean the foundation -
- Review the stickers displaying important information. -
- Replace the grounding cables in the foundation

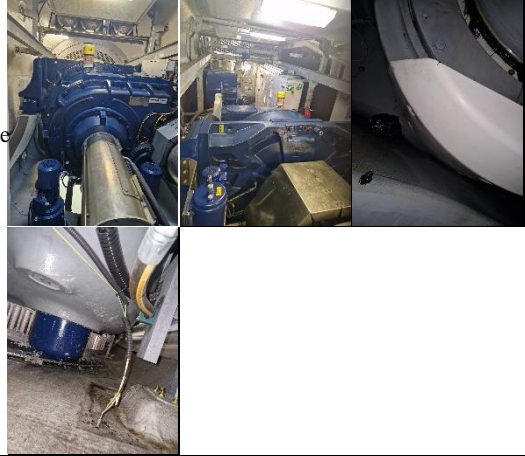
Description	Status	Observations	"Images"
Nacelle	Cleanliness Condition/ General	Deteriorated condition	<p>Slight oil spill under the slow shaft.</p> <p>EDPR comment: The necessary cleaning will be carried out by SGRE during the next maintenance.</p>
