TECHNICAL AUDIT REPORT

Location of intervention: Wind farm «
Source de Sèves », 50490 – Vaudrimesnil.

Intervention No .: H0270241200000000329 **Nature
of the mission :** Technical audit of a wind power plant.

VDN 2 audited turbine

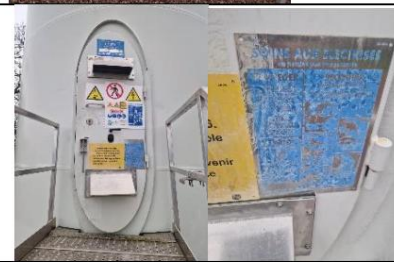
Condition of the access door, filter, grid, lock.	Degraded state	The sign on the door is damaged by weather conditions. <i>EDPR Comment: A check will be made during the next site inspection by EDPR</i>

- Clean the foundation
- Perform a review of the stickers showing important information.
- Replace the ground cables in the foundation

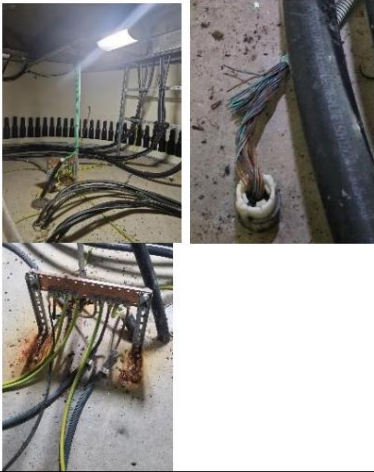
Description	State	Observations	Images
Foundation	State of cleanliness	Serious condition	Rusty and damaged ground cable <i>EDPR Comment: A specific inspection will be carried out during the year (QAQC Foundation)</i>

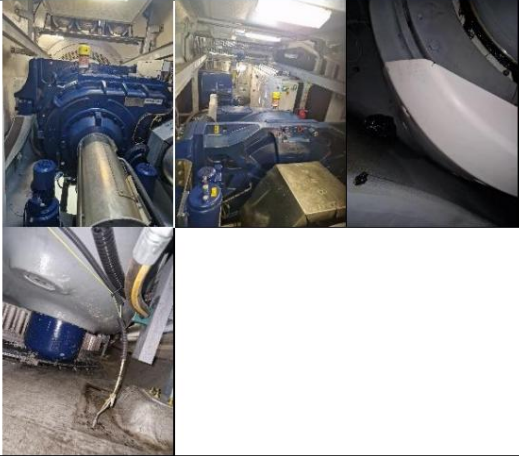
Description	State	Observations	Images
Nacelle	State of cleanliness/General	Degraded state	Slight grease overflow under the slow shaft. <i>EDPR Comment: The necessary cleaning will be carried out by SGRE during the next maintenance.</i>

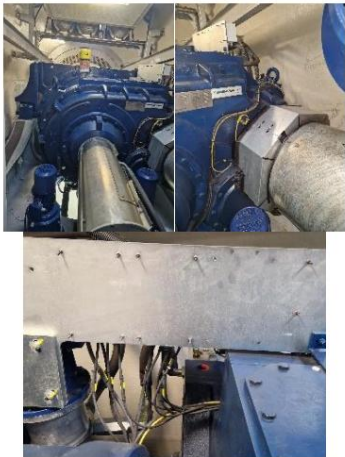
Description	State	Observations	Images
General condition	Checking cleanliness, presence of covers and screens, electrical risks and mechanical risks.	Degraded state	<p>The entire gearbox is very correct. However, the arrangement and dispersion of the electrical cables need to be reconsidered. In this design, there is a risk of wear of the electrical cables. The installation of cable ducts would avoid this risk and improve space optimization.</p> <p><i>EDPR Comment: Repair will be carried out if some components are damaged, but the arrangement will not be affected</i></p>

- Find a better arrangement for the layout of the gear box electrical cables, it
It is advisable to install cable ducts to optimize space.
- Repair the leak.

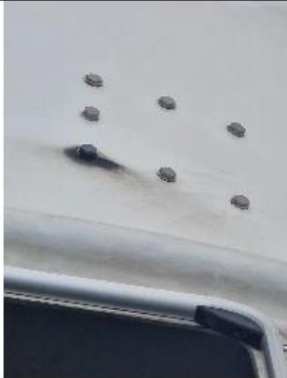
Description	State	Observations	Images
General condition	Access	Degraded state	<p>A screw is damaged and the roof is slightly dented at the access hatch.</p> <p><i>EDPR Comment: The Repair necessary will be carried out by SGRE during the next maintenance</i></p>

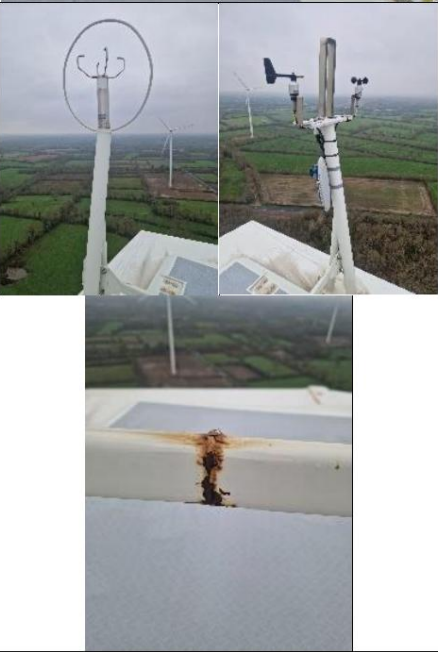
Weather mast	Degraded state	<p>Trace of rust on the part connecting the 2 weather masts.</p> <p><i>EDPR Comment: EDPR will check how to handle this issue.</i></p>

- Clean and repaint the mast at the corroded part

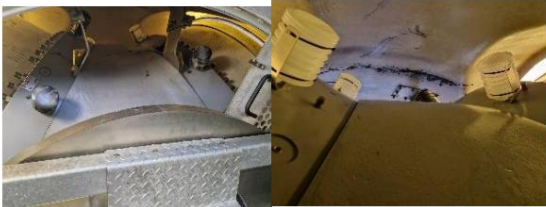
HUB	Access	Degraded state	<p>A little grease present at the entrance</p> <p><i>EDPR Comment: The necessary cleaning will be carried out by SGRE during the next maintenance.</i></p>

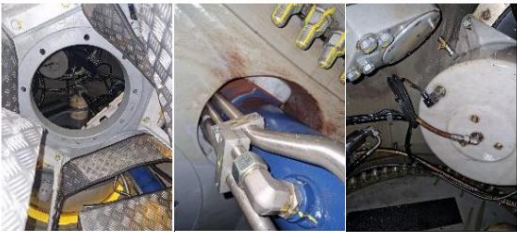
Interior	Degraded state	<p>Presence of dust and oil which can accelerate the degradation of the hoses</p> <p><i>EDPR Comment: The necessary cleaning will be carried out by SGRE during the next maintenance.</i></p>
