# TECHNICAL AUDIT REPORT

Location of intervention: Wind power plant "  
Source of Sèves, 50490 ? Vaudrimesnil.

Case number: 2412H0270000001 Intervention number: H0270241200000000329  
Nature of the mission: Technical audit of a wind farm.

Identification:	VDN 2
Builder:	Siemens Gamesa
Model:	SG97 T120
Power (W):	2 MW
Tower height (m):	120 m
Rotor (m):	97 m
Maintainer:	SGRE

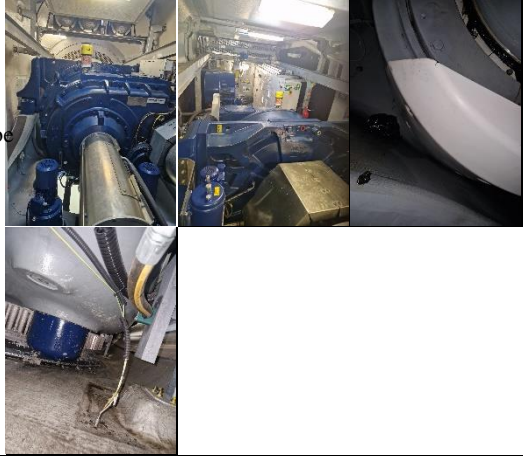
Description	Condition	Observations	Images
Aerial work platform	"Cleanliness/General Condition"	Damaged condition	Slight grease overflow under the slow shaft.  EDPR Comment: The necessary cleaning will be carried out by SGRE during the next maintenance.

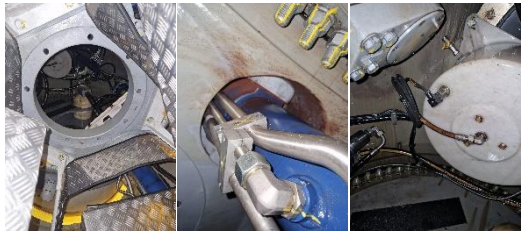
Inside	Damaged condition	<p>Presence of dust and oil that may accelerate the degradation of the flexible connectors</p> <p>EDPR Comment: The necessary cleaning will be carried out by SGRE during the next maintenance.</p>
