TECHNICAL AUDIT REPORT

Location of intervention: Wind farm "
Source of Sèves, 50490 ? Vaudrimesnil.

Case number: 2412H0270000001 Intervention number: H0270241200000000329
Nature of the mission: Technical audit of a wind farm.

Identification:	VDN 2
Builder:	Siemens Gamesa
Model:	SG97 T120
Power (W):	2 MW
Tower height (m):	120 m
Rotor (m):	97 m
Maintainer:	SGRE

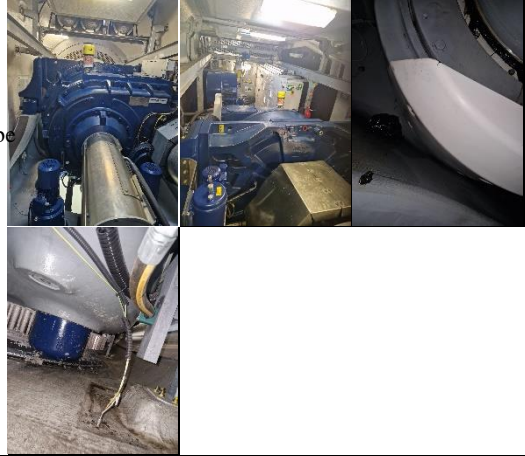
Description	Condition	Observations	Images
Aerial work platform	Cleanliness/General Condition	Dilapidated condition	Slight grease overflow under the slow tree. EDPR Comment: The necessary cleaning will be carried out by SGRE during the next maintenance.
