# TECHNICAL AUDIT REPORT

Location of intervention: Wind farm "  
Source of Sèves, 50490 ? Vaudrimesnil.

Case number: 2412H0270000001 Intervention number: H0270241200000000329  
Nature of the mission: Technical audit of a wind farm.

Identification:	VDN 2
Manufacturer:	Siemens Gamesa
Model:	SG97 T120
Power (W):	2 MW
Tower height (m):	120 m
Rotor (m):	97 m
Maintainer:	SGRE

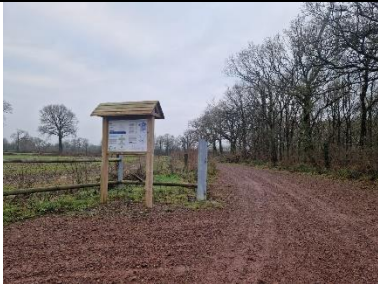
Description	Status	Observations	"Images"
Access	Presence of the ICPE panel at the entrance of the access.	Normal condition	No defects were found during the audit.

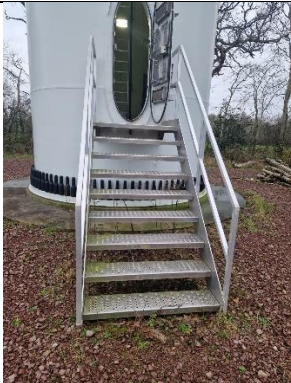
Access	Visual inspection of foundations, search for cracks and deterioration, bolting.	Degraded condition	<p>Foam has appeared, making the foundation slippery.</p> <p>EDPR Comment: The inspection will be carried out during the next maintenance by SGRE</p>

- Clean the foundation -

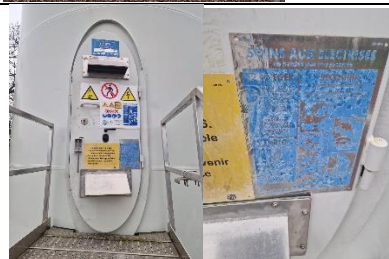
Condition of the access door, filter, grille, and locking mechanism.	Deteriorated condition	<p>The display on the door is damaged by weather conditions.</p> <p>Comment from EDPR: A check will be carried out during the next site inspection by EDPR</p>

- Review the stickers displaying important information. -

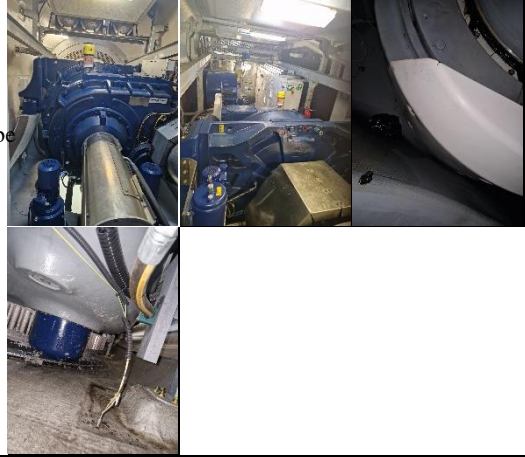
Description	Status	Observations	"Images"
Nacelle	Cleanliness Condition/ General	Deteriorated condition	Slight oil spill under the slow shaft.  EDPR Comment: The necessary cleaning will be carried out by SGRE during the next maintenance.

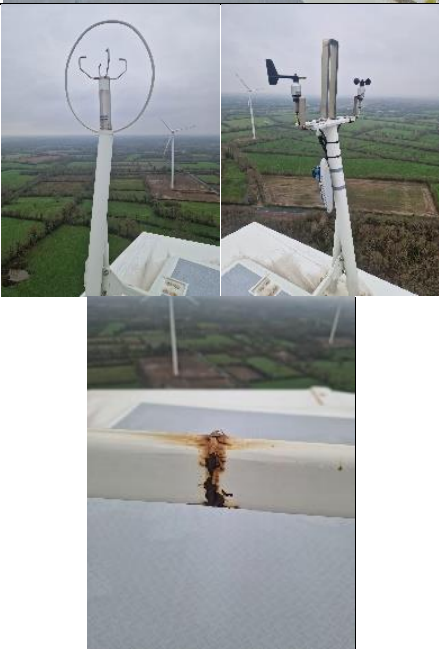
Weather mast	Degraded state	<p>Rust trace on the part connecting the 2 meteorological masts.</p> <p>Comment from EDPR: EDPR will check how to manage this issue.</p>

- Clean and repaint the mast at the level of the corroded part
