Pre-Purchase Building & Pest Inspection Report

BUILDING & PEST REPORT

Property Address: 45 Evans Street, Balmain NSW, Australia

Date of Inspection: 13/06/2024

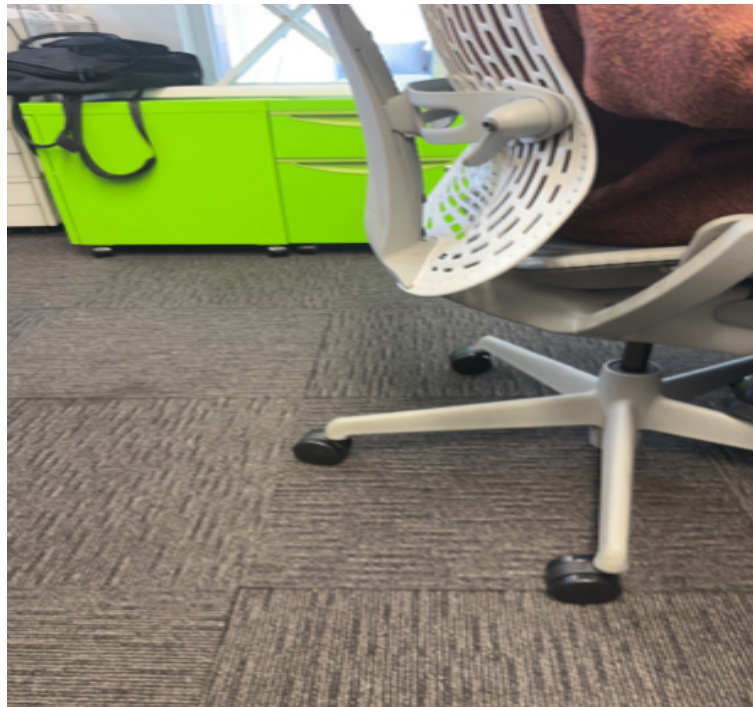
This is defect 1
