## SIRE 2.0 EDITOR

### Observation Declaration for LCKX-0907-4736-7478

Vessel Name	New Frontier1
IMO	9765079
Inspection Date	27-May-2025
Port of Inspection	Spain - Algeciras [ESALG]

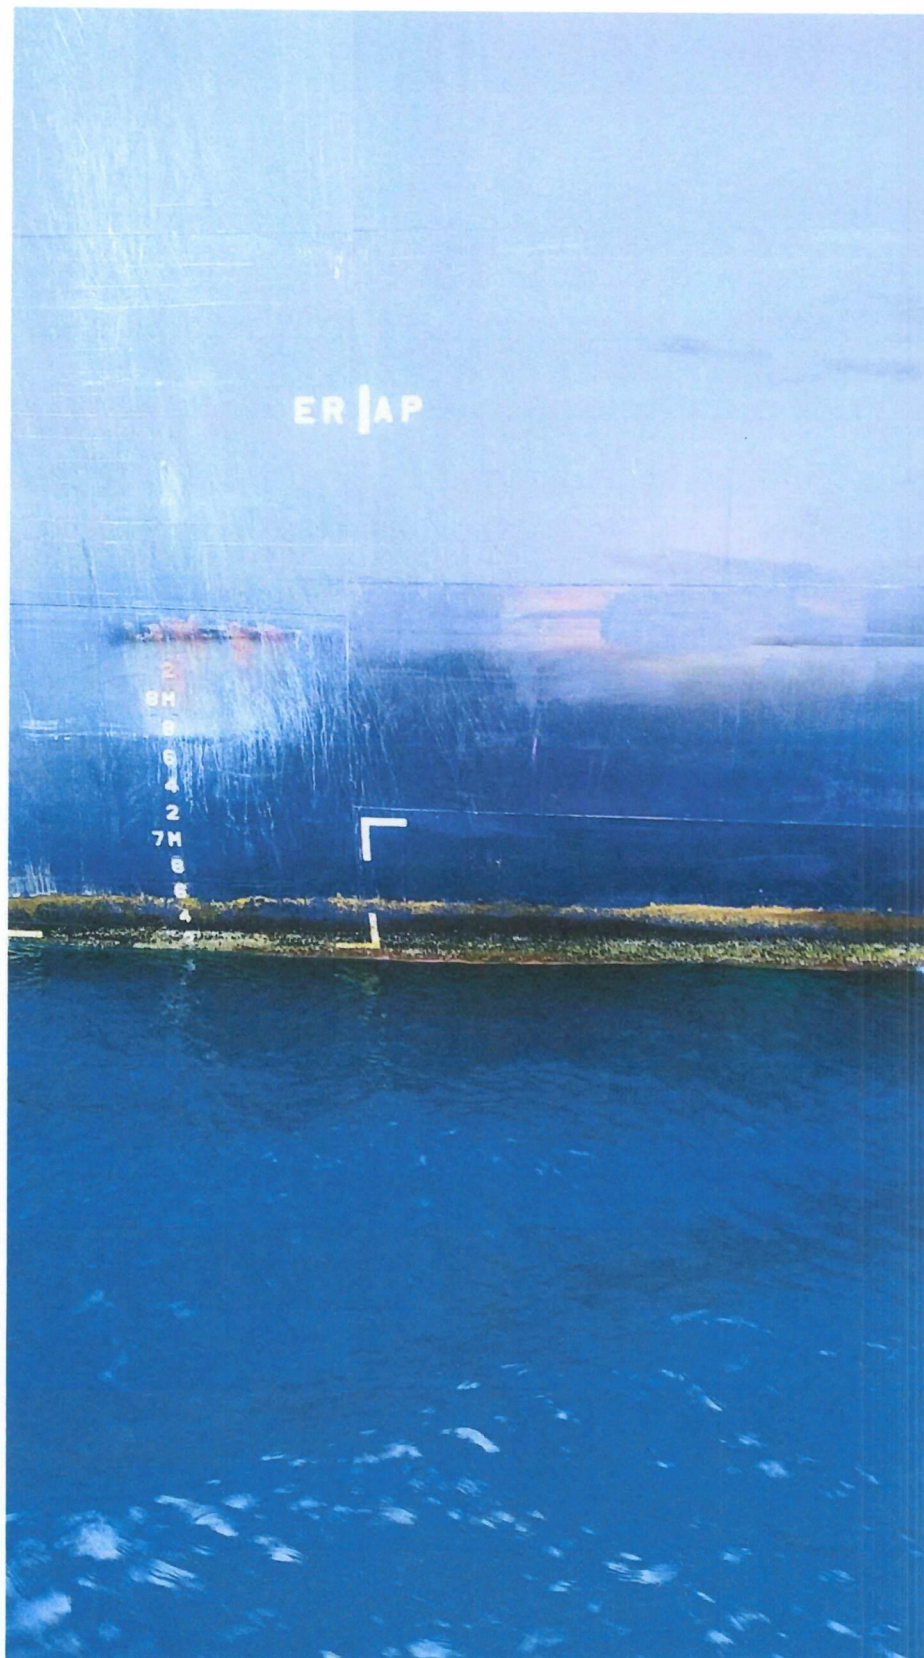
5. Was photograph no.5, hull aft end port side, representative of the condition as seen onboard at the time of the inspection and, if so, was it free of any areas for concern?

*The vessel had been issued with the Class "Asset Note" - "Port side shell set-in frames 9-14 in the way of the purifier room (between S.L. 20-21)". As per the Survey Status Report printed out on 27-May-2025, the Note was issued on 10-May-2025. For details see picture attached to observation 11.1.5.*

Photograph **Photo not representative**

**Photograph supplied: Area/item shown not representative of the overall condition**  
*The ship's hull was affected by marine growth.*

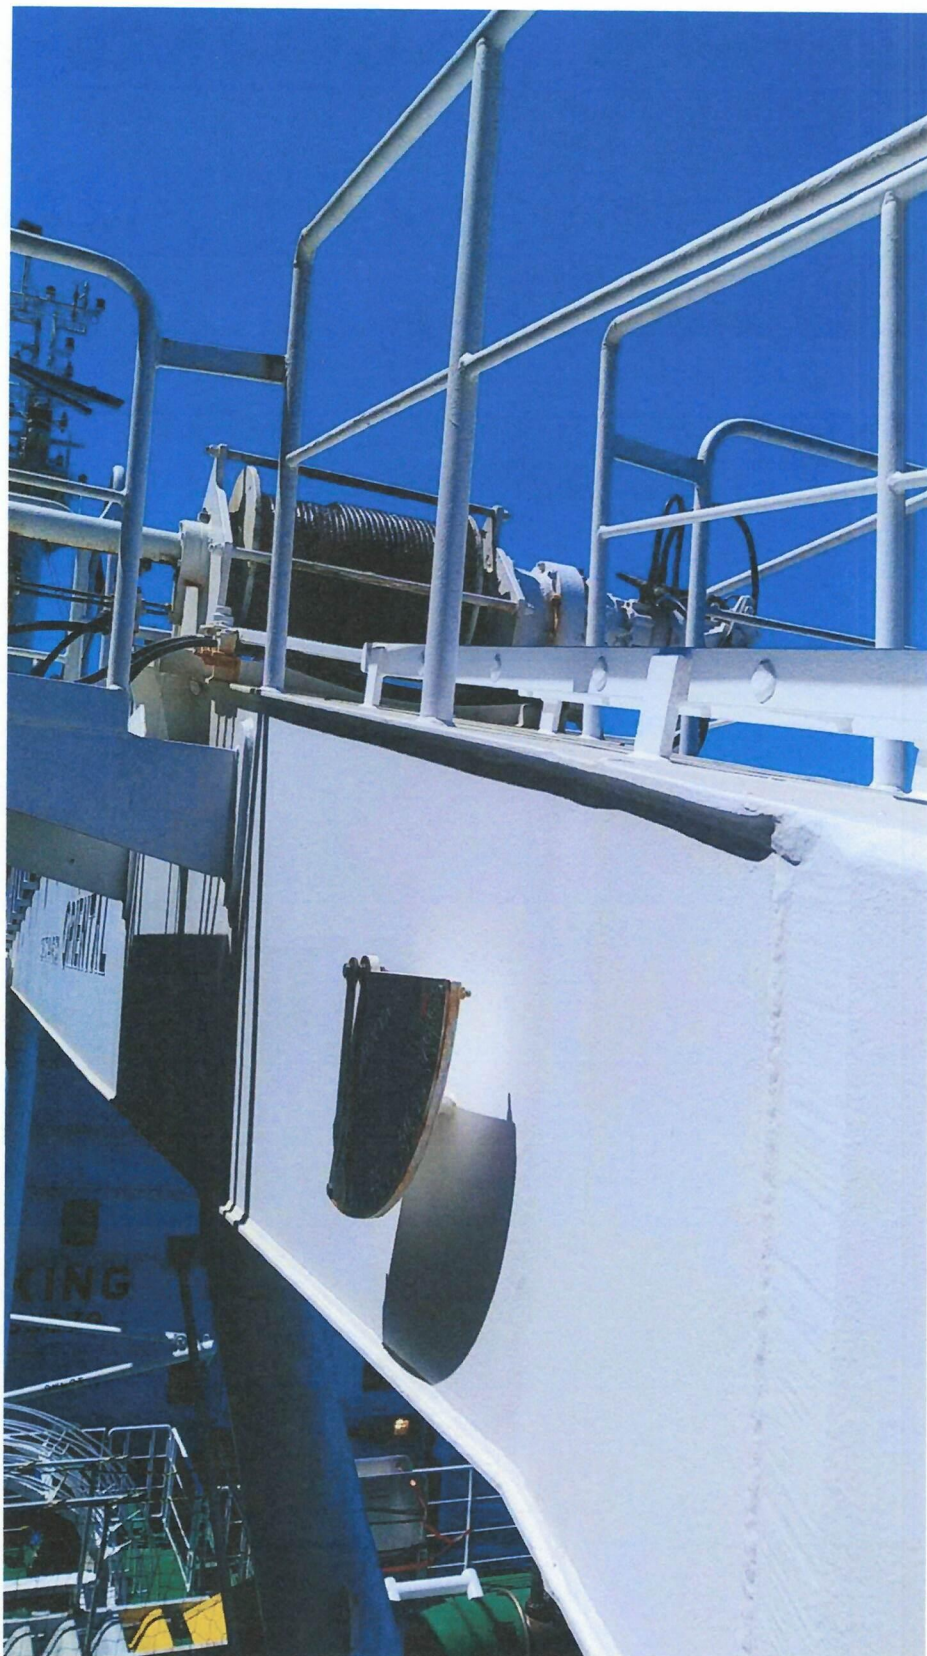
14. Was photograph no.14, one hose crane hoisting winch, stowed wire and limit switches, representative of the condition as seen onboard at the time of the inspection and, if so, was it free of any areas for concern?

Photograph Photo not representative

Photograph supplied: Other - Text

*The requested equipment was not visible in the ship's photo.*
