## STM32L432KB/KC and STM32L442KC device errata

This document applies to the part numbers of STM32L432KB/KC and STM32L442KC devices and the device variants as stated in this page.

It gives a summary and a description of the device errata, with respect to the device datasheet and reference manual RM0394.

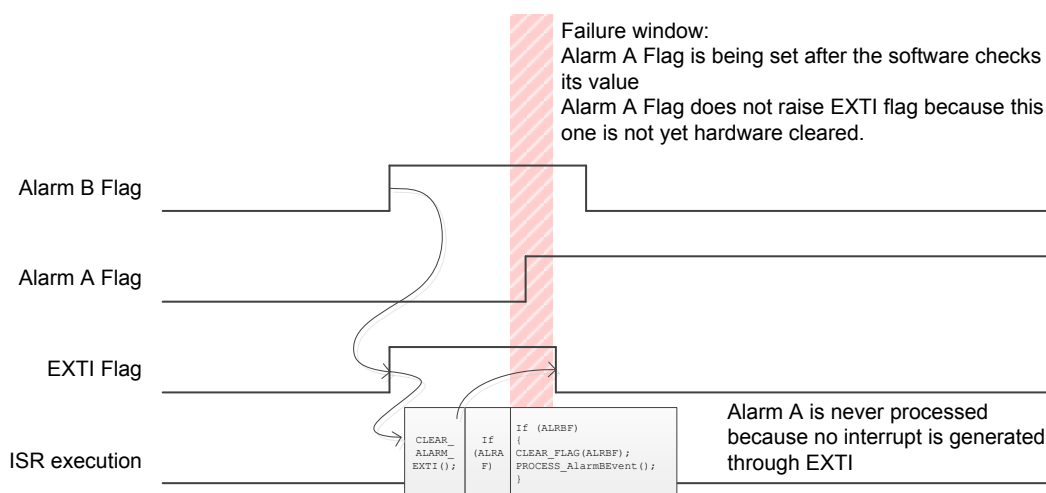
**Figure 1. Masked RTC interrupt**

The following code example and figure illustrate the failure mechanism: The Alarm A event is lost (fails to generate interrupt) as it occurs in the failure window, that is, after checking the Alarm A event flag but before the effective clear of the EXTI interrupt flag by hardware. The effective clear of the EXTI interrupt flag is delayed with respect to the software instruction to clear it.
