AM335x Sitara™ Processors

Silicon Revisions 2.1, 2.0, 1.0

Silicon Errata

Literature Number: SPRZ360G
October 2011 – Revised January 2016

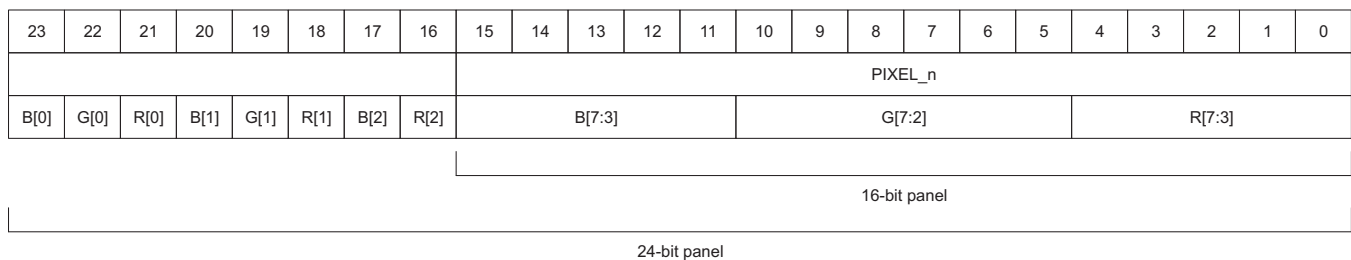
Figure 2. RGB888 Mode LCD Controller Output Pin Mapping (LCD_DATA[23:0])

The blue and red color assignments to the LCD data pins are reversed when operating in RGB888 (24bpp) mode compared to RGB565 (16bpp) mode. In order to correctly display RGB888 data from the SGX, or any source formatted as RGB in memory, it is necessary to connect the LCD panel as shown in [Figure 2](#). Using the LCD Controller with this connection scheme limits the use of RGB565 mode. Any data generated for the RGB565 mode requires the red and blue color data values be swapped in order to display the correct color.
