# PCB Design Review

PCB as received from PCB Engineer

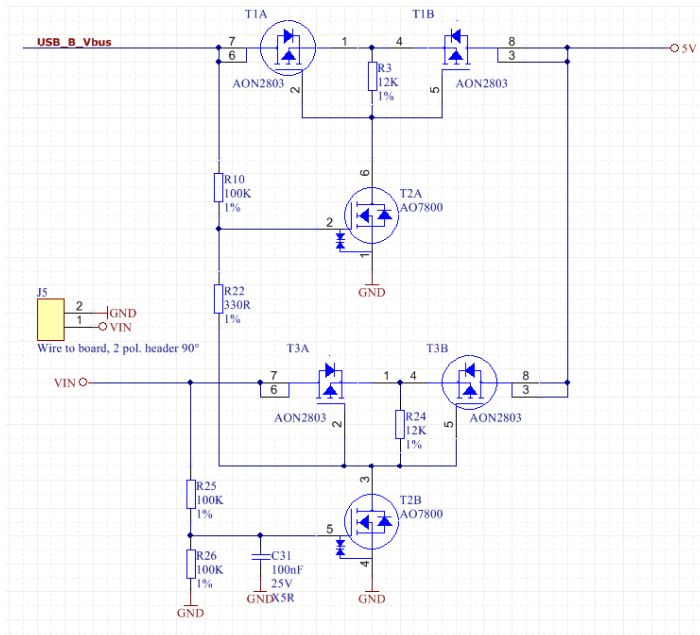
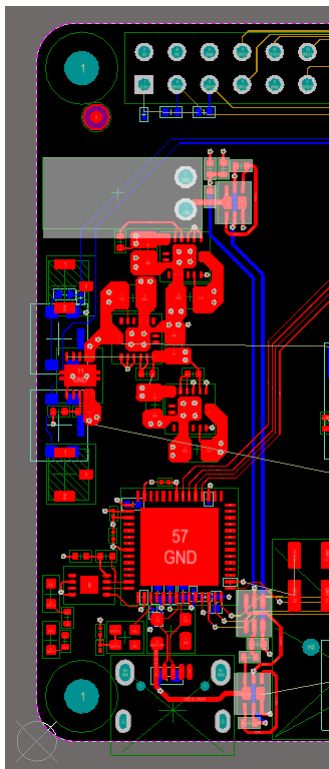
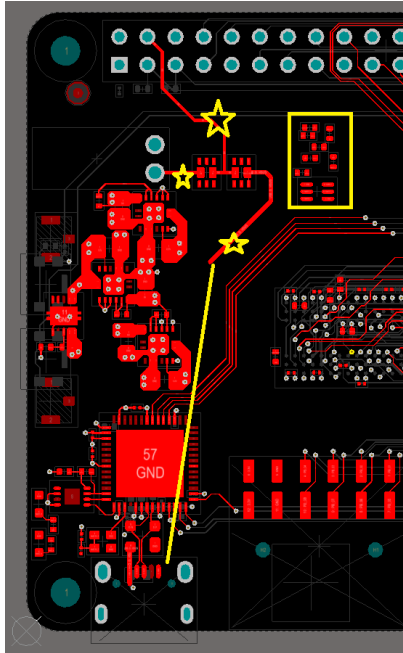
## Issue #1

### Placement and wiring of Power Switch components

Those components build a simple 2 to 1 Power select switch, two inputs and one output.

This is how the components are placed, notice the blue bottom side POWER traces!

This is pre-placement for the two power switches, all wires carrying power are marked with yellow. In the yellow box are additional components that do not carry any current and are not as important as of placement and routing.

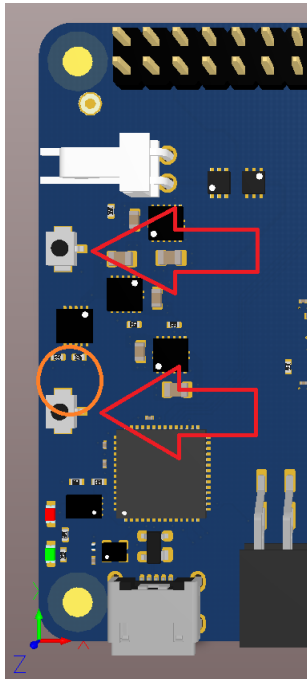
## Issue #2

Placement of components too close to user interface – there are two push-buttons, where it would be better to have more clearance so the fingertips would not touch any electronic components.

Marked with orange is “fingertip” pressing the button and touching LDO feedback resistors!

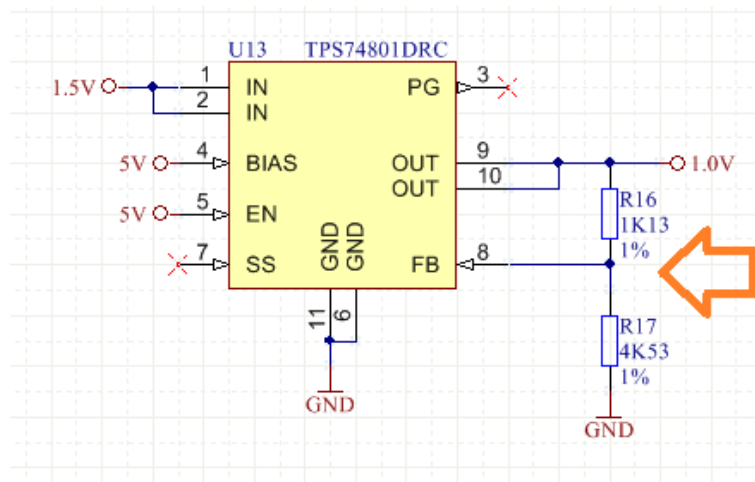
This is where you would touch the feedback pin of the LDO, the most sensitive pin that can cause the output voltage to change and potentially damage some more components.

There was no need to place the LDO that close to the buttons!

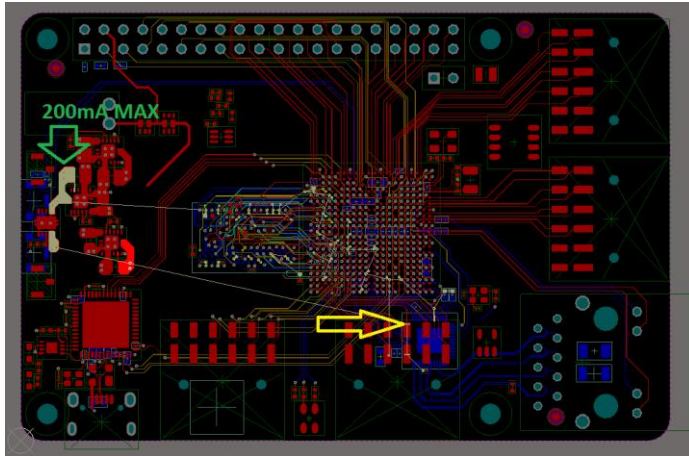
#### Placement of 1.0V LDO

Yellow marks where the Ethernet PHY needs the 1.0V that is powering also sensitive analog circuits, so placing the LDO closer would be also better as of noise coupling. Green marks where the PCB designed did draw a POLYREGION for power signals that can carry maximum of 200mA (typical 95mA). There is no need for polygons for power nets that do not carry significant currents.

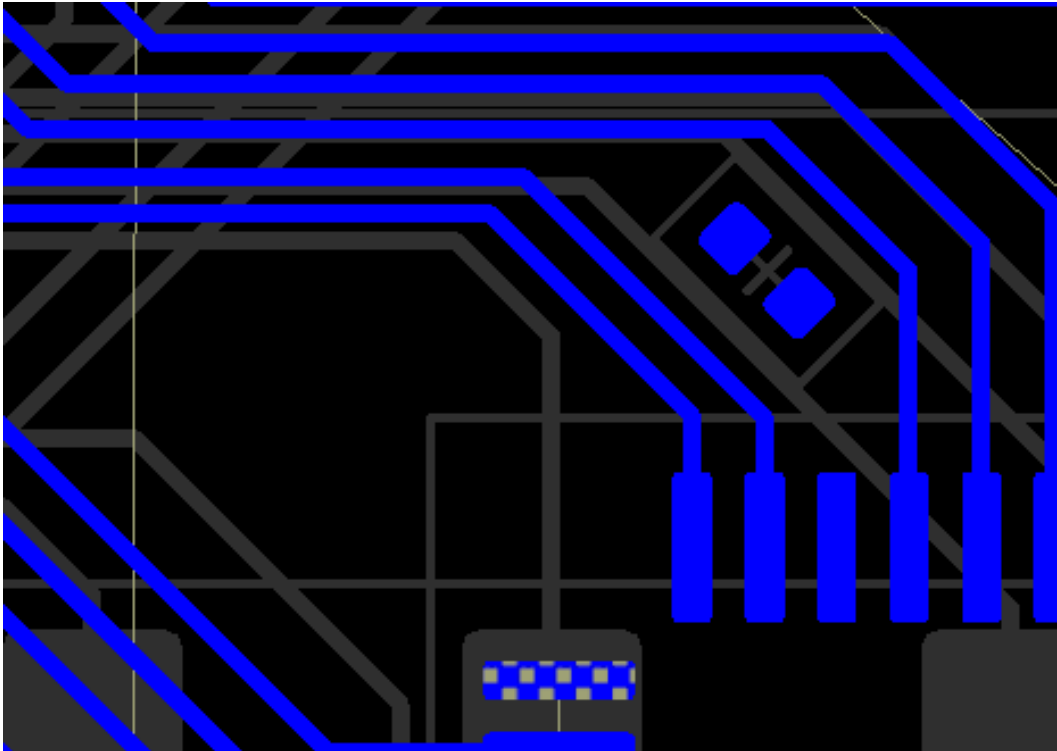
Rotation 45 degrees!?

Only one single component has been rotated by 45 degrees. While assembly at 45 or any other angle is possible it should really if avoided if not really needed.

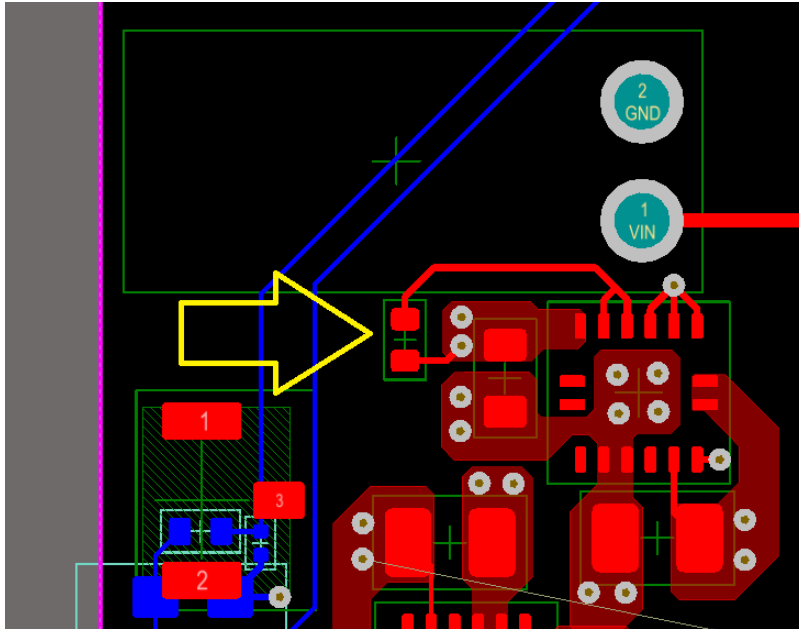
## Issue #5

SMD component too close to connector, potential damage when inserting cable/connector.

Component by arrow is moved to not collide with connector courtyard, so it looks like legal placement.

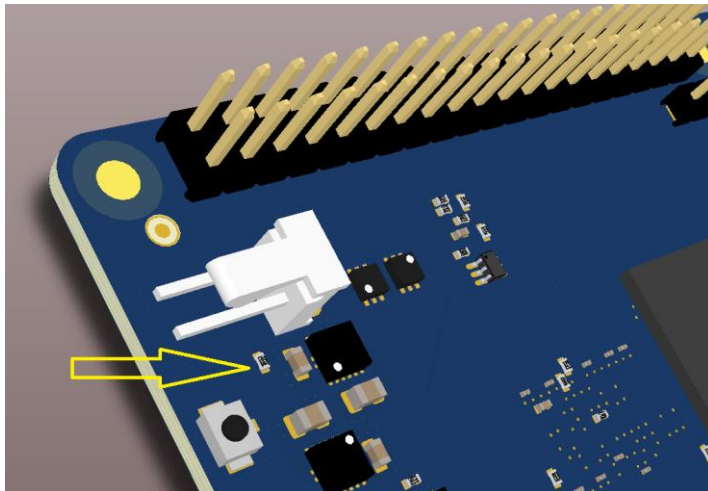
This is how it looks in 3D View, it is clear that there is a danger that connector when plugged in could damage the resistor! And there is absolutely no need to place that resistor so close to the connector.

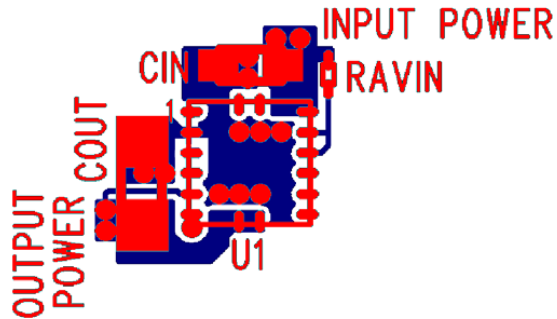
This is IC vendor recommended PCB layout.

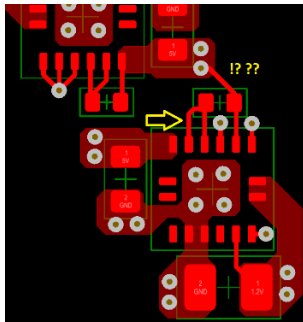
## AVIN routing issue #1

Marked yellow is AVIN input that as per recommendation has to be connected to VIN at Quiet point as visible in the recommended layout. The PCB designer however connected the AVIN first to VID1 and then to VIN of different DCDC converter!

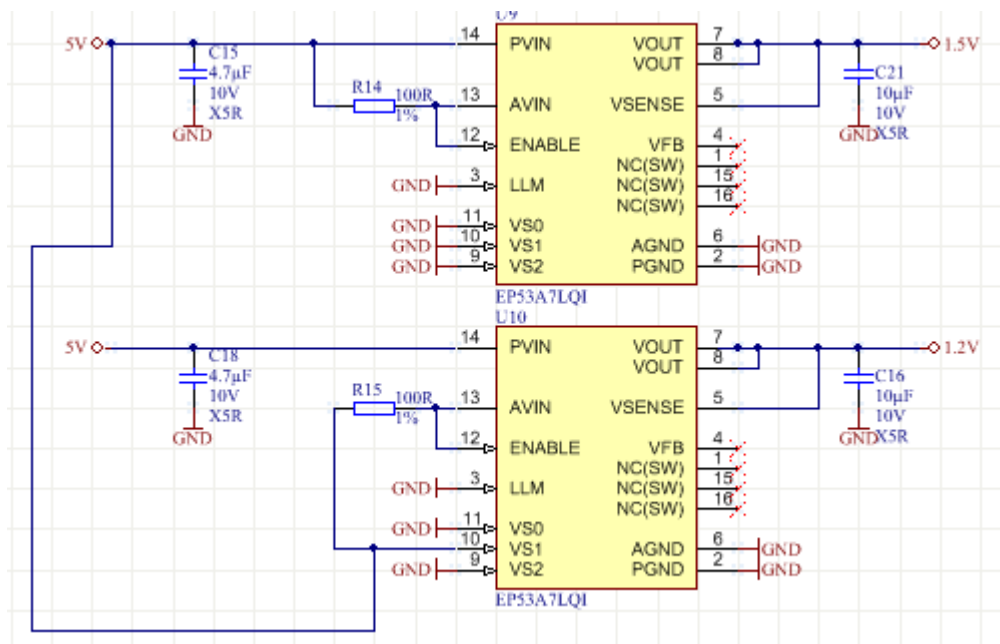
This is how his work would be in “back annotated” schematic:

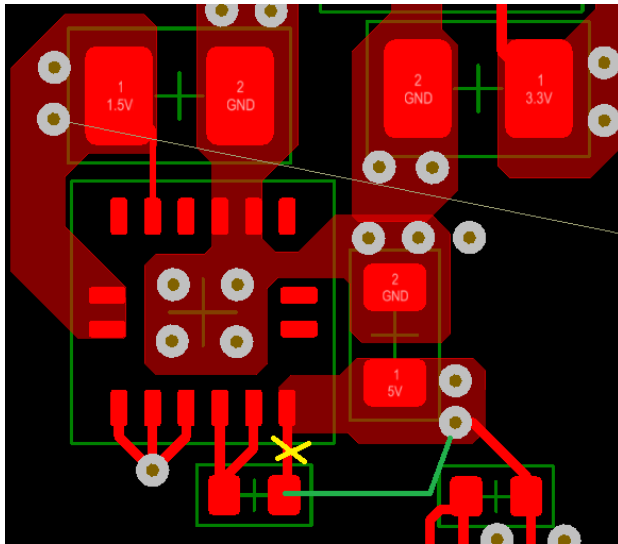
### AVIN routing issue #2

AVIN routing at second DCDC also incorrect, marked green is where the AVIN connection should be.

Third DCDC AVIN connection looks correct, but this is not because PCB engineer did know what or why he is doing, no he had to move the AVIN resistor to correct place because there was a connector that did not allow it to be at wrong place! So it was co-incidence that one AVIN from DCDC was wired correctly.

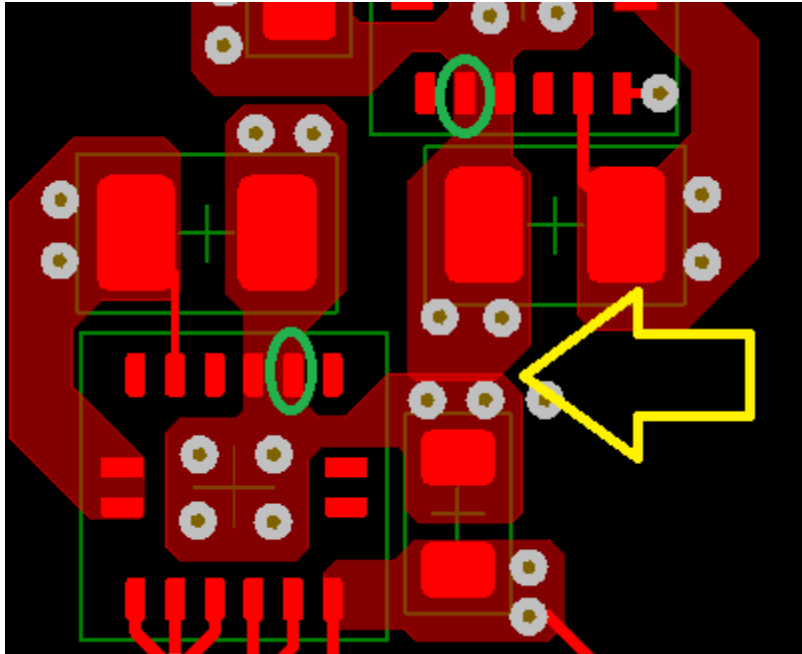
## Issue #8

Incorrect GND connection

GND of VIN Capacitor from one DCDC is with direct top layer copper connected to GND point of VOUT capacitor of another DCDC. In datasheet: Input and output grounds should only connect at PGND pin (marked green).

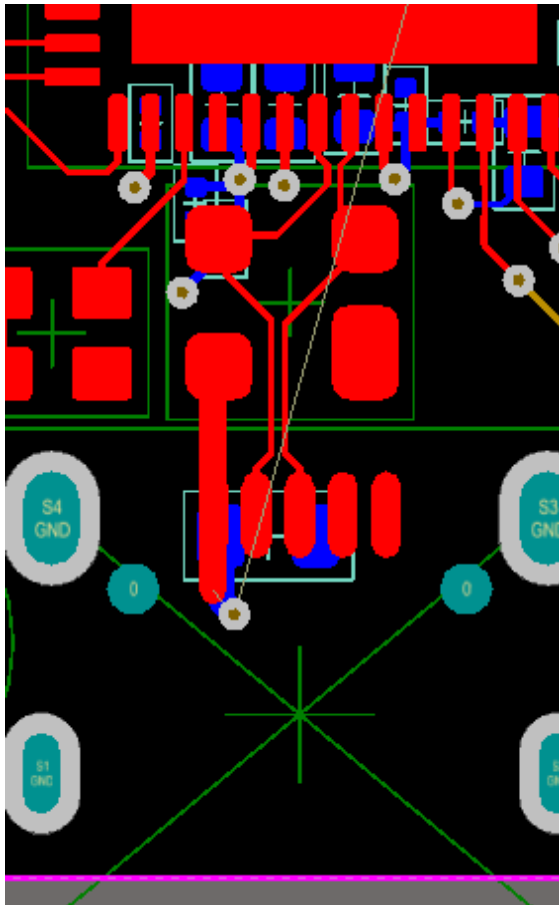
### Differential routing

This looks nasty, could be improved.

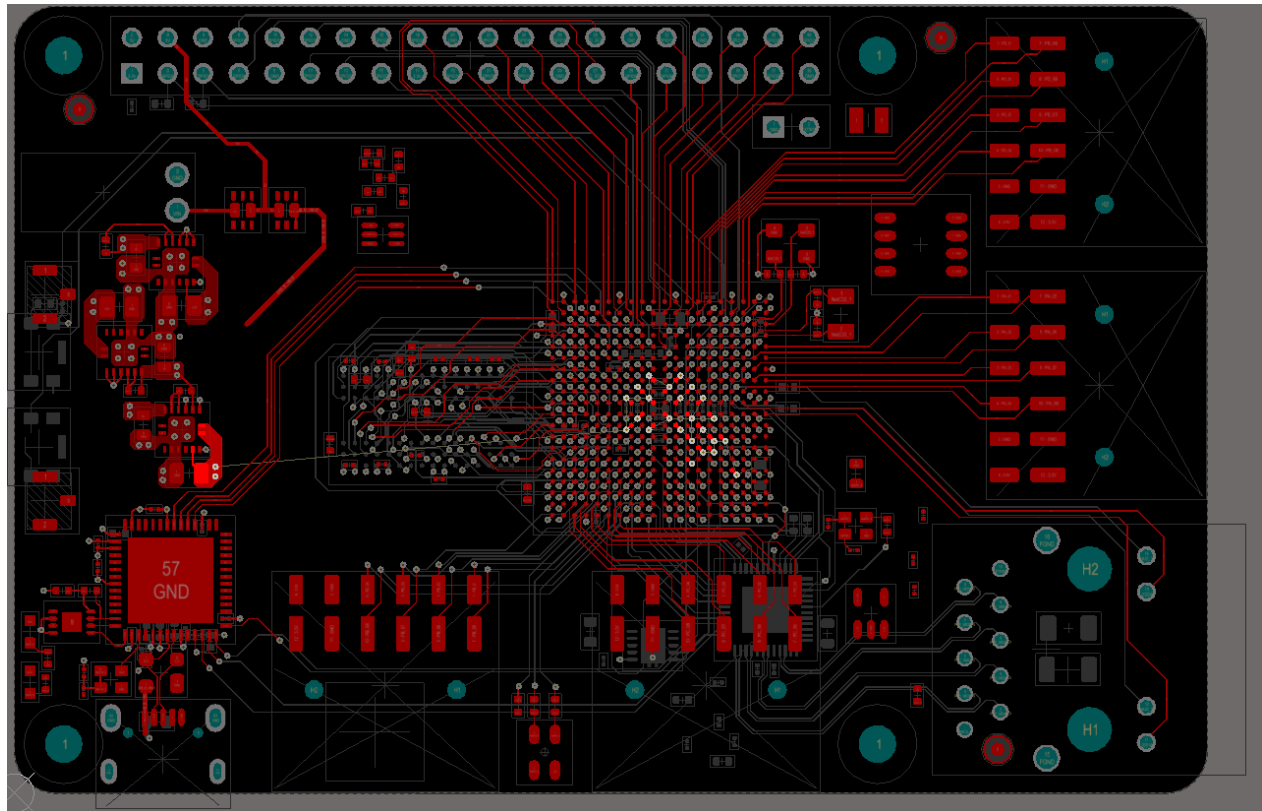
## Issue #10

Bad placement for FPGA Core Voltage DCDC regulator.

DCDC Regulator could be placed much closer to where the current is needed, as is the 1.2V core supply current must go all the way below DDR3 memory to reach the middle of the FPGA BGA Package.

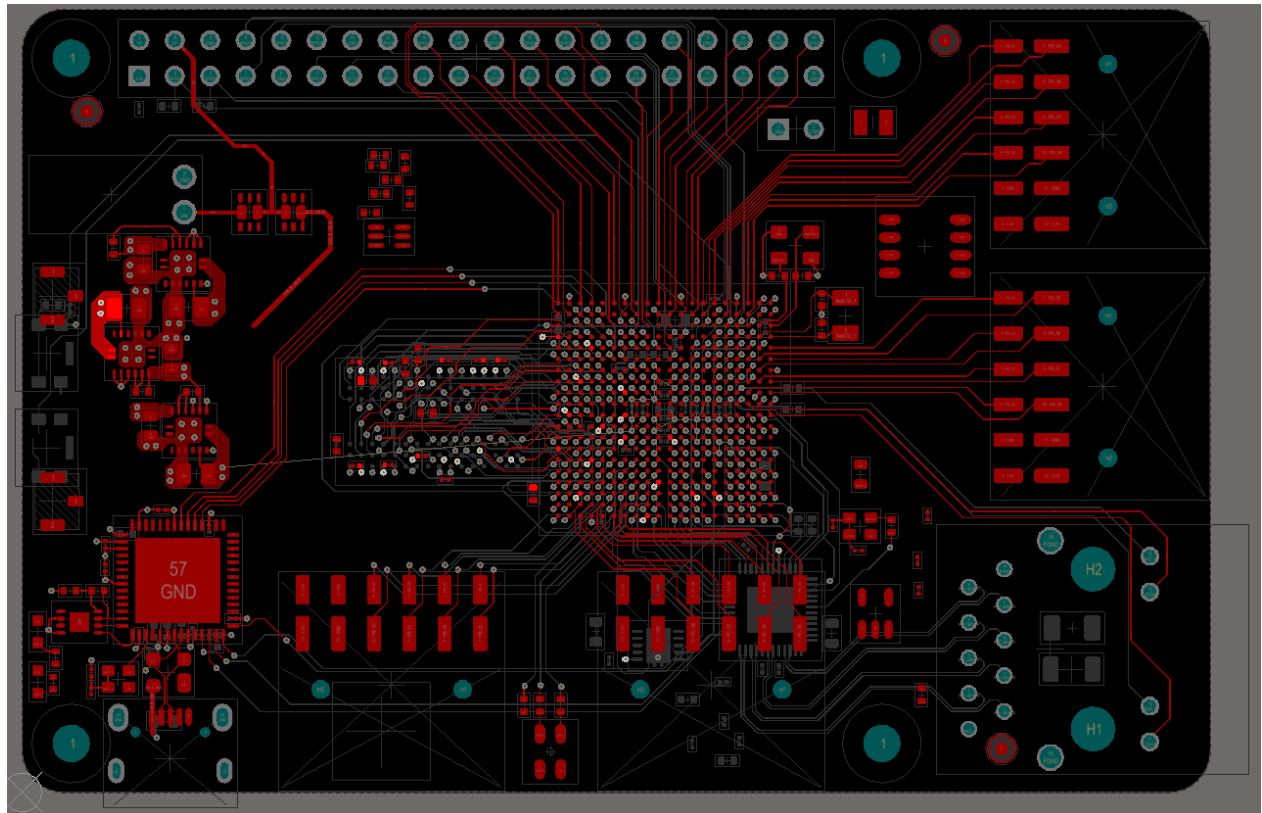
## Issue #11

Bad placement of 1.5V DCDC Regulator

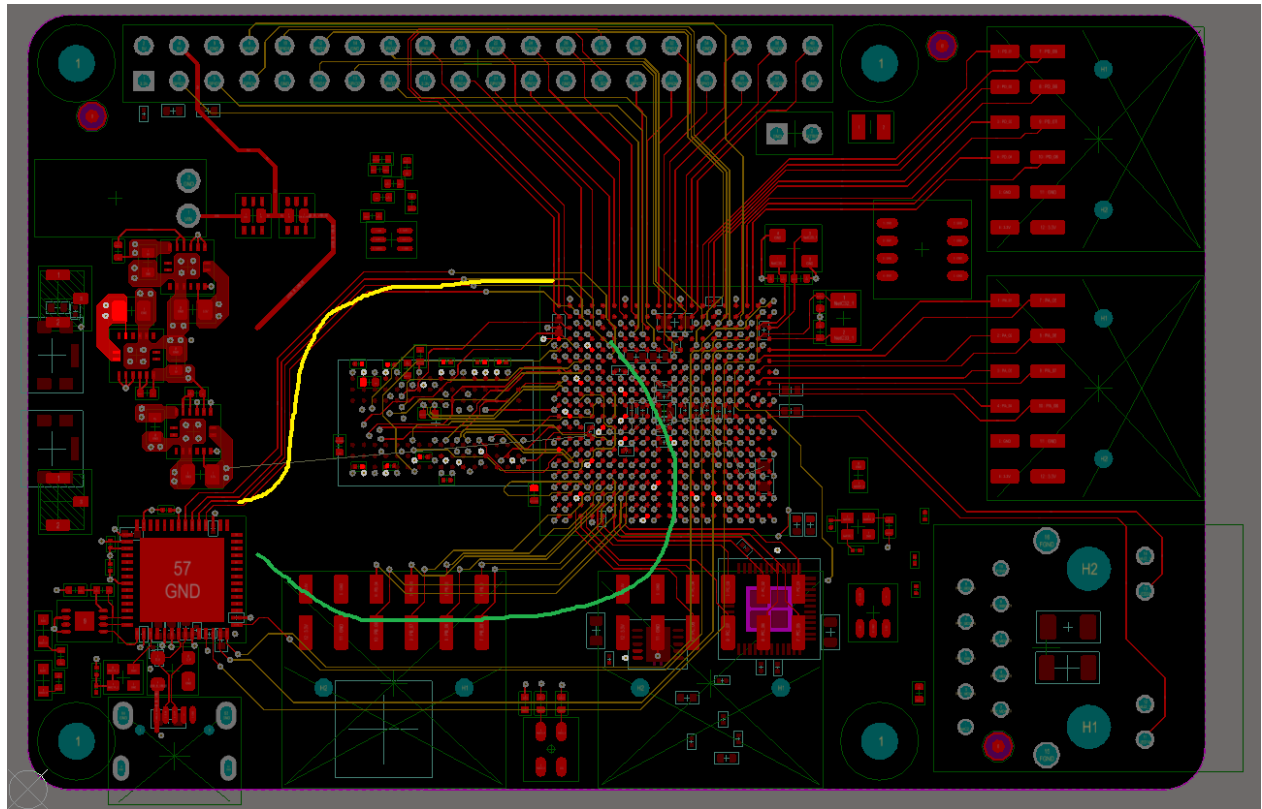
## Issue #12

Routing priority, minor

Marked yellow are traces from PCB engineer, marked green are same traces in inner layer, leaving all the routing resources and TOP layer placement around the yellow line free.
