VEDANTA LIMITED

PRELIMINARY REPORT FOR IN LINE INSPECTION RUN

**14 INCH RD TO RT WATER INJECTION PIPELINE,
10.64 km**

SUBCONTRACT NO- PF-109943-R-24-189

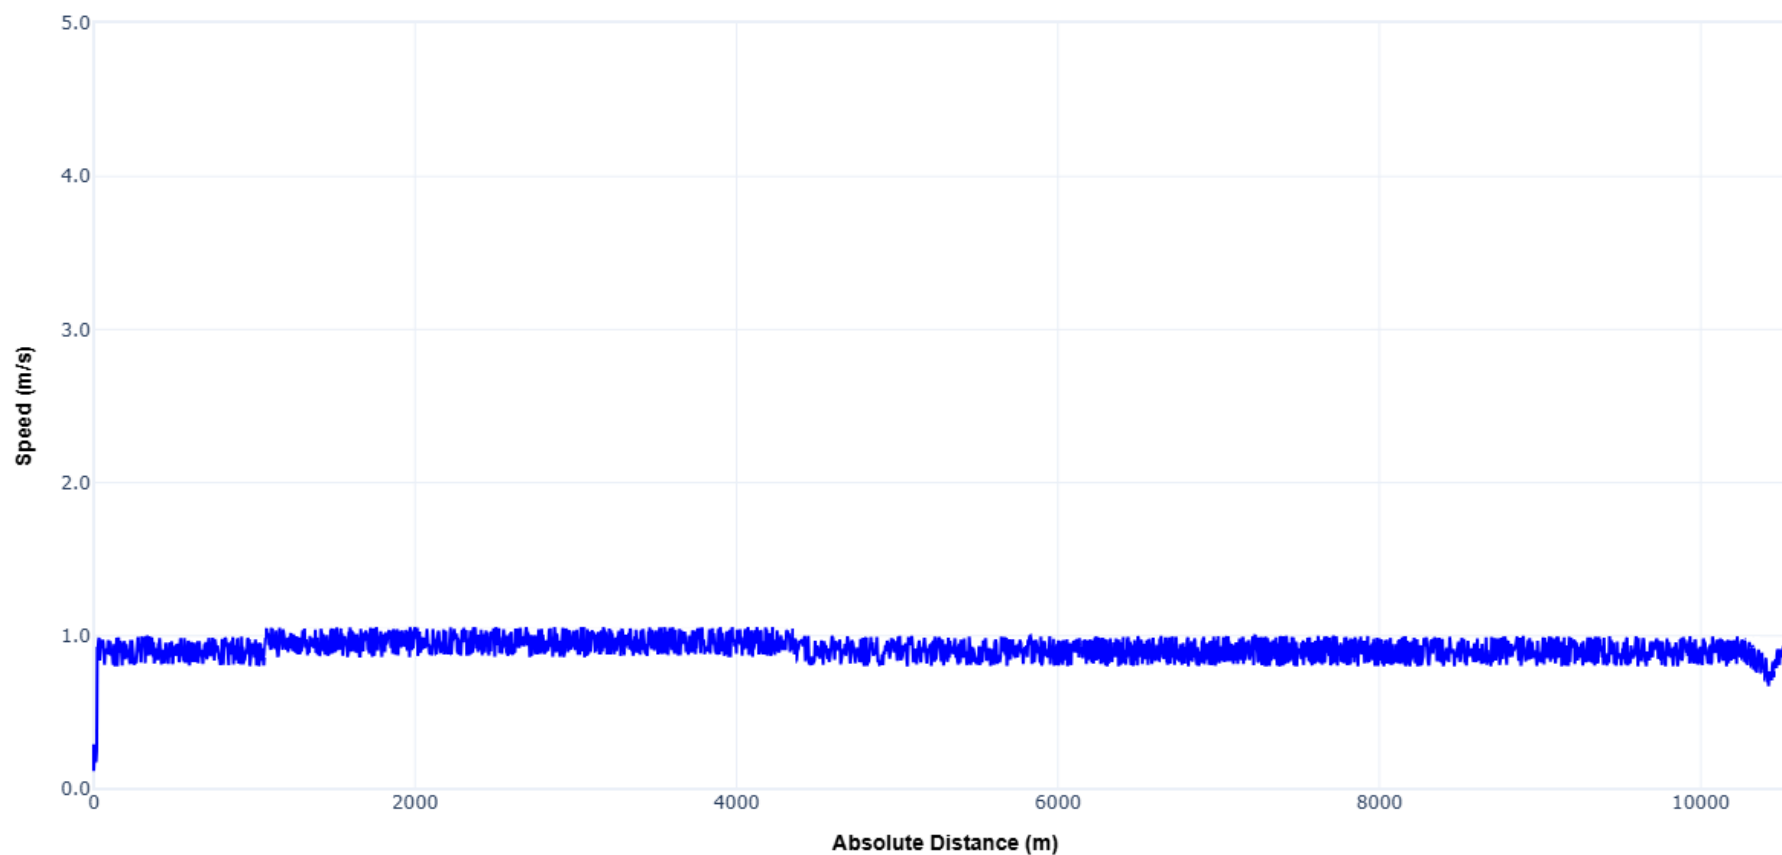
3.2 Speed Profile EGP Tool

Comprehensive details on runs performed during this operation are supplied
The Speed range during the EGP inspection run is between 0.75 m/s to 1 m/s.

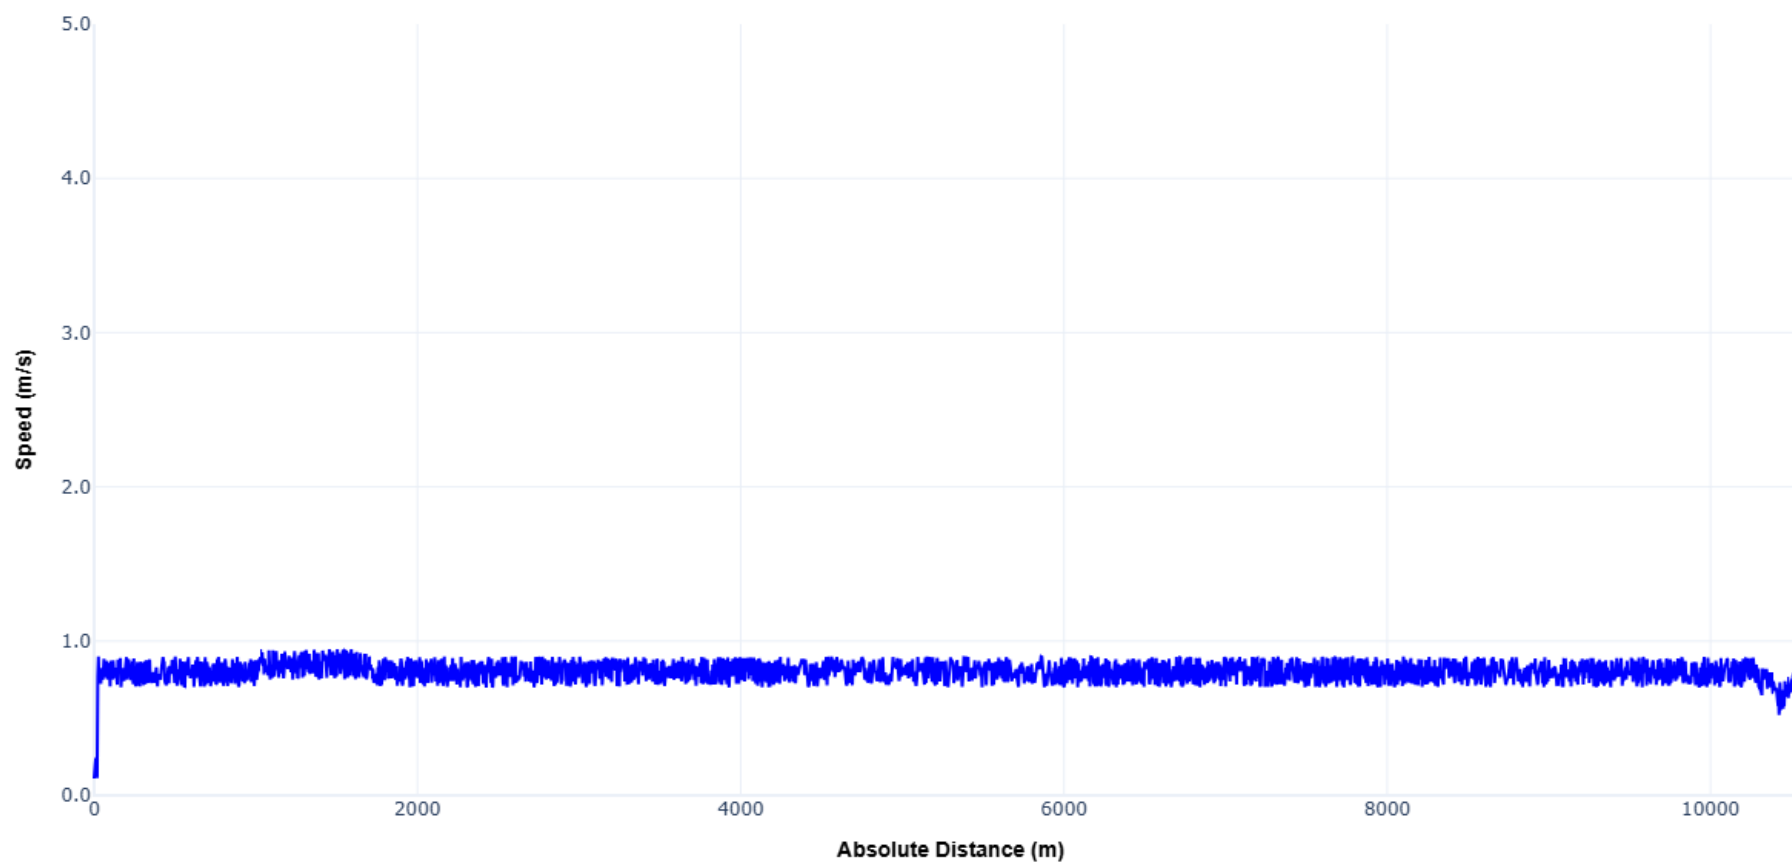
3.6 Speed Profile MFL Tool Run #2

Comprehensive details on runs performed during this operation are supplied
The Speed range during the MFL inspection run is between 0.65 m/s to 0.9 m/s.

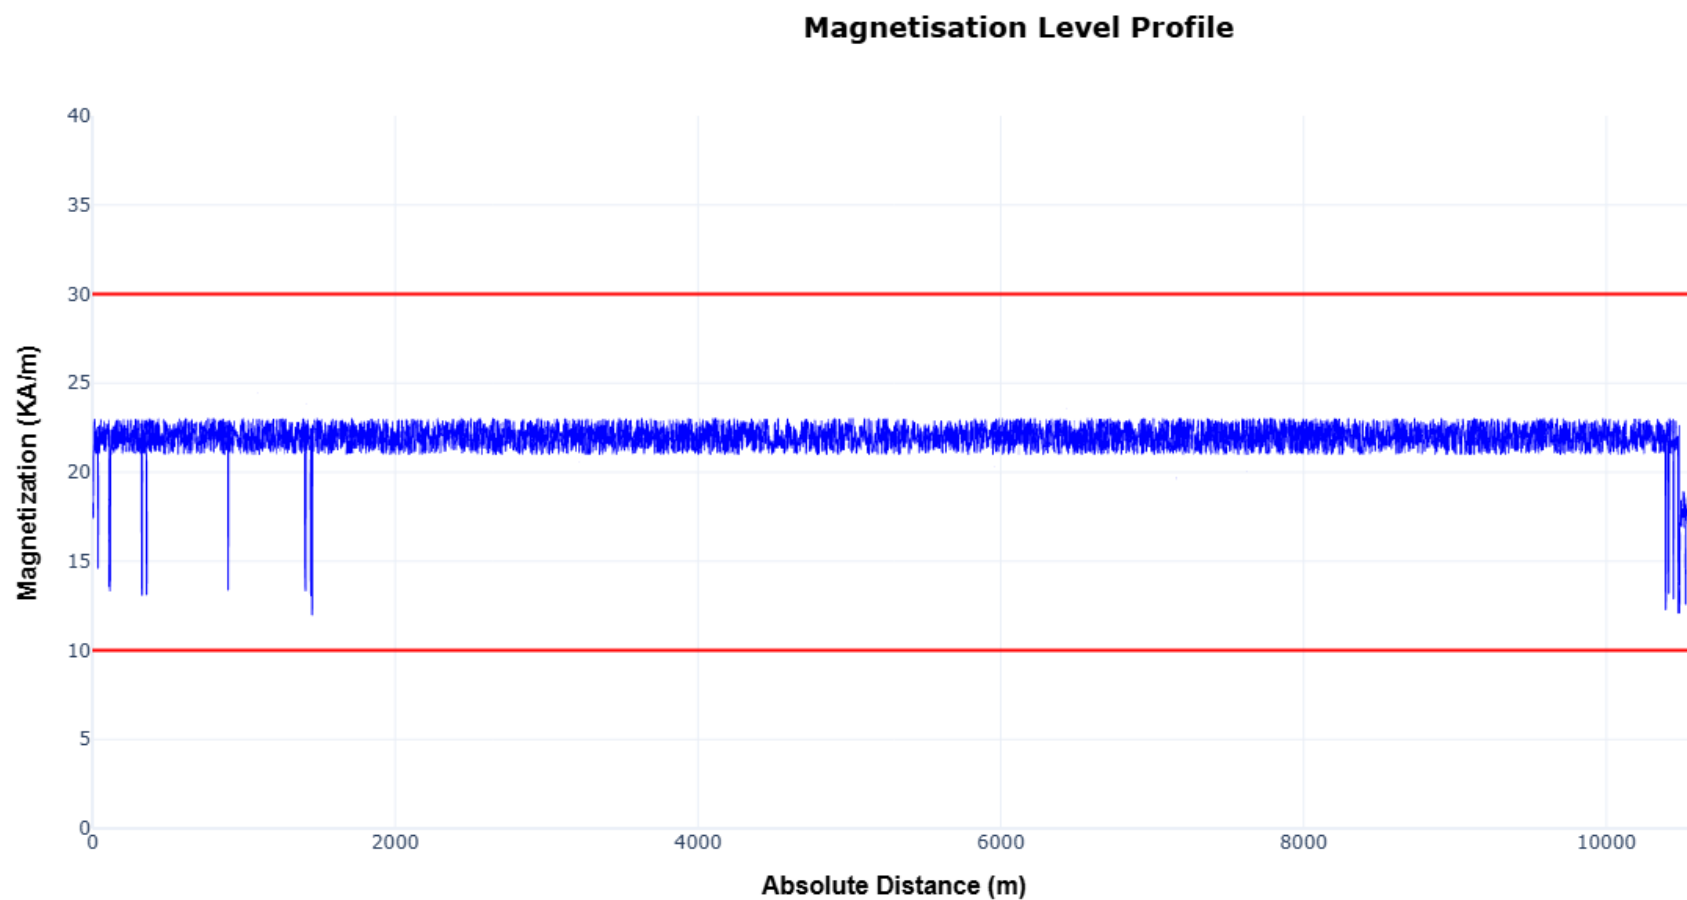
3.8 Magnetization Profile MFL Tool Run #2

Start of Data Recording	Reducer at RD
End of Data Recording	Reducer at RT
Total Recorded length	10.610 Km
Average Speed	0.8 m/s
Magnetization Level	Acceptable
