MODIFICATION No. 23554P3127

TITLE : AIR CONDITIONING - COCKPIT - INTRODUCE PROTECTION AGAINST WATER CONDENSATION.

SERVICE BULLETIN No. : A320-21-1072

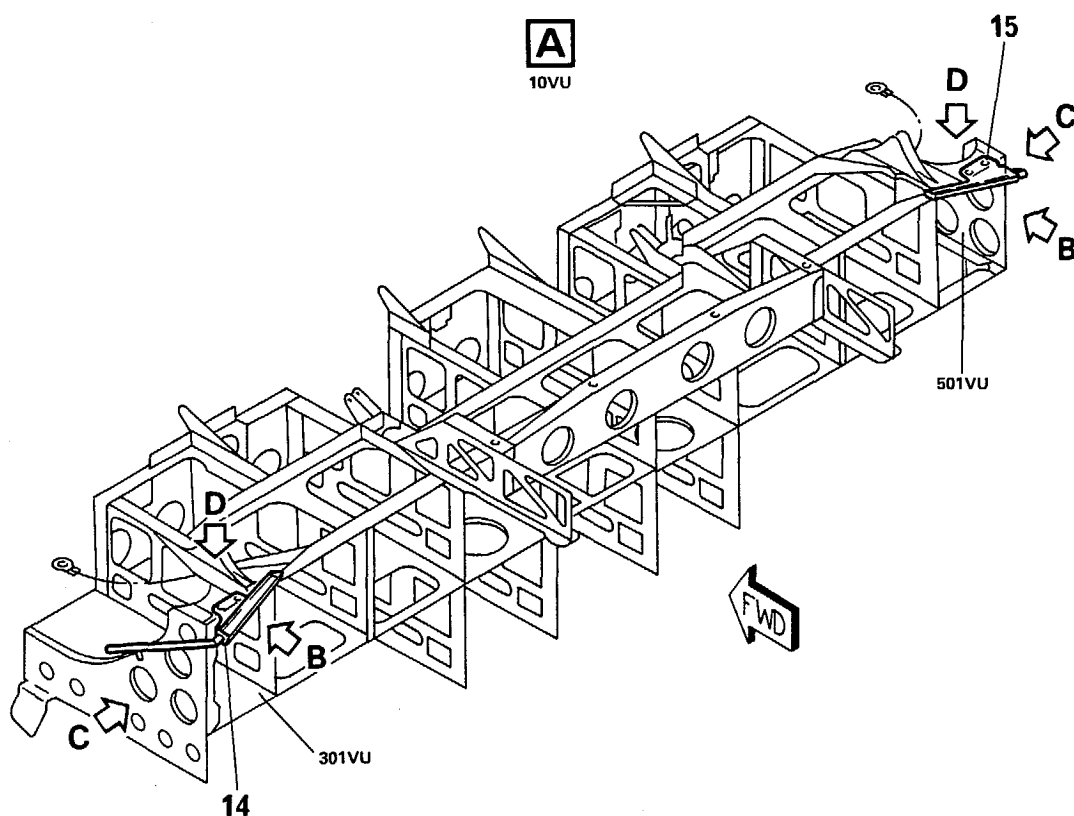
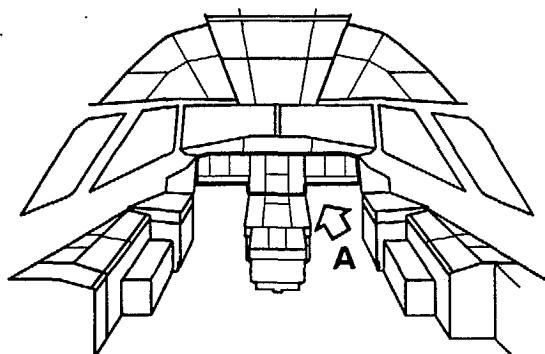
Installation of a Trough under the Lower Post of the Front Window
Frame at 301VU and 500VU
Figure 5, Sheet 1 of 3

Some operators have reported damage and nuisance due to condensed
water ; several locations have been identified mainly on the front
window frame, on the sliding window casings on the cockpit, on the
ceiling visible structures between frame 14 and frame 23 and at the
lower and upper L and R windshield front sections.

- (5) Installation of a trough under the lower post of the front window frame at 301VU and 500VU

- (a) On the structure 10VU, left and right sides, refer to the specified dimensions, make marks and drill the 3.2 mm (0.126 in.) holes to the intermediate diameter.
- (b) Put the trough assies Items 14 and 15 in position on the structure 10VU. Align the hole that is on the trough and on the sides of the structure 10VU.
- (c) Temporarily, attach the trough assies and drill the 4 mm (0.157 in.) holes to the final diameters.
- (d) Remove the trough assies, clean and deburr.

(e) Apply sealant Mat. No. 09-016 (Ref. CML) and install :

1 trough assy	D9251277800000	Item 14
1 trough assy	D9251277800100	Item 15
2 + 2 screws	NAS1096-1-5	Item 17
1 + 1 screw	NAS1100-08-10	Item 19
2 + 2 washers	ASNA2397-6L	Item 20
1 + 1 washer	ASNA2397-8	Item 21
1 + 1 nut	MS21042-08	Item 23
2 + 2 nuts	MS21042-06	Item 24
