TITLE : AIR CONDITIONING - FLOW CONTROL AND INDICATION - INSTALL MODIFIED FLOW  
CONTROL VALVE (FCV) PN 1303A0000-03

SERVICE BULLETIN No. : A320-21-1134

## SERVICE BULLETIN REVISION TRANSMITTAL SHEET

## SERVICE BULLETIN SUMMARY

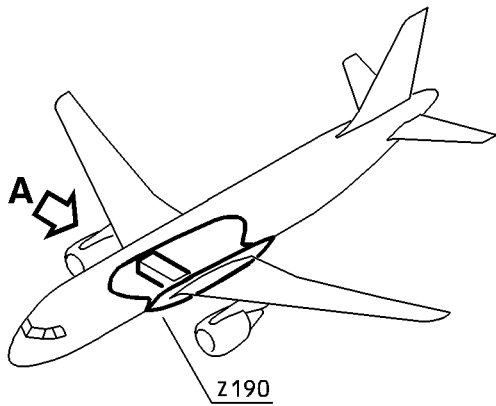
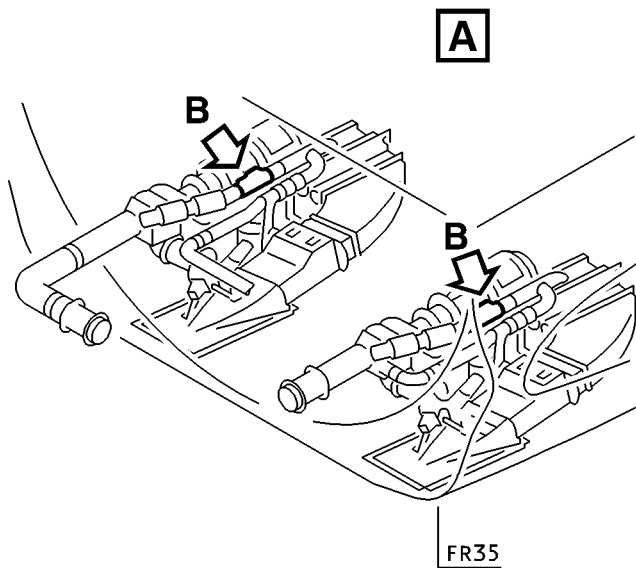
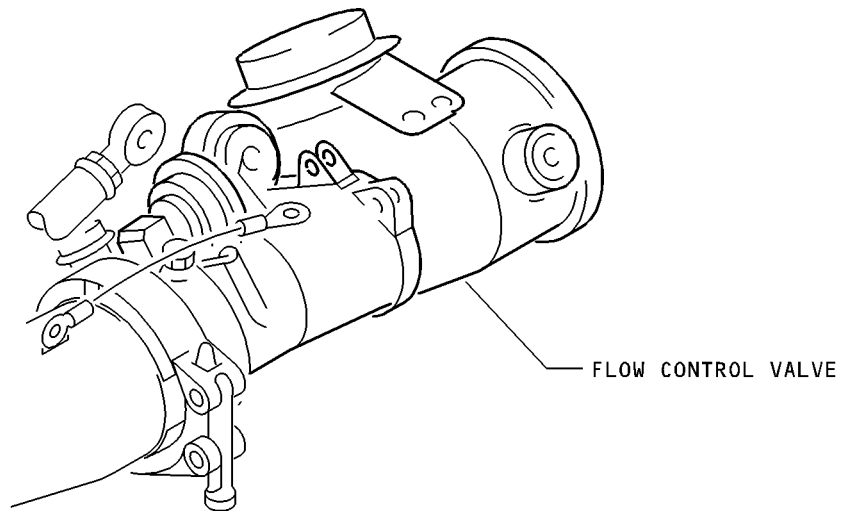
**B**  
TYPICAL

Operators have reported further failures of the Flow Control Valve (FCV) after introduction of the FCV 1303A0000-02. These failures were identified subsequent to difficulties in starting the air conditioning packs, or "air pack 1 (2) fault" or "air pack 1 (2) regul fault" ECAM warnings. The fault was cleared by replacement of the FCV. Operators have also experienced cases where the opposite pack was set to default high flow.

This Service Bulletin advises operators of the issue of LIEBHERR-AEROSPACE Service Bulletin No. 1303-21-03 which details the procedure to replace the existing flow control valves 8HB and 11HB by modified valves. The new, improved valves incorporate numerous modifications including a new overpressure limitation clapper.

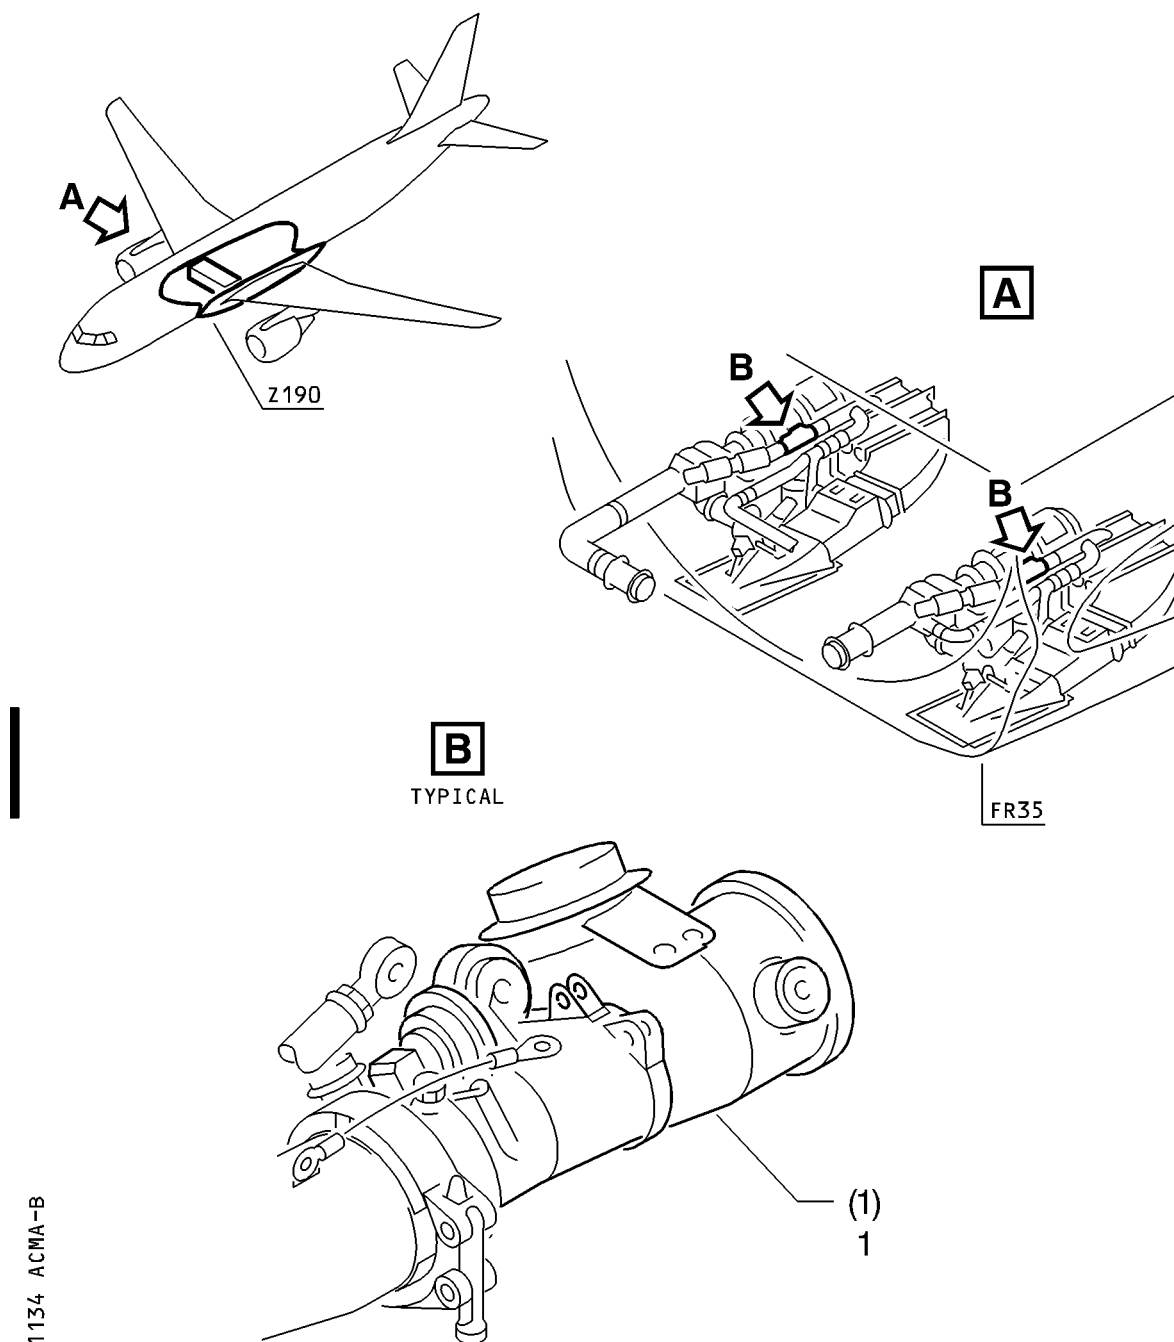
Figure 1 Sheet 1  
Removal/Installation of the Flow Control Valves 8HB and 11HB

Operators have reported further failures of the Flow Control Valve (FCV) after introduction of the FCV 1303A0000-02. These failures were identified subsequent to difficulties in starting the air conditioning packs, or "air pack 1 (2) fault" or "air pack 1 (2) regul fault" ECAM warnings. The fault was cleared by replacement of the FCV. Operators have also experienced cases where the opposite pack was set to default high flow.

- (1) Remove/Install the Flow Control Valves (FCV) 8HB and 11HB.

- (a) Remove, refer to AMM 21-51-51 Page block 401 :

- (b) Modify the FCVs, refer to LIEBHERR AEROSPACE Service Bulletin No. 1303-21-03.

- (c) Install, refer to AMM 21-51-51 Page block 401 :
