SERVICE BULLETIN
SUMMARY

TITLE: AIR CONDITIONING - DISTRIBUTION - INSPECTION OF DRAIN PIPES**MODIFICATIONS**

SERVICE BULLETIN No.: A320-21-1174

A318/A319/A320/A321

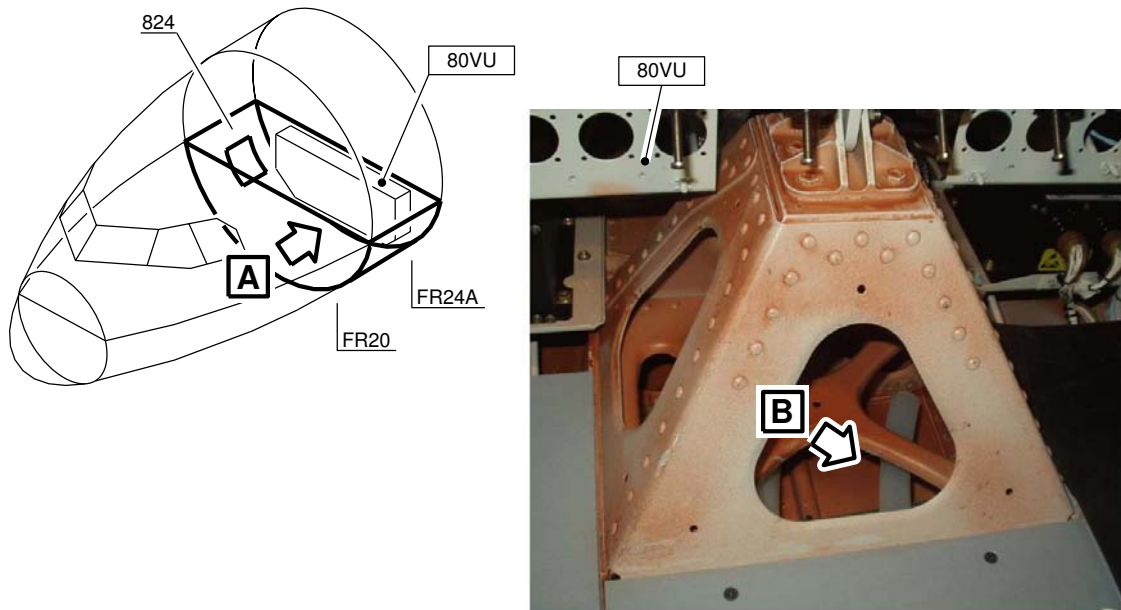
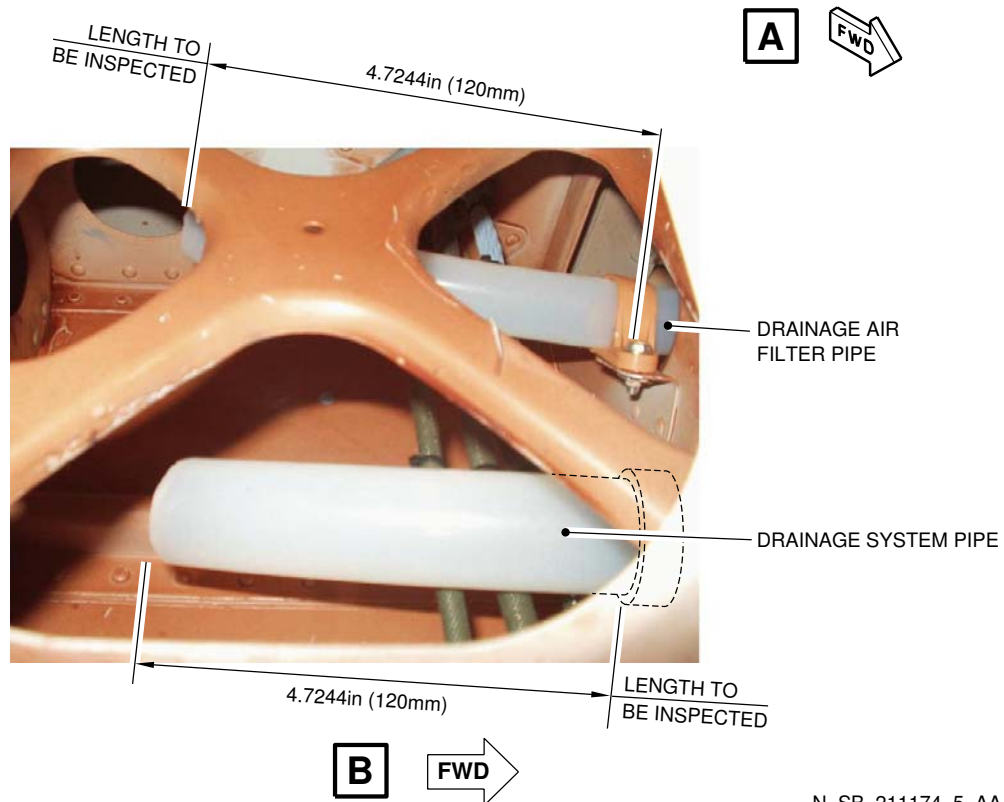
Figure A-FAAAA - Sheet 01
AREA TO BE INSPECTED.

Air filter drain pipe and cabin floor grid drain pipe have been found too short during Final Assembly Line Inspection. Following a new issue of drainage system installation drawing, drain pipe length after the last clamp moved from 1.9685 in. (50 mm) to 4.7244 in. (120 mm). The modification of that dimension is linked to windmilling modification which moves the 80VU support pyramid forward. However on some aircraft having had this windmilling modification the length of the drain pipes after the last clamp remained with 1.9685 in. (50 mm); This defect can lead to dripping of drainage liquid on electrical wires (routes 1M, 2M, 1S, 2S)

- (a) For the inspection area, Refer to [Fig. A-FAAAA](#)
- (b) Do a detailed visual inspection, Refer to [Fig. A-FABAA](#)
- (c) For the inspection report, Refer to [Fig. A-FADAA](#)
