Service Bulletin

Number: 737-27-1282
Original Issue: March 15, 2007
Revision 2: September 04, 2015
ATA System: 2721

SUBJECT: FLIGHT CONTROLS - Rudder and Rudder Trim Control System - Wire Bundle W443
and Left Forward Rudder Quadrant Clearance Inspection

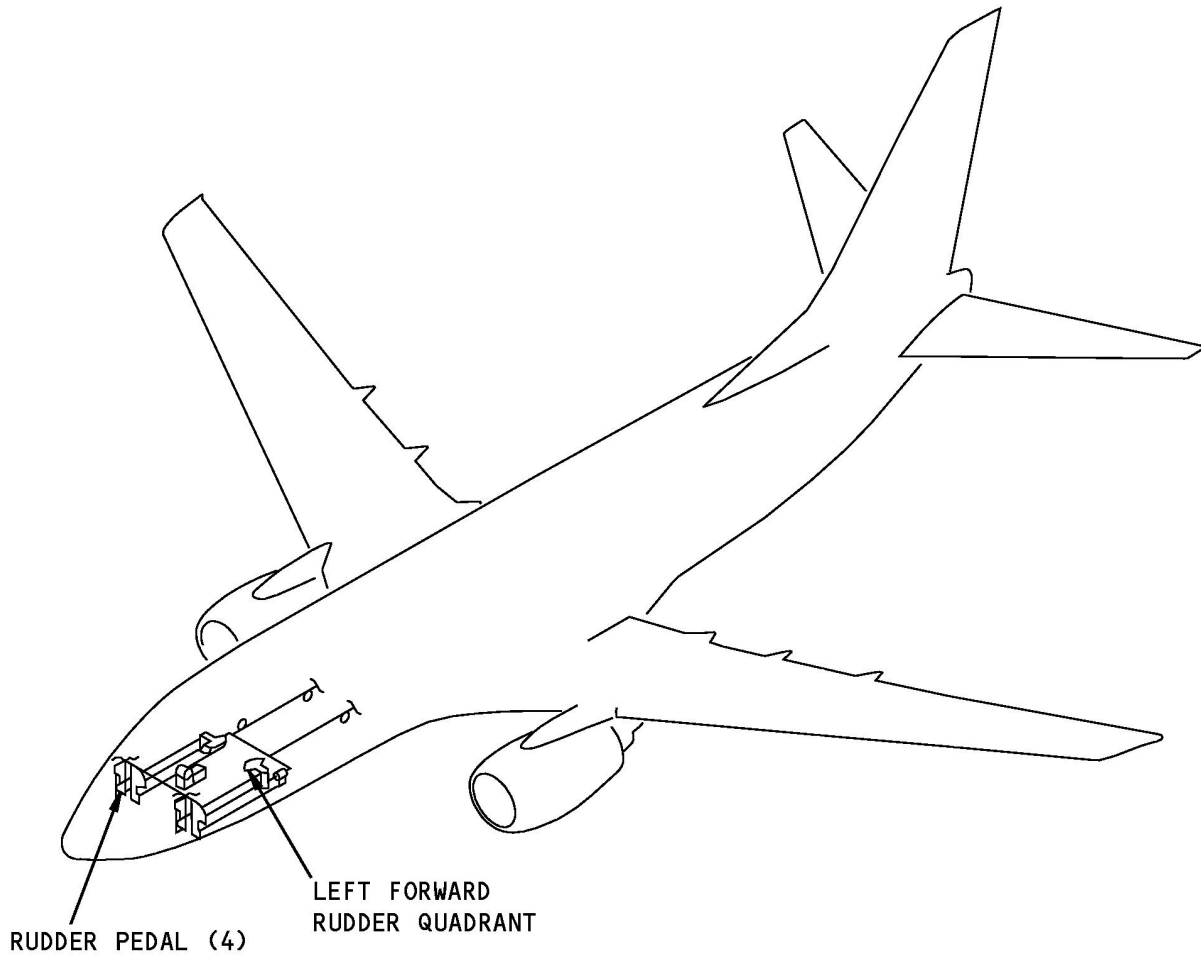
1319650

DO AN INSPECTION OF WIRE BUNDLE W443 AT THE LEFT FORWARD RUDDER QUADRANT TO CHECK FOR DAMAGE, MEASURE THE CLEARANCE BETWEEN THE QUADRANT AND WIRE BUNDLE. REPAIR ANY DAMAGE FOUND, ADJUST WIRE BUNDLE ROUTING AS NECESSARY TO OBTAIN THE MINIMUM PERMITTED CLEARANCE OF 0.5 INCH.

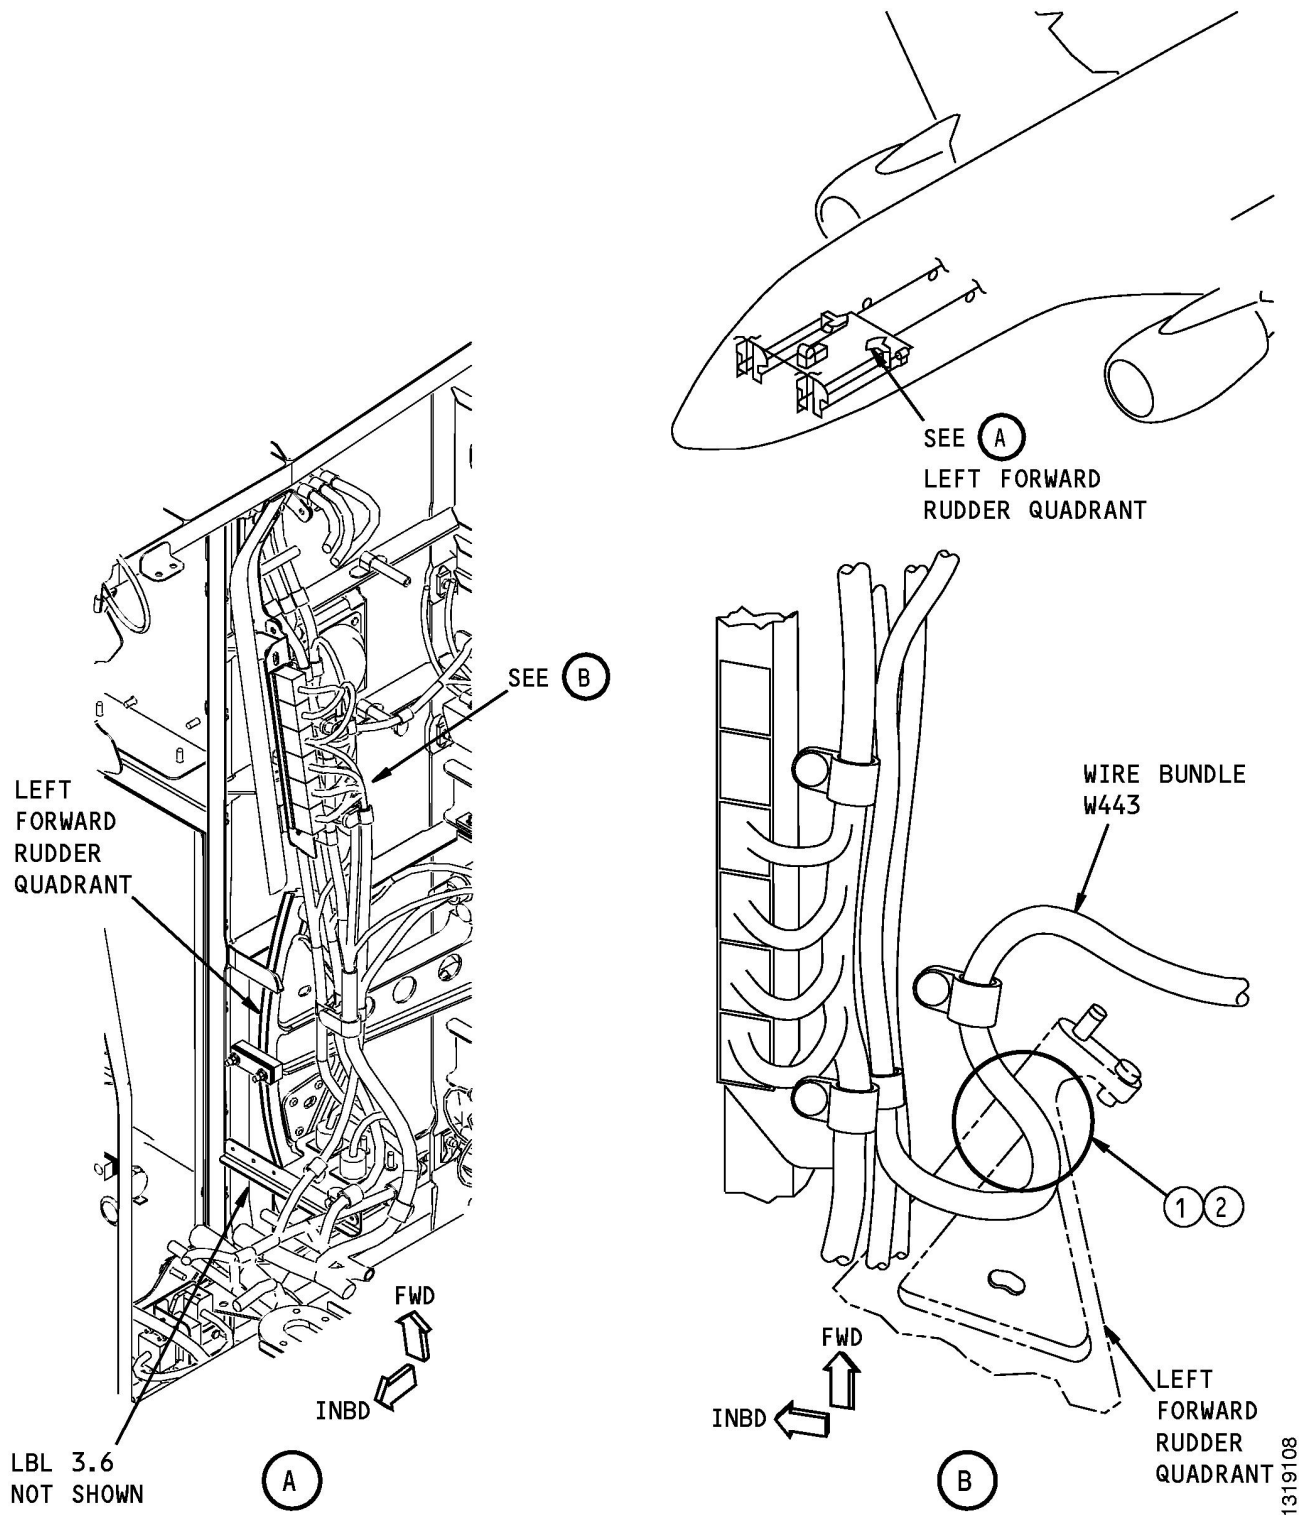
**FIGURE 1: WIRE BUNDLE W443 INSPECTION FOR DAMAGE
(SHEET 1 OF 2)**

This service bulletin is sent to tell operators that on some airplanes an interference (riding) condition may exist between wire bundle W443 and the Left Forward rudder quadrant. The interference can occur during full Right Rudder travel. Restricted control surface movement and wire bundle damage can occur when there is not sufficient clearance between wire bundle W443 and the left forward rudder quadrant. If this Service Bulletin is not done, the wire bundle could restrict the free movement of the rudder quadrant. If the wire bundle is damaged, uncommanded stabilizer trim or autopilot disconnects could occur.

5. Part 1: Wire Bundle W443 Inspection for damage.
 - a. Push and hold the pilot's right rudder pedal fully to the travel stops.
 - b. Do a detailed inspection of the wire bundle W443 for damage and measure for a minimum clearance of 0.5 inch in accordance with FIGURE 1.

STEP	TASK	NAME	IDENTIFICATION	QTY	MORE DATA
1	Inspect	Wire Bundle	W443	-	do a detailed inspection for damage to the wire bundle protection sleeve, and/or damage to the wire jacket or insulation. (a)
2	Measure	Wire Bundle Clearance	W443	-	for a minimum clearance of 0.5 inch from left forward rudder quadrant full travel motion.
(a) Refer to SWPM 20-10-13 and SWPM 20-10-06, as accepted procedures.

- (1) If the wire bundle is not damaged and a minimum 0.5 inch clearance exists between the forward rudder quadrant, then put the airplane back to a serviceable condition.

- (2) If the wire bundle is not damaged and a 0.5 inch clearance does not exist between the forward rudder quadrant, then do Part 2: Wire Bundle W443 Clearance Adjustment.

- (3) If the wire bundle is damaged then repair in accordance with Part 3: Wire Bundle W443 Repair and Clearance Adjustment.
 - c. Slowly release the pilot's right rudder pedal fully.
