A320/A321

SERVICE BULLETIN CHANGE NOTICE

S.B. No. A320-21-1028 REV. 3
Mod. No. 20752P1057

TITLE : AIR CONDITIONING - COCKPIT CLIMATIZATION THERMAL COMFORT
IMPROVEMENT.

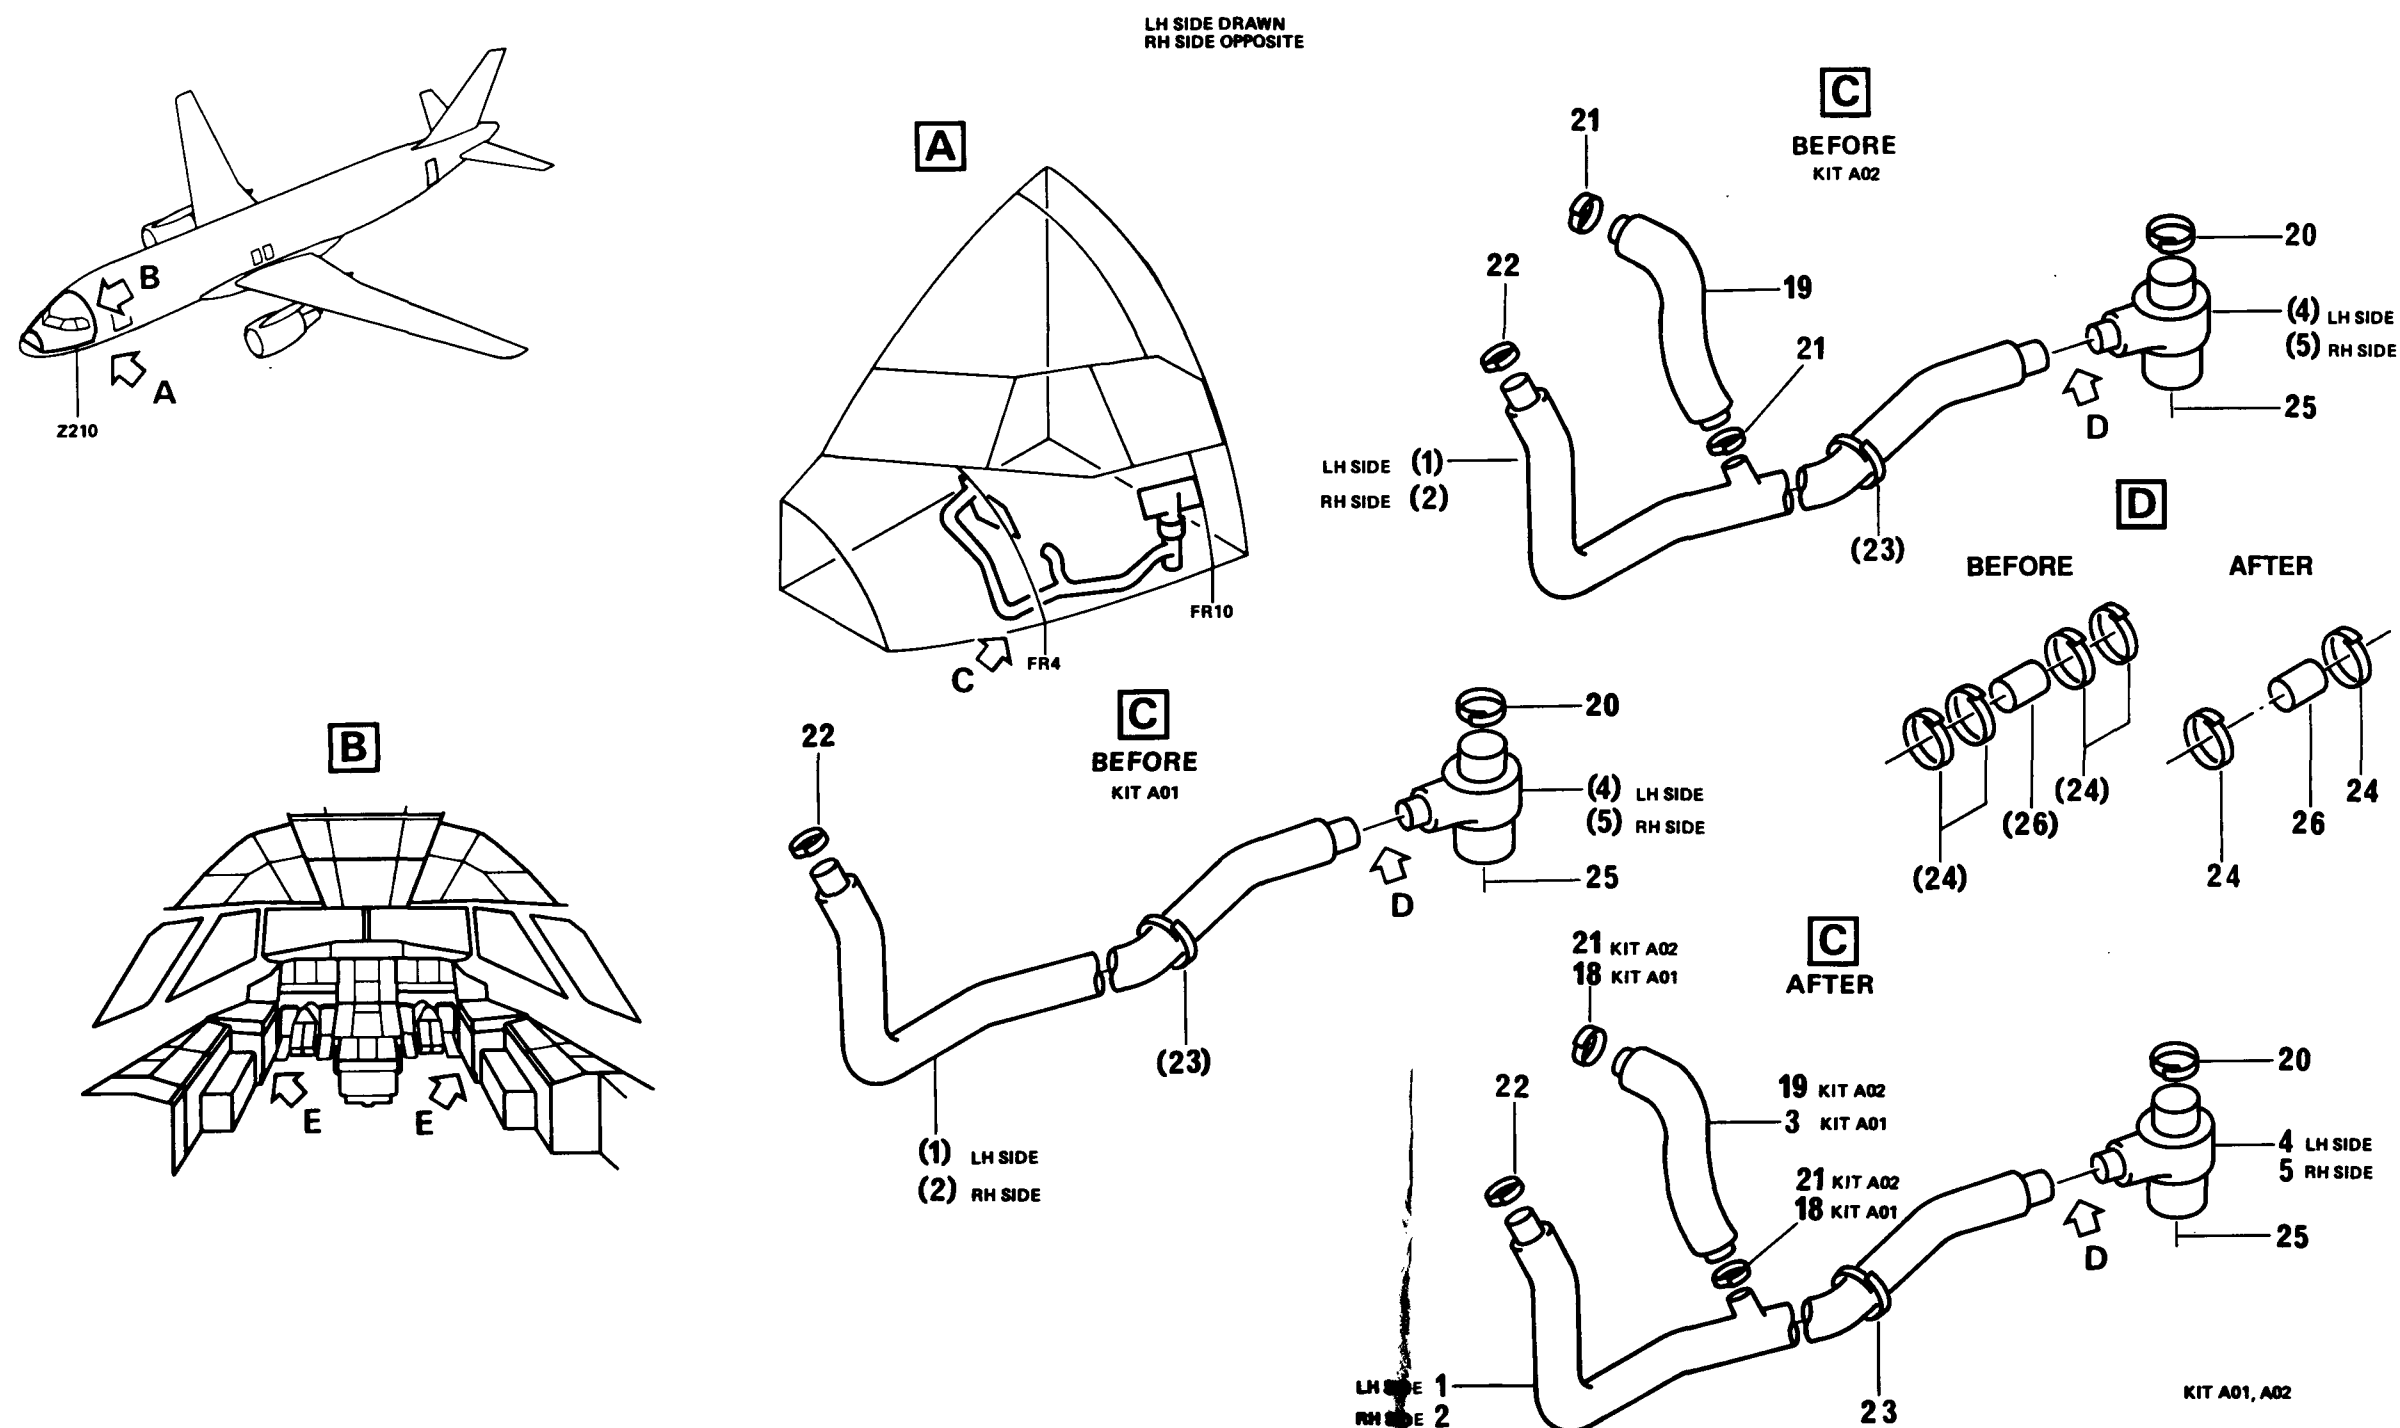
Cockpit Air Distribution Ducting Installation
Figure 1, Sheet 1 of 3

A low room temperature has been evidenced in the Pilots' foot area.

- (1) Remove the duct of the supply system in the flight compartment, zones 211, 212.

(2) Install the new duct of the air conditioning system in the flight compartment and the adjustment system.
