S.B. No. A320-21-1025 REV. 2

TITLE : AIR CONDITIONING - AVIONICS VENTILATION - IMPROVE INSULATION OF
TEMPERATURE SENSOR AND ACCURACY OF SKIN TEMPERATURE READING.

SERVICE BULLETIN No. : A320-21-1025

REVISION TRANSMITTAL SHEET

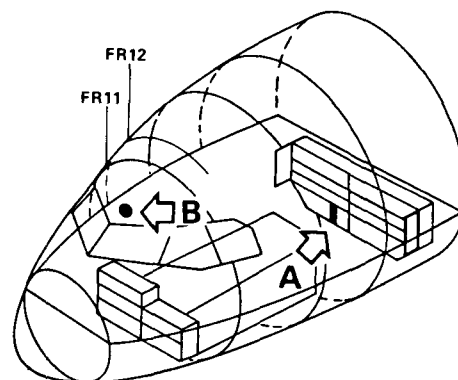
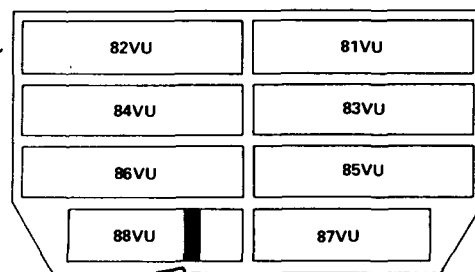
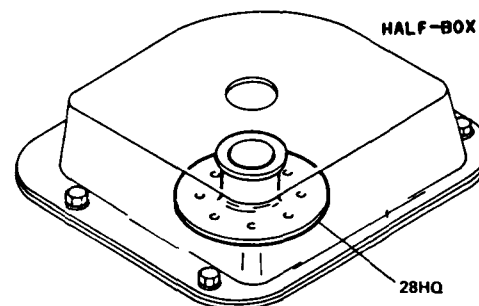
The avionics ventilation skin air valves should close on ground at an OAT of + 5°C and lower to prevent ice formation at the inlet. During ground operation with OAT lower than + 5°C, the skin air valves have been observed open, also under these conditions the skin air valve has been observed to be blocked with ice :

This Service Bulletin improves the accuracy of aircraft skin temperature reading by modifying the AEVC and adding a thermal insulation on the temperature sensor.

- (1) In zone 128, at shelf 88VU of electronics rack 80VU,
Replacement of Avionics Equipment Ventilation Computer (A.E.V.C.)
10HQ modified as per instructions in CROUZET Service Bulletin No. 87292325-21-002.

- (2) In zone 126, between STA579/FR11 and STA605/FR12, above the right lateral stringer, Installation of a box and a thermal insulation on the skin temperature sensor 28HQ.

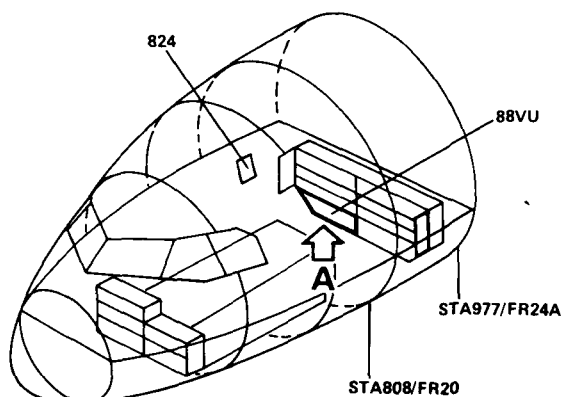
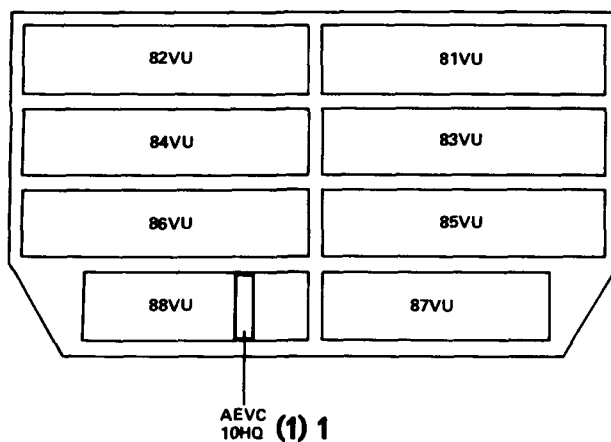
At Shelf 88VU of electronics rack 80VU,
Replacement of Avionics Equipment Ventilation Computer (A.E.V.C.) 10HQ
Figure 1

The avionics ventilation skin air valves should close on ground at an OAT of + 5°C and lower to prevent ice formation at the inlet. During ground operation with OAT lower than + 5°C, the skin air valves have been observed open, also under these conditions the skin air valve has been observed to be blocked with ice :

This Service Bulletin improves the accuracy of aircraft skin temperature reading by modifying the AEVC and adding a thermal insulation on the temperature sensor.

At the shelf 88VU of the electronics rack 80VU, replace the Avionics Equipment Ventilation Computer (A.E.V.C.) 10HQ (Ref. AMM 21-26-34, P. Block 401).

(a) Remove :

1 A.E.V.C. (10HQ)

(b) Install :

1 modified A.E.V.C. (10HQ) 87292325V04 Item 1 (Ref. the instructions in CROUZET Service Bulletin No. 87292325-21-002).
