A319/A320/A321

TITLE : AIR CONDITIONING - INSPECT PACK RAM AIR INLETS

This page transmits Revision No. 02 of Service Bulletin No. A320-21-1062.

SERVICE BULLETIN No. : A320-21-1062

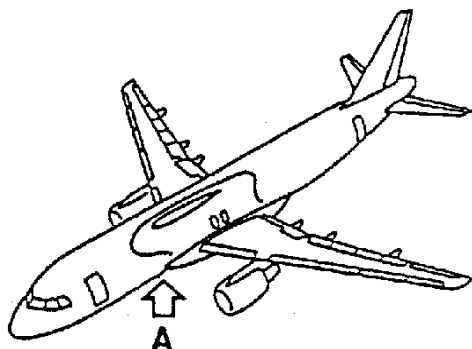
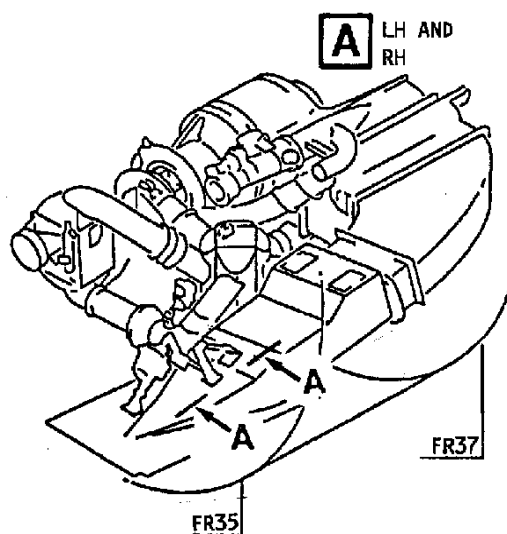
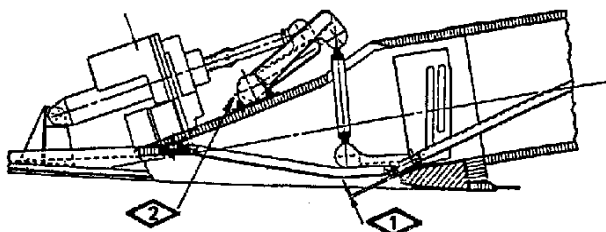
Several operators have reported excessive wear of the inlet flap linkage components which could lead to disconnection of the flap mechanism and subsequent pack overheat.

This Service Bulletin introduces an inspection of the actuation mechanism between the electrical actuator and the inlet flap for play and an inspection of the gap between the intake nose and diffuser ramp.

- ① GAP DIMENSION INLET NOSE/DIFFUSER RAMP
(OVER ENTIRE RAMP WIDTH)
- ② INSPECTING THE PLAY OF THE ACTUATION MECHANISM

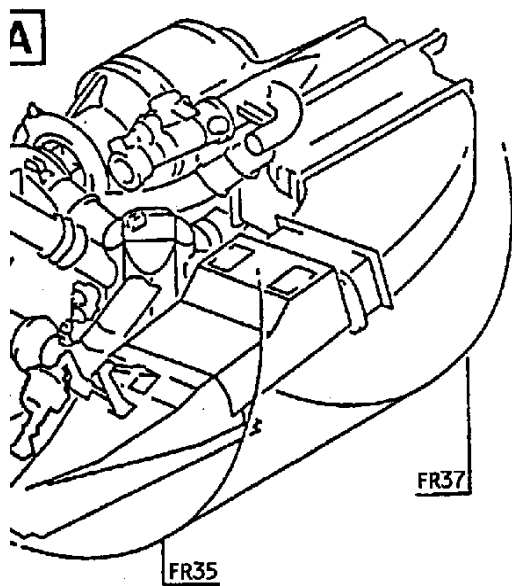
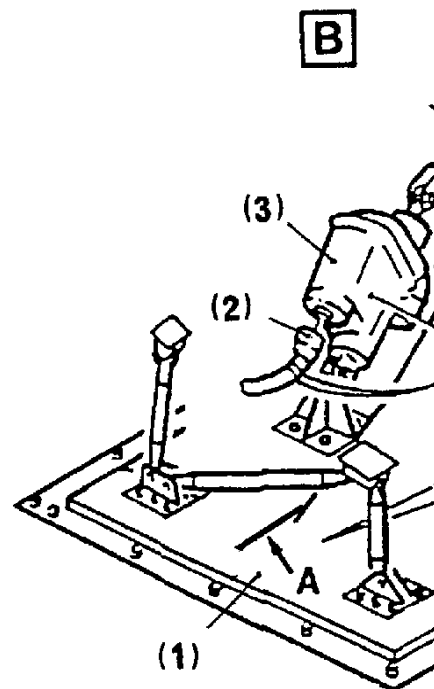
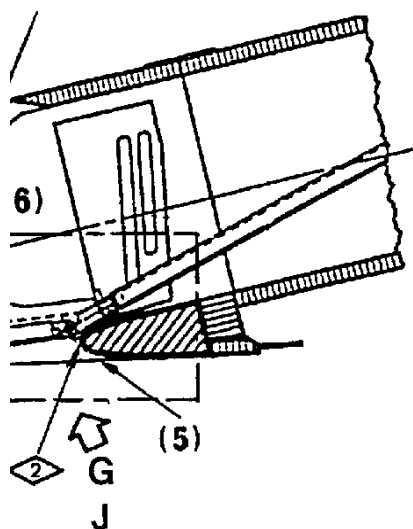
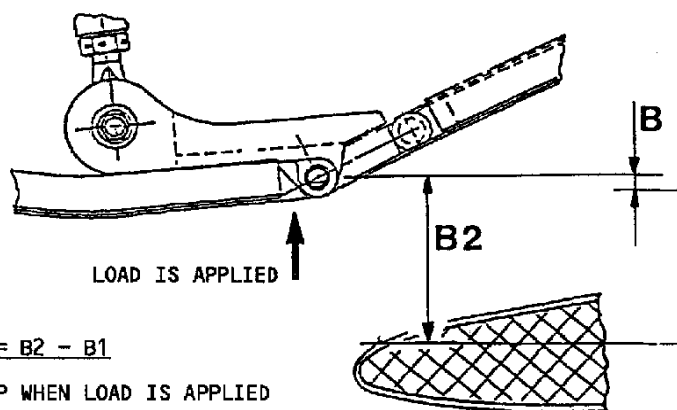
Figure 2 Sheet 1

PLAY B = B2 - B1

B2 = GAP WHEN LOAD IS APPLIED

B1 = GAP WHEN LOAD IS NOT APPLIED

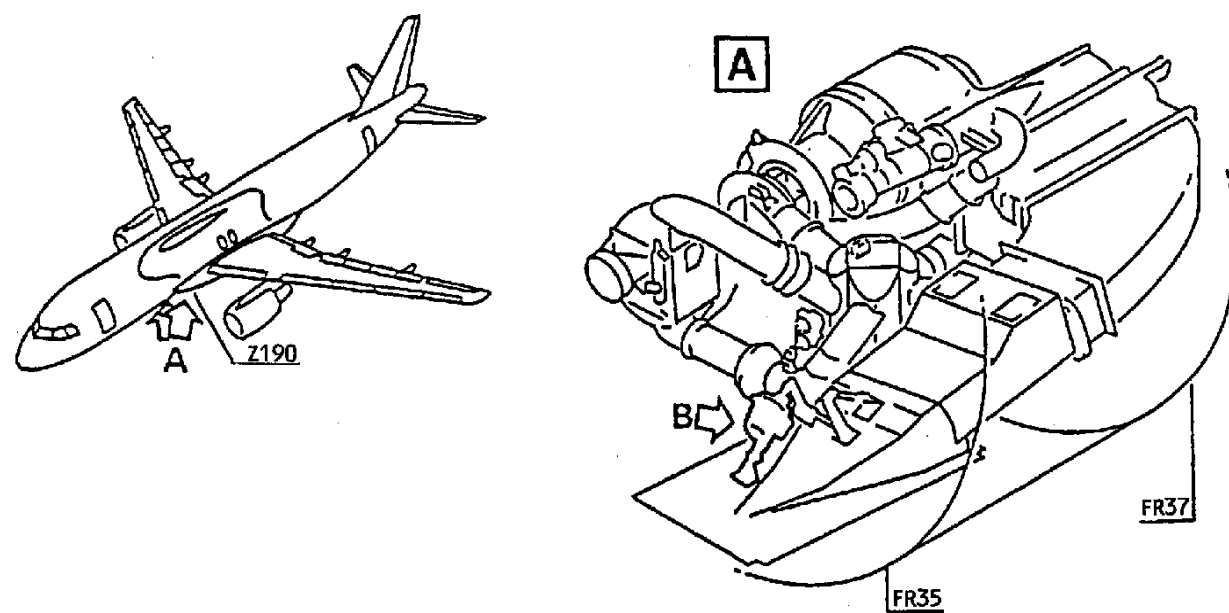
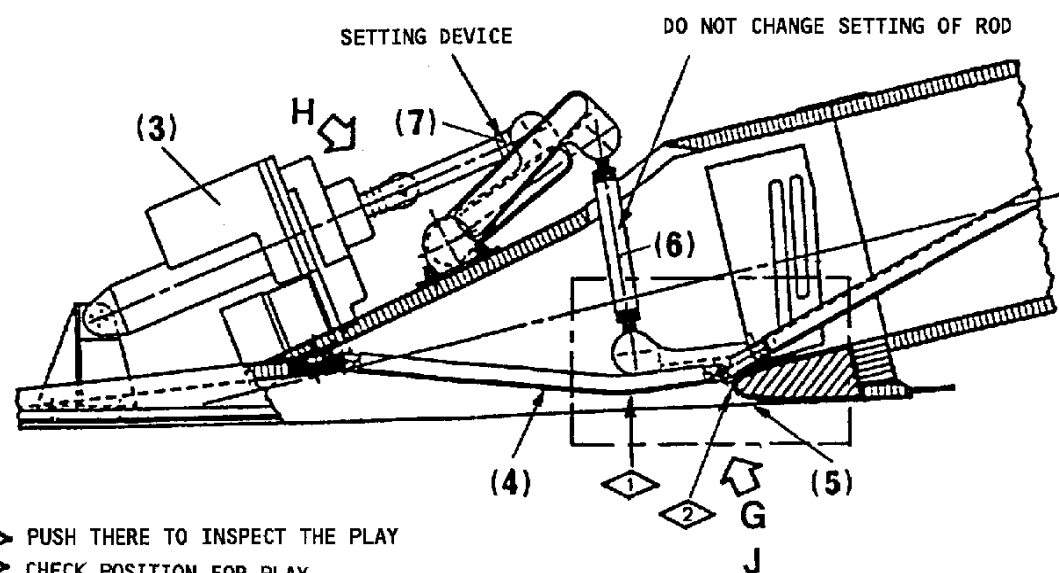
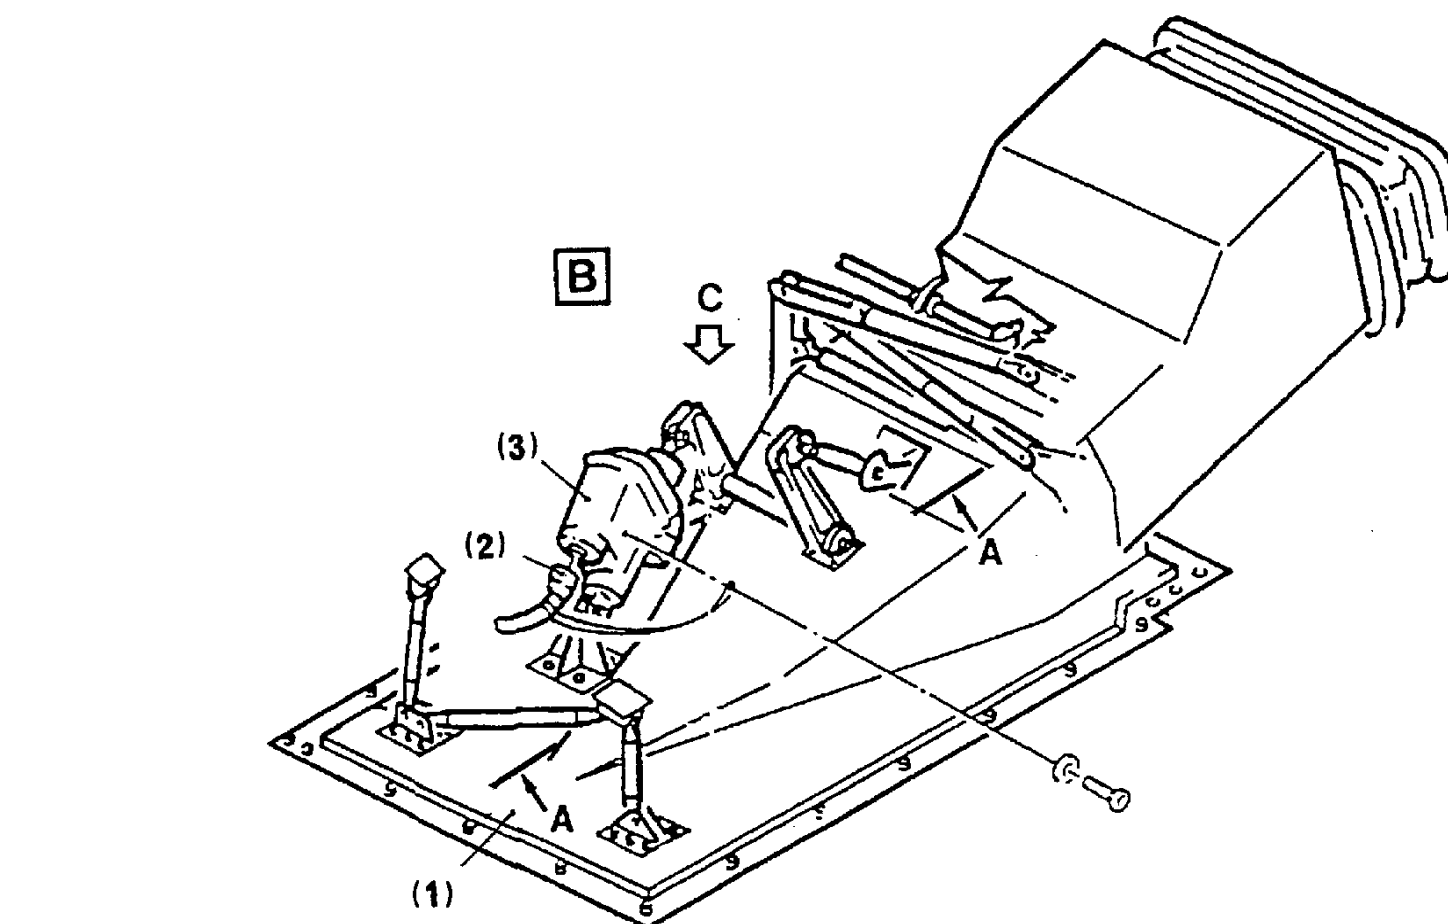
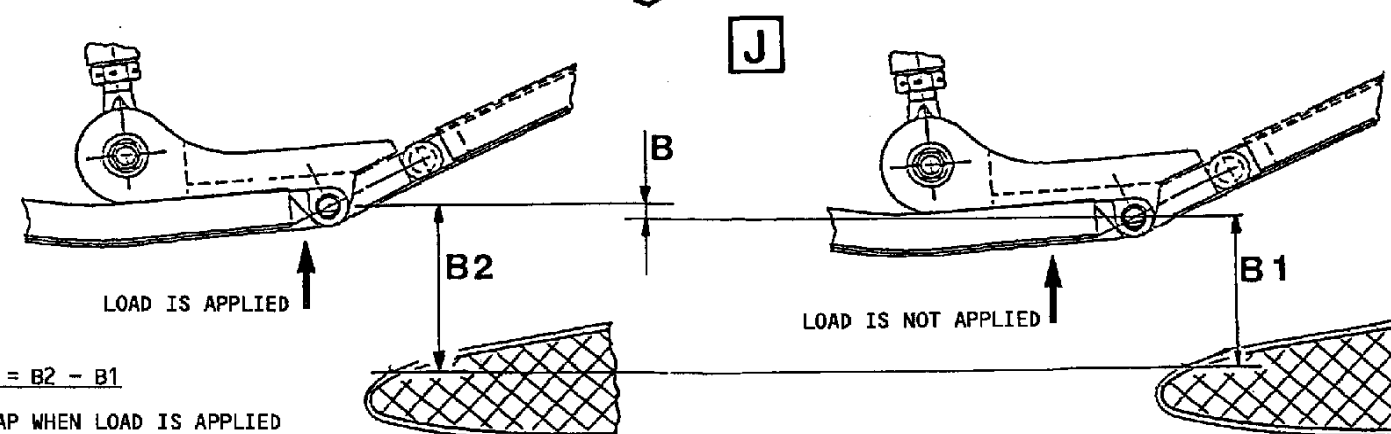
Inspection of the Ram Air Inlet
Figure 2 Sheet 1

(a) Try to move the diffuser ramp, item (4), by hand at position shown in Figure 2, Sheet 1, section A-A and check the play:

- 1 Measure the play 'B' (gap B2 minus gap B1) between the flaps and intake nose as shown in detail J, refer to Figure 2, Sheet 1.
- 2 If the play is less than 1mm (0.039in.), repeat this Inspection Service Bulletin at the next fourth A-check.

- 1 PUSH THERE TO INSPECT THE PLAY
2 CHECK POSITION FOR PLAY

$$\text{PLAY B} = \text{B2} - \text{B1}$$

B2 = GAP WHEN LOAD IS APPLIED

B1 = GAP WHEN LOAD IS NOT APPLIED

- 4 If the play is more than 3mm (0.118in.), check the following connections (at items); if necessary disconnect the lever, item (15), at the electrical actuator and retain the bushes, item (10), and fastening parts:

- at pins, item (20) and (22)
 - between lever, item (11), of the inlet flap and rod, item (6)
 - between lever, item (12), and rod, item (6)
 - between lever, item (12), and lever, item (15)

- between lever, item (15), and eye-end of the electrical actuator, item (3)
 - at the connection between actuator, item (3), and the actuator bracket

- 5 Replace the respective component(s) and repeat the inspection procedure as given before.

CAUTION: DO NOT TURN-OUT THE EYE END OF THE ROD MORE THAN 6.0mm (0.236in.)

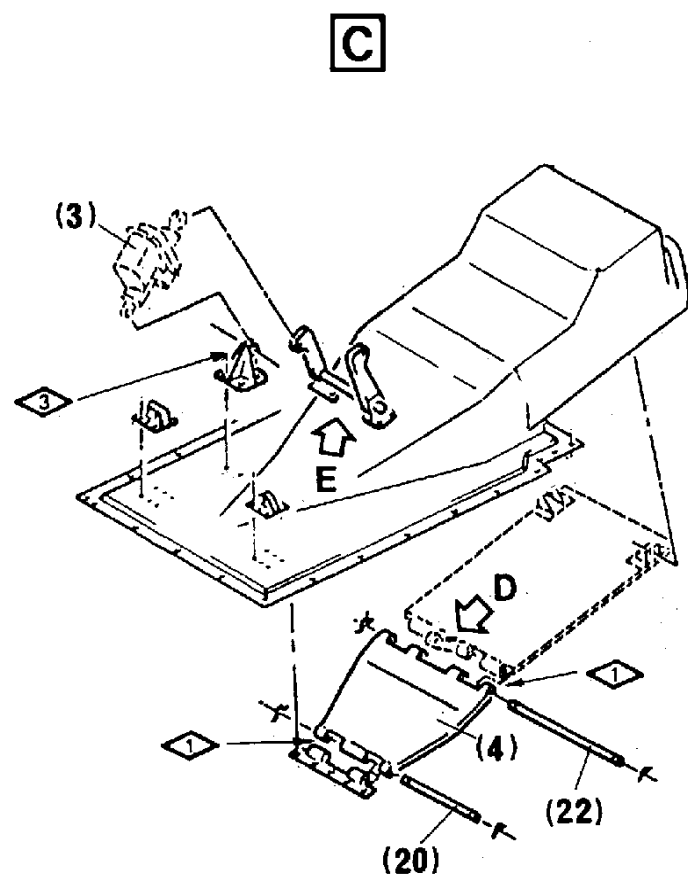
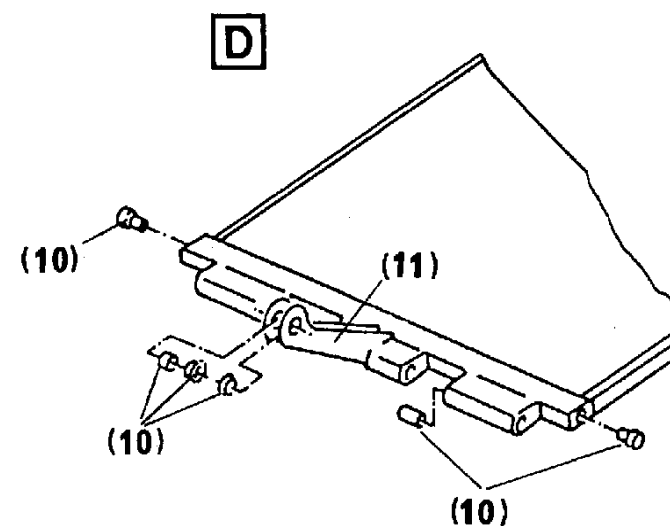
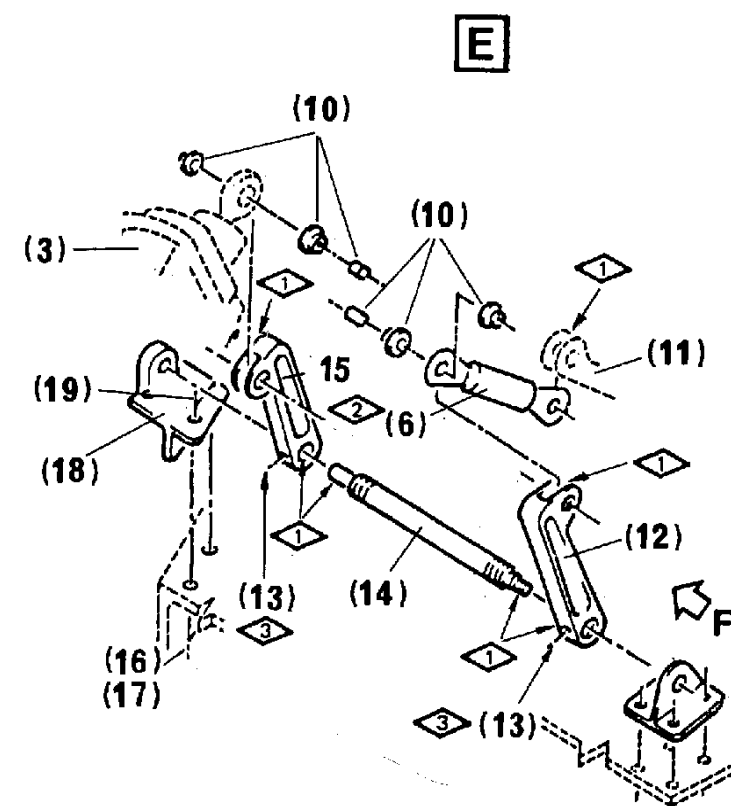
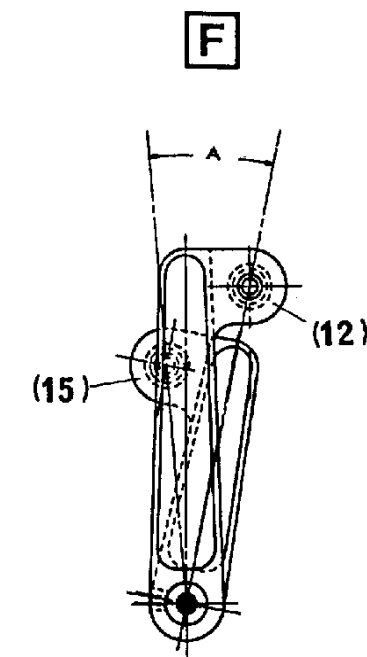
Inspection of the Ram Air Inlet
Figure 2 Sheet 2

- 1 PLAY TO BE INSPECTED
- 2 DO NOT CHANGE SETTING OF ROD
- 3 APPLIED WITH LOCTITE 241, MAT No. 08-007

- 6 If the mechanism between lever, item (12), and lever, item (15), was disconnected, an adjustment procedure as given in Para. B.(2) has to be performed.

- (a) Position the levers, item (12) and (15), in line with the appropriate components. For the lever, item (12), with the lever, item (11), of the inlet flap and for the lever, item (15), with the electrical actuator, item (3). Secure the positions temporarily with the setscrews, item (13).
- (b) Position the lever, item (15), on the shaft, item (14), so that the angle between the levers is 16deg, refer to detail F.
- NOTE : If the lever, item (15), is positioned one tooth to the left or right of the required position, the effective position will then be 6deg or 26deg.
- (c) When the levers are positioned correctly, secure the lever positions with the setscrews, item (13), and apply LOCTITE 241, Mat. No. 08-007.

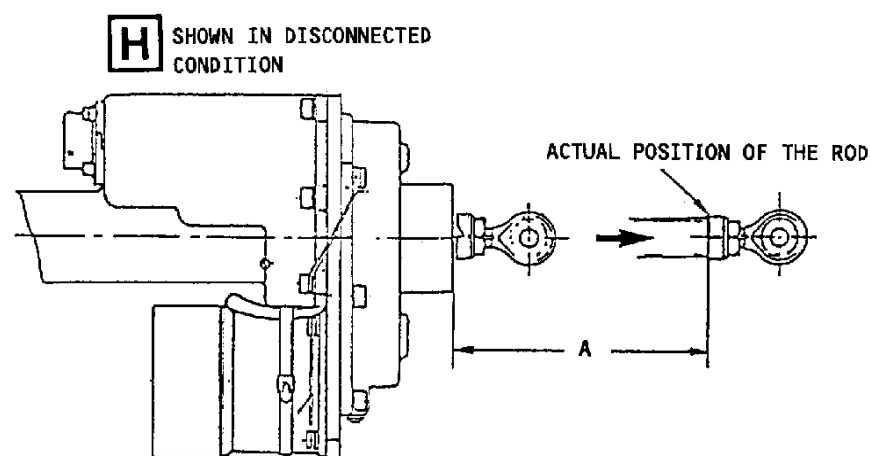
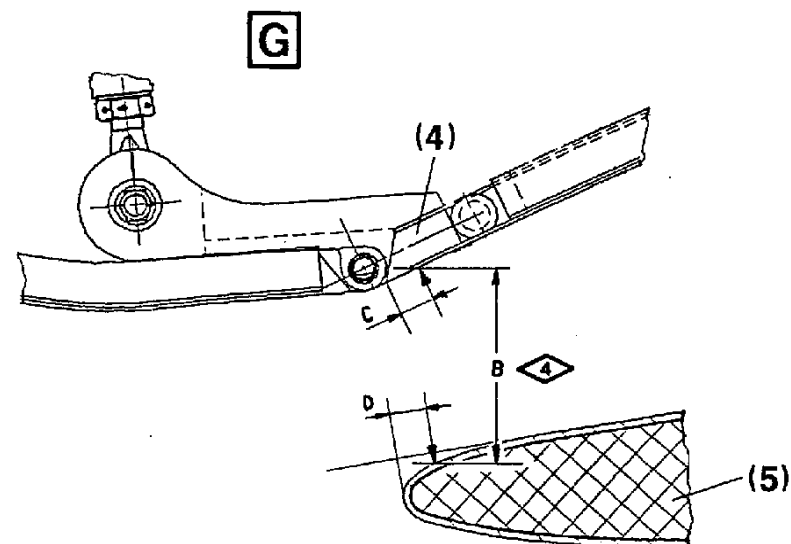
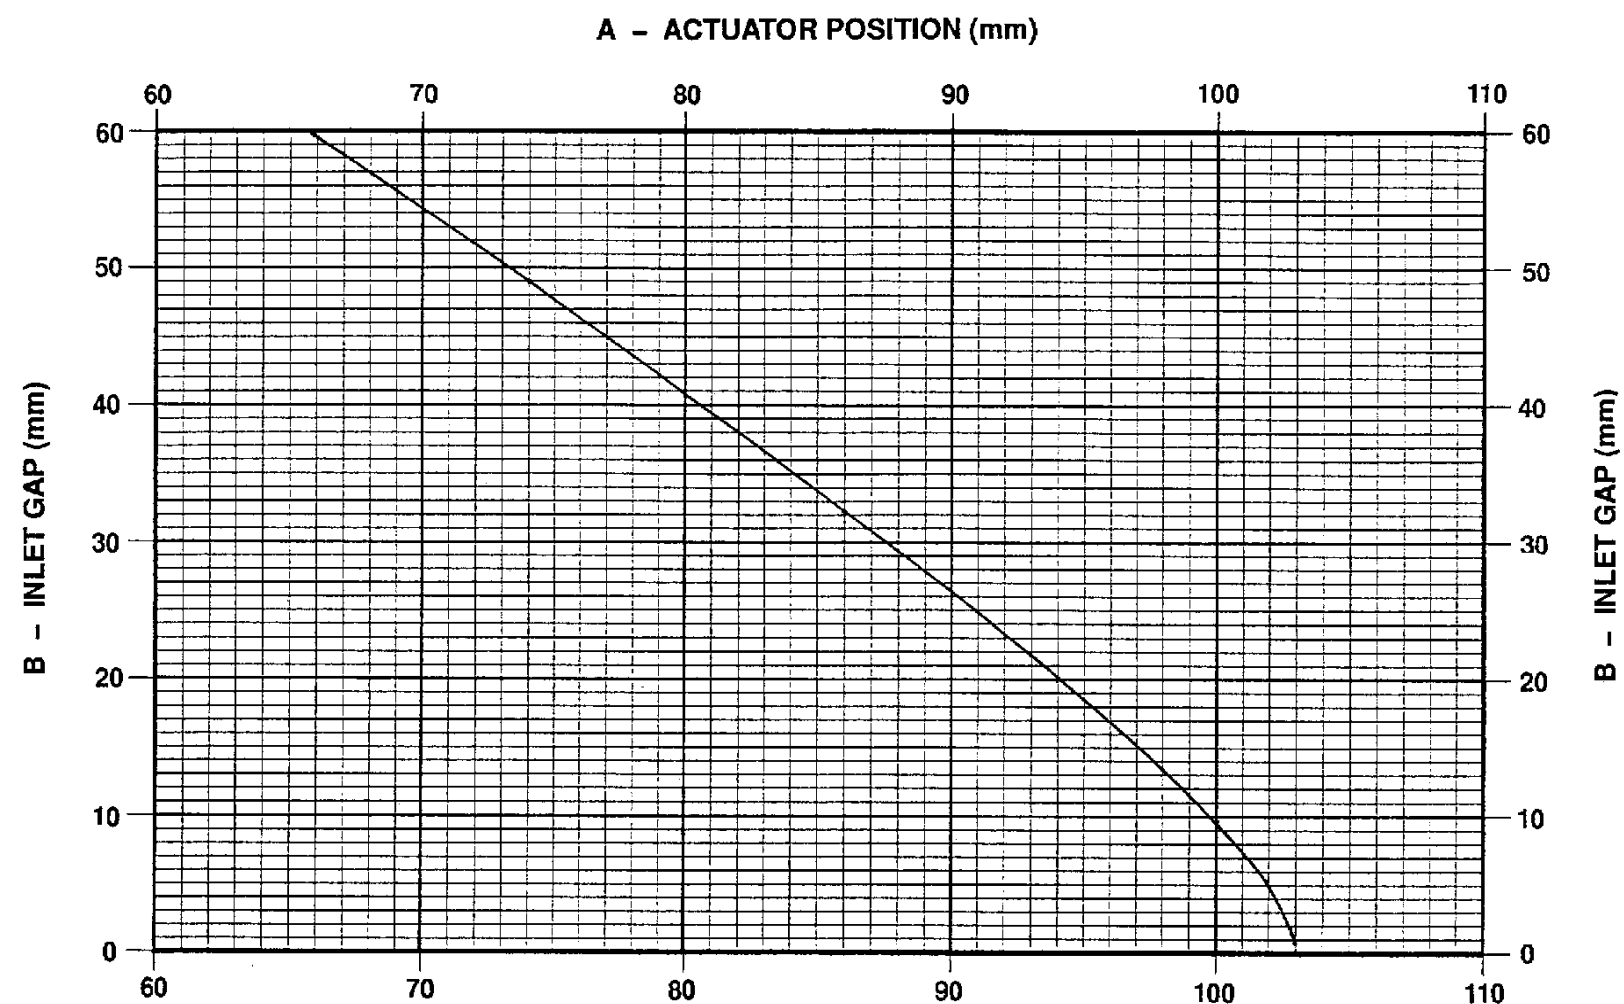
Figure 3 Sheet 1

- (a) Set markings to the positions as follows, shown in detail G

- (b) Measure the actual rod position 'A' of the electrical actuator, item (3), shown in detail H.

NOTE : The tolerance of the compared diffuser ramp position is +1.5mm (0.059in.).

A = TO BE MEASURED
B = TO BE DETERMINED WITH THE GRAPH (SEE RH SIDE)
TOLERANCE +1.5mm (0.059in.)
C = 10mm (0.349in.) TO FLAP HINGE
D = 10mm (0.394in.) FROM EDGE

4 LATERAL POSITION IS APPROX. CENTER OF THE INTAKE

- (c) Transfer the measured distance 'A' to the graph and determine the flap position 'B' (inlet gap) with the graph.
- (d) Measure the gap between the marked positions at the intake nose, item (5) and the diffuser ramp, item (4).
- (4) Compare the determined inlet gap 'B' with the actual diffuser ramp position 'B', shown in detail G:
- If the actual diffuser ramp position (inlet gap) is in the determined position 'B', proceed with Para. B.(6).
 - If the actual diffuser ramp position (inlet gap) is not in the determined position 'B' proceed with Para. B.(5).

- (b) Adjust flap position by rotating the rod end half a turn (half turn corresponds to 0.5mm (0.019in.) movement).

- (c) After the adjustment, connect the mechanism (Refer to AMM: 21-61-51, P. Block 401) and torque tighten the lock nut to 0.60m.daN (53.09lb.in.) and secure with the tab washer.
