TITLE : AIR CONDITIONING - PRESSURE CONTROL AND MONITORING - REPLACE THE  
SUPPORT BRACKETS FOR THE OUTFLOW VALVE 10HL

This page transmits Revision No. 01 of Service Bulletin No. A320-21-1125.

SERVICE BULLETIN No. : A320-21-1125

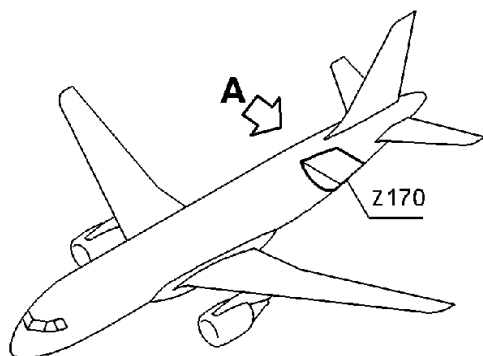
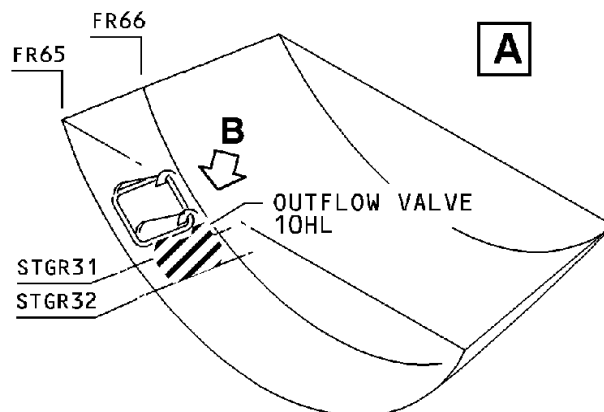
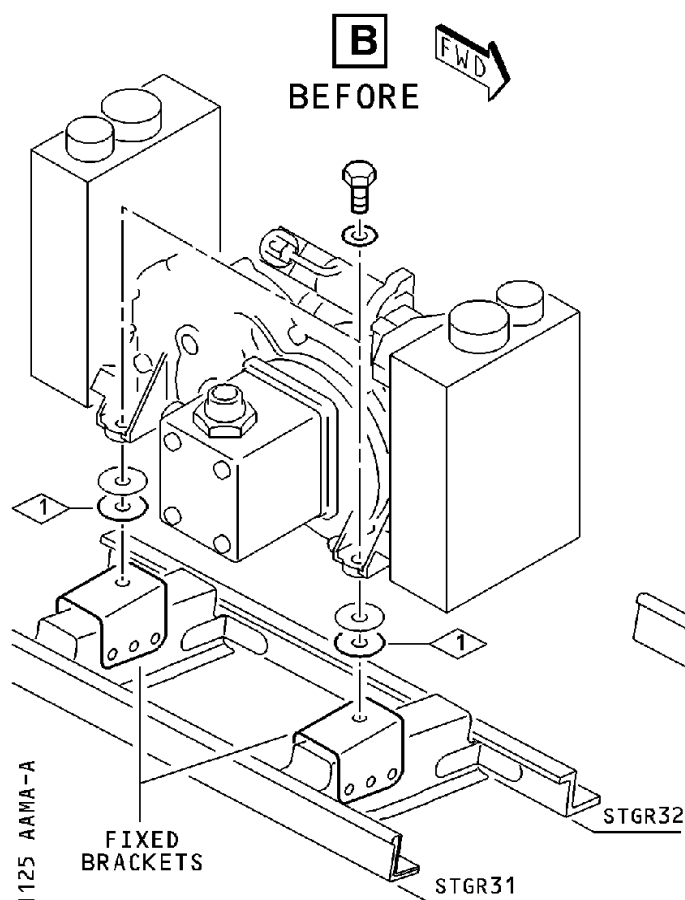
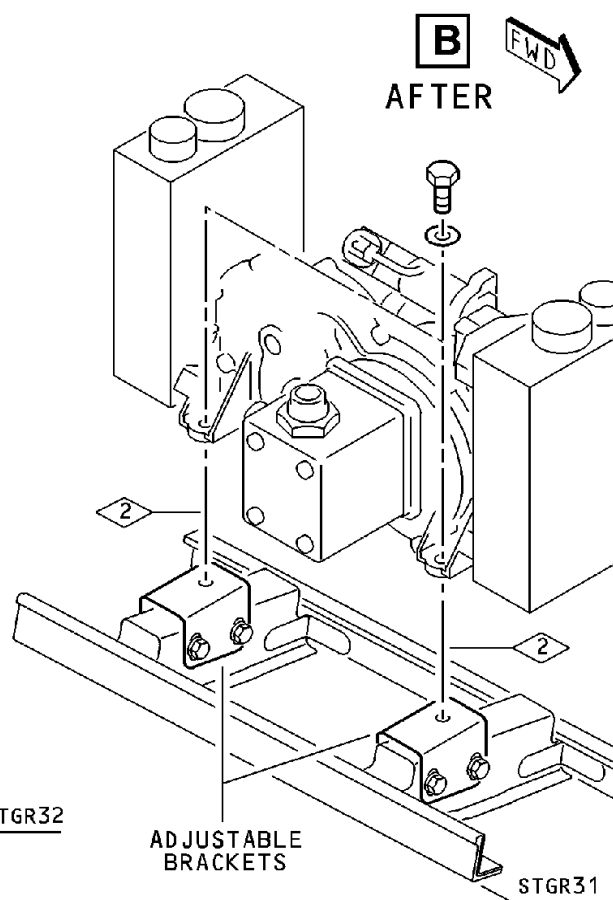
NB6 21 1125 AAMA-A

- 1 A GAP IS POSSIBLE BETWEEN THE SUPPORT BRACKETS AND THE OUTFLOW VALVE 10HL. ANY GAP HAS BEEN BALANCED BY WASHERS BEFORE DELIVERY OF THE AIRCRAFT.
- 2 NO GAP IS POSSIBLE AFTER THE INSTALLATION OF ADJUSTABLE BRACKETS.

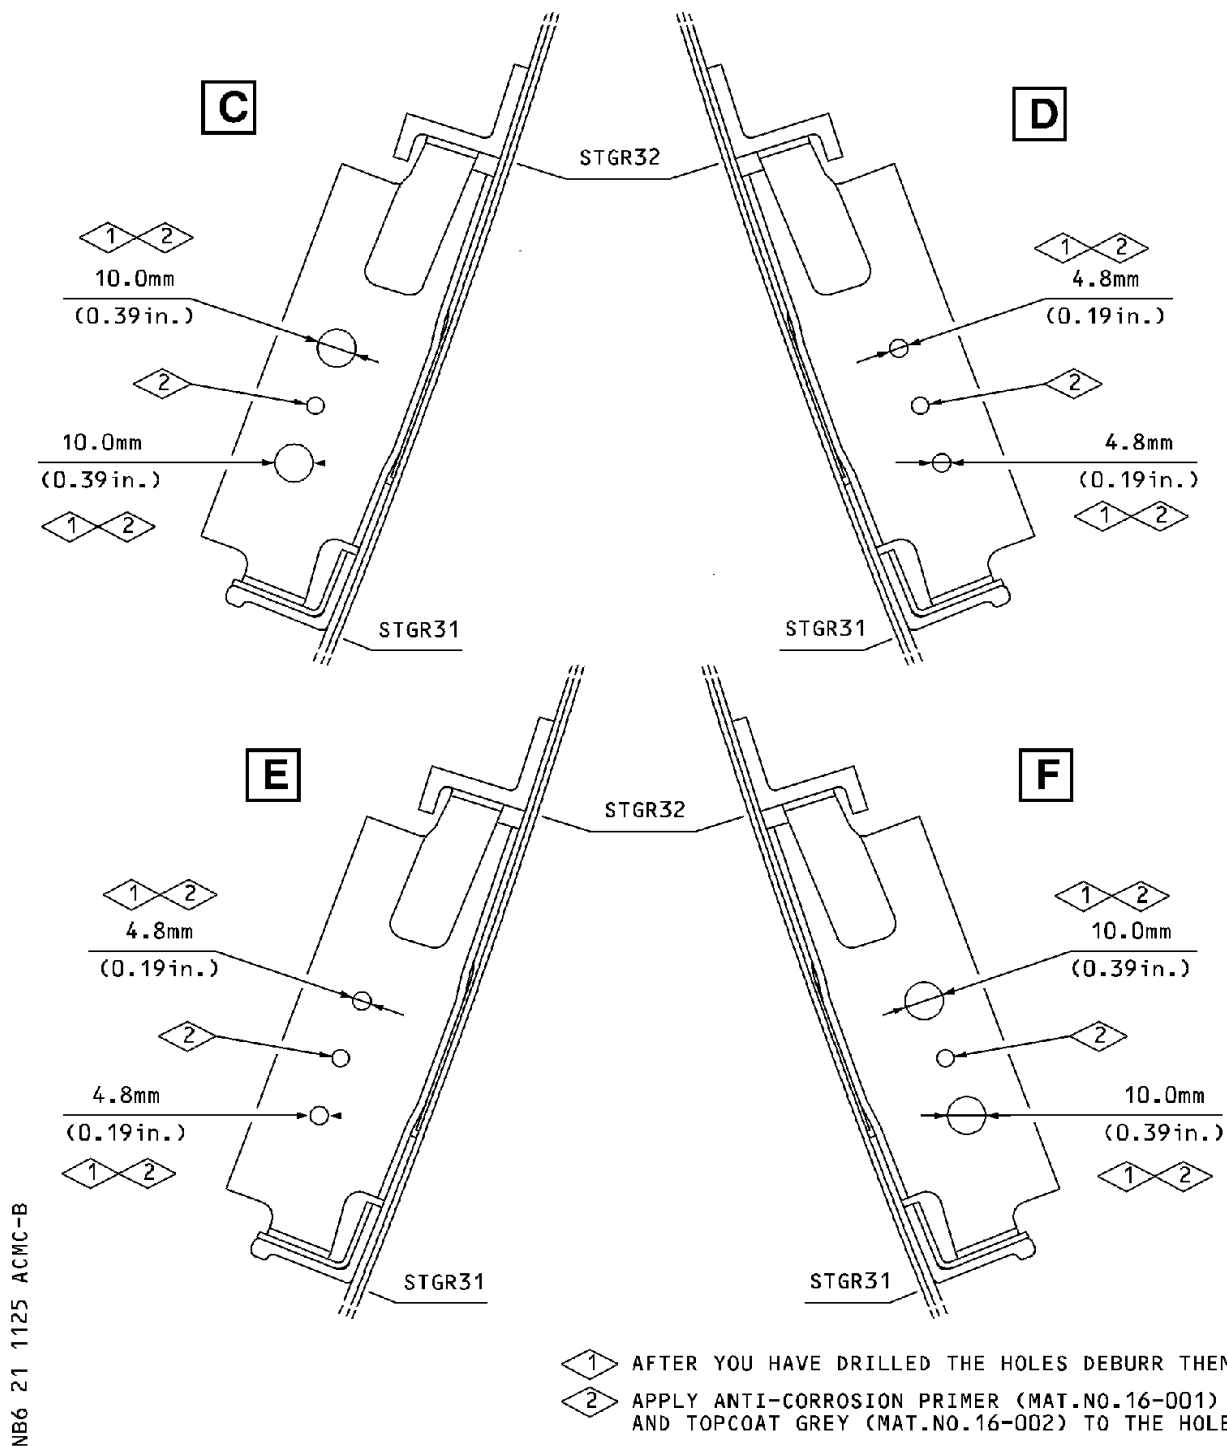
Figure 1 Sheet 3  
Replacement of Support Brackets

This Revision has been issued to correct the details showing the hole diameters at Figure 1, Sheet 3.

- Illustration, Figure 1, Sheet 3, hole diameters revised.

(0.19in.) dia. and deburr them as shown in Figure 1 ,  
Sheet 2 and Sheet 3 , Detail D and E.

- 5 Between STGR 31 and STGR 32, RH, drill the holes 10,0 mm  
(0.39 in.) dia. and deburr them as shown in Figure 1 ,  
Sheet 2 and Sheet 3 , Detail C and F.
