Number: 737-28A1263
Original Issue: February 19, 2007
Revision 3: December 23, 2014
ATA System: 2822

SUBJECT: FUEL - Engine Fuel Feed System - Fuel Boost Pump Electrical Wire and Sleeve in
Fuel Tank Conduit - Inspection / Replacement

BOEING SERVICE BULLETIN 737-28A1263

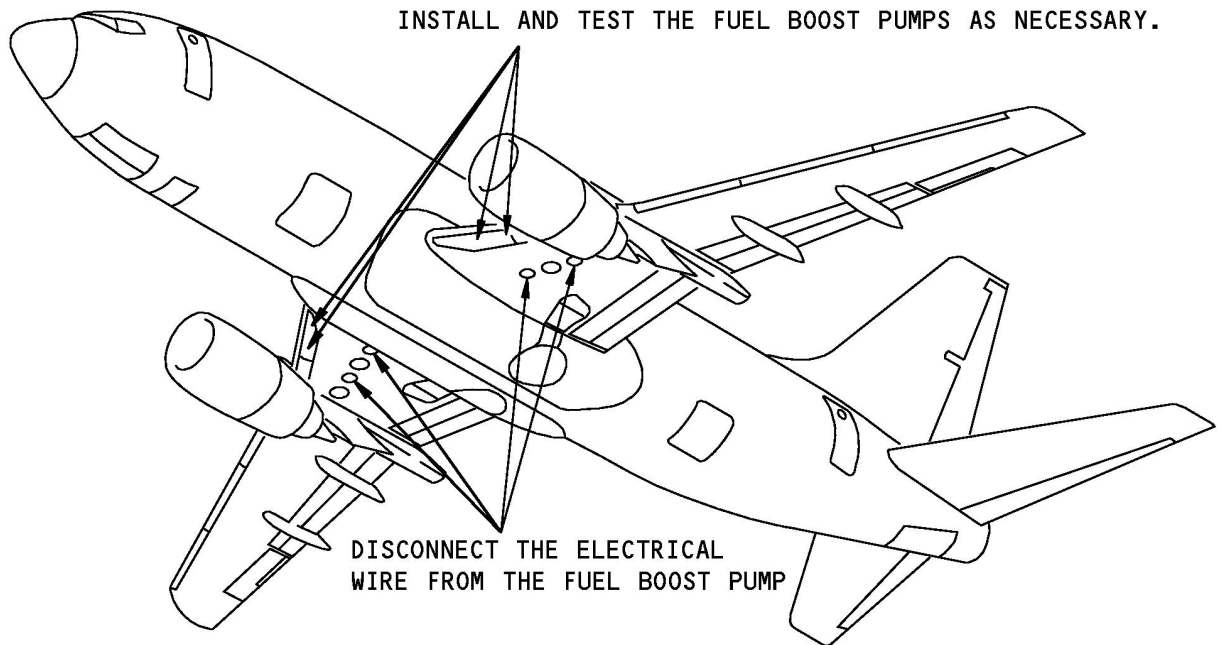
1305424

REMOVE THE FUEL BOOST PUMPS AS NECESSARY.
PULL THE ELECTRICAL WIRE AND SLEEVE OUT OF THE CONDUIT.
INSPECT THE SLEEVE AND REPLACE.
INSPECT THE ELECTRIC WIRE AND REPLACE AS NECESSARY.
INSPECT THE CONDUIT AND REPLACE AS NECESSARY.
INSTALL AND TEST THE ELECTRICAL WIRE.
INSTALL AND TEST THE FUEL BOOST PUMPS AS NECESSARY.

DISCONNECT THE ELECTRICAL
WIRE FROM THE FUEL BOOST PUMP
