**TITLE: AIR CONDITIONING- GENERAL- CONDITIONED SERVICE AIR SYSTEM
(CSAS) - INSTALL IMPROVED CSAS CONTROL UNIT (CCU-K05)**

MODIFICATION No.: 152075K15181

This page transmits Revision No.01 of Service Bulletin No.A320-21-1197

SERVICE BULLETIN No.: A320-21-1197

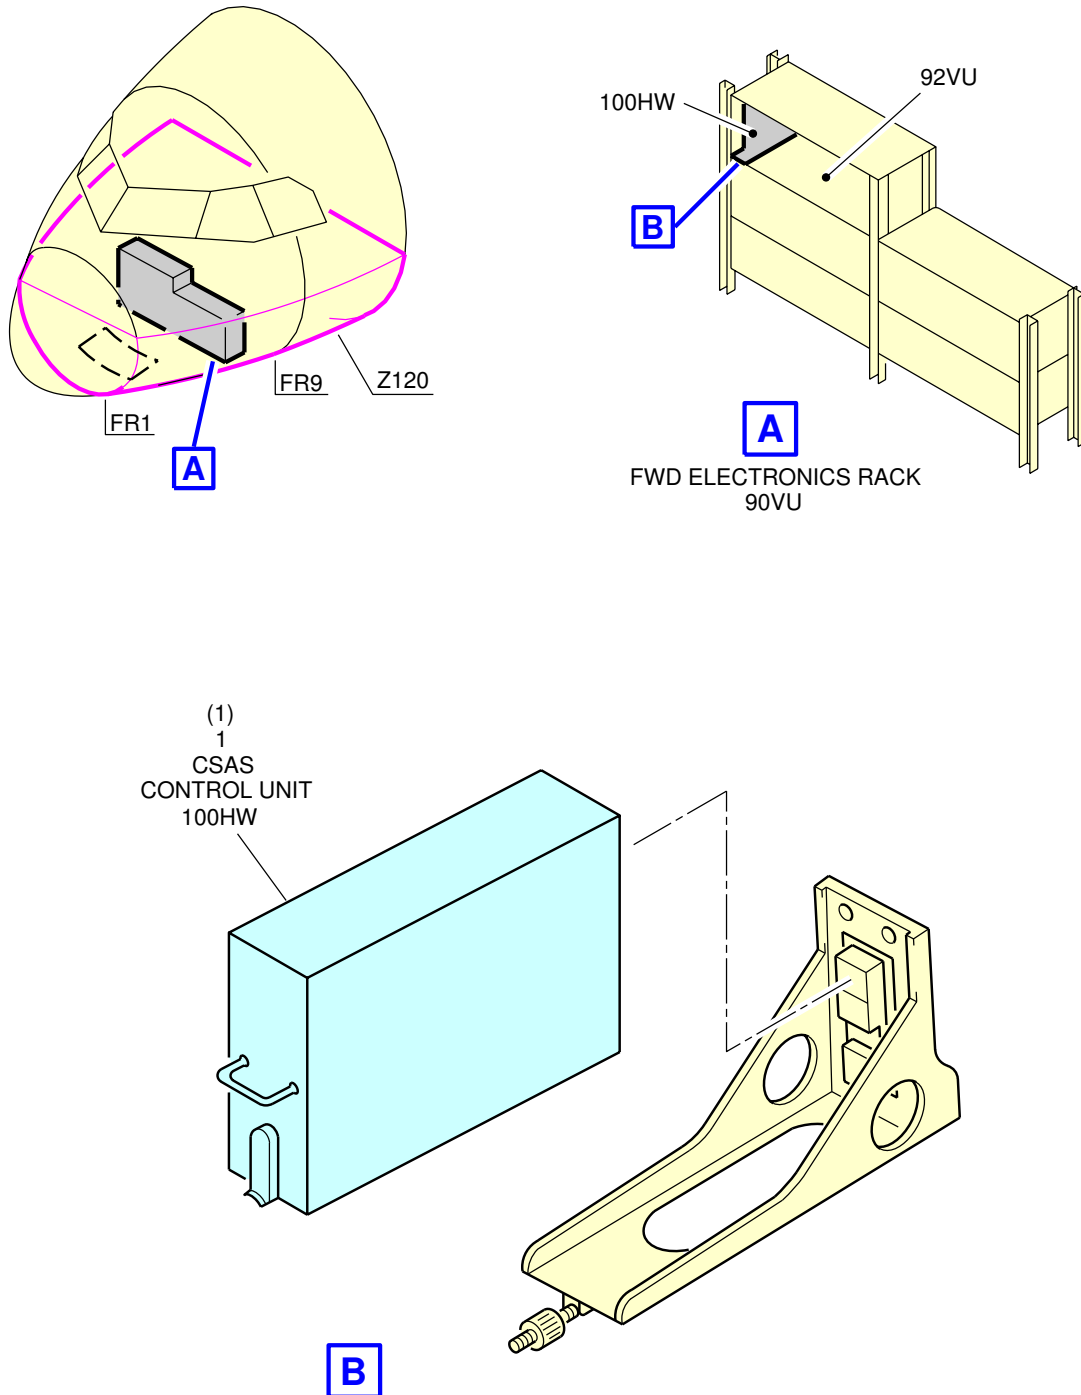
Figure A-GBAAA - Sheet 01
Replace the CSAS Control Unit

In-Service experience has identified necessary improvements in the system functionality of the Conditioned Service Air System (CSAS) Control Unit PN 3959A0000K04.

This Service Bulletin has been issued to inform operators of the issue of LIEBHERR AEROSPACE Service Bulletin No. 3959A-21-02, which updates the CSAS Control Unit software from PN 3959A1000S18 to PN 3959A1000S26.

- (a) Remove, refer to AMM Task 21-58-34-000-001 and [Fig. A-GBAAA Sheet 01](#):

1 Controller-CSAS 3959A0000K04 Item (1)

- (a) Modify the CSAS Control Unit as given in LIEBHERR AEROSPACE Service Bulletin No. 3959A-21-02.

- (a) Install, refer to AMM Task 21-58-34-400-001 and [Fig. A-GBAAA Sheet 01](#):

1 Controller-CSAS 3959A0000K05 Item 1
