737

Service Bulletin

Number: 737-24-1165
Original Issue: April 28, 2005
Revision 2: April 29, 2015
ATA System: 2434

SUBJECT: ELECTRICAL POWER - Standby Power System - Removal and Replacement of the Static Inverter Module

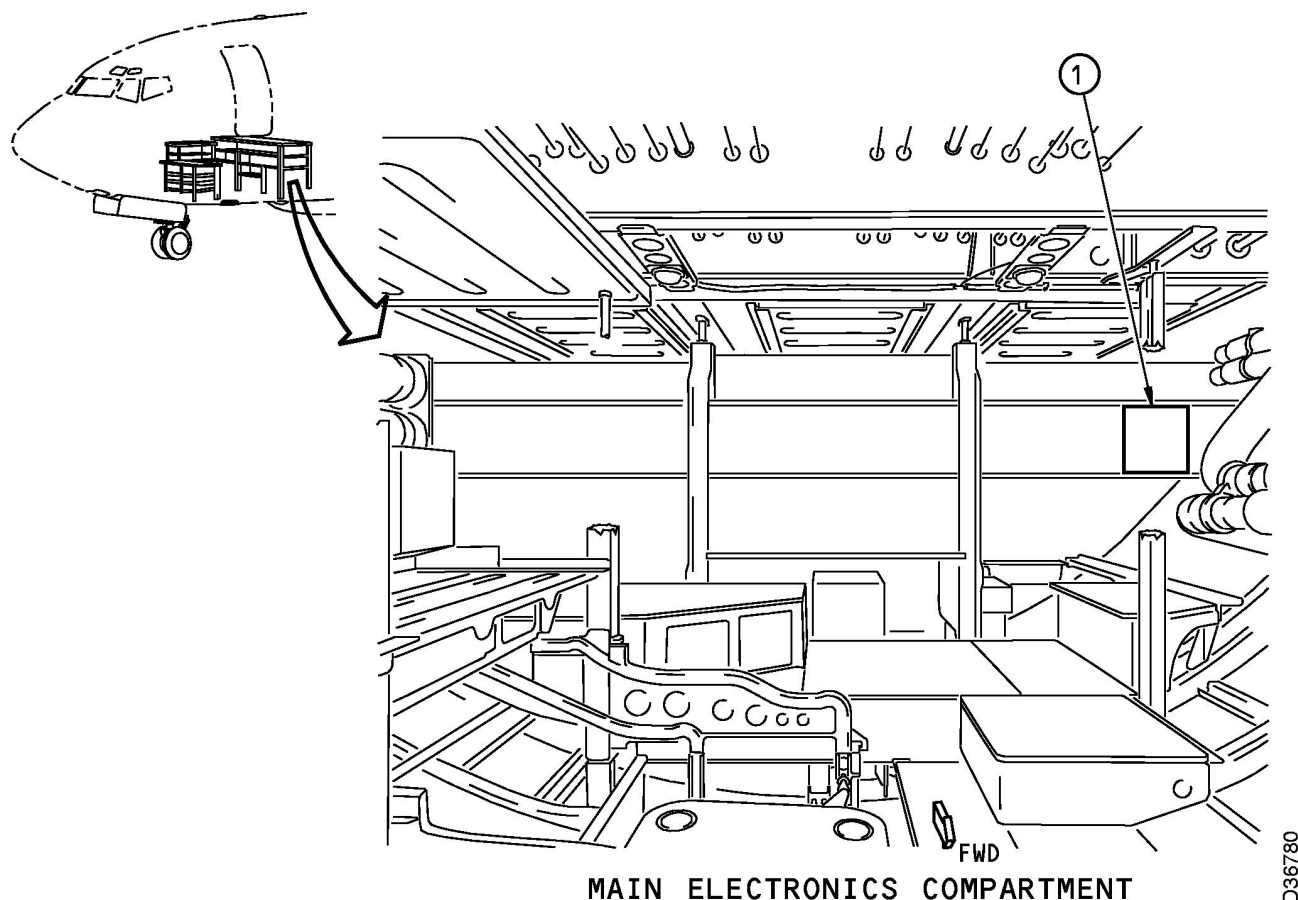
**FIGURE 1: REMOVAL OF THE STATIC INVERTER
(SHEET 1 OF 1)**

STEP	TASK	PART NAME	IDENTIFICATION	QTY	MORE DATA
1	Remove	Static Inverter	S282T004-10 (Supplier Part Number: 1-002-0102-1000) or S282T004-20 (Supplier Part Number: 1-002-0102-2062)	1	(a)
(a) From the E2-2 electronics shelf. Refer to 737-600/700/800/900 AMM 20-10-07 and 737-600/700/800/900 AMM 24-34-21 as an accepted procedure.
