S.B. No. A320-21-1030 REV. 1

TITLE : AIR CONDITIONING - AVIONICS COOLING - IMPROVE EFFICIENCY OF  
WATER DUST STOPPAGE.

SERVICE BULLETIN No. : A320-21-1030

TITLE : AIR CONDITIONING - AVIONICS COOLING - IMPROVE EFFICIENCY OF WATER  
DUST STOPPAGE.

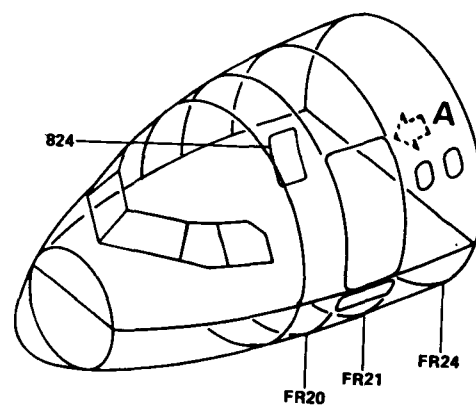
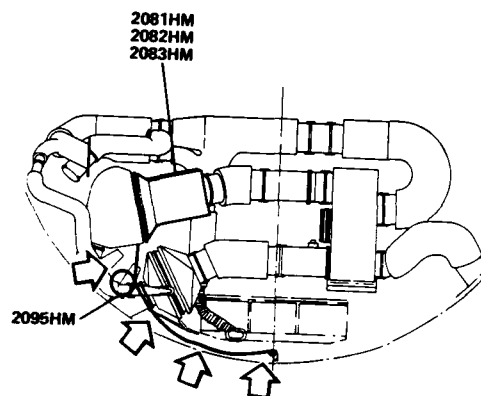
The reason of this Service Bulletin is to improve water extraction efficiency during heavy rain conditions and to increase the life of the demister filter assembly.

Accomplishment of this Service Bulletin prevents water ingress into avionics ventilation ducting during heavy rain conditions.

- (2) Replacing the demister filter assembly by a new modified as per instructions given in LE BOZEC ET GAUTIER Service Bulletin No. 34800A200-2-21-01.
- (3) Installing the new drain system of this filter.
- (4) Test.
- (5) Close-up.

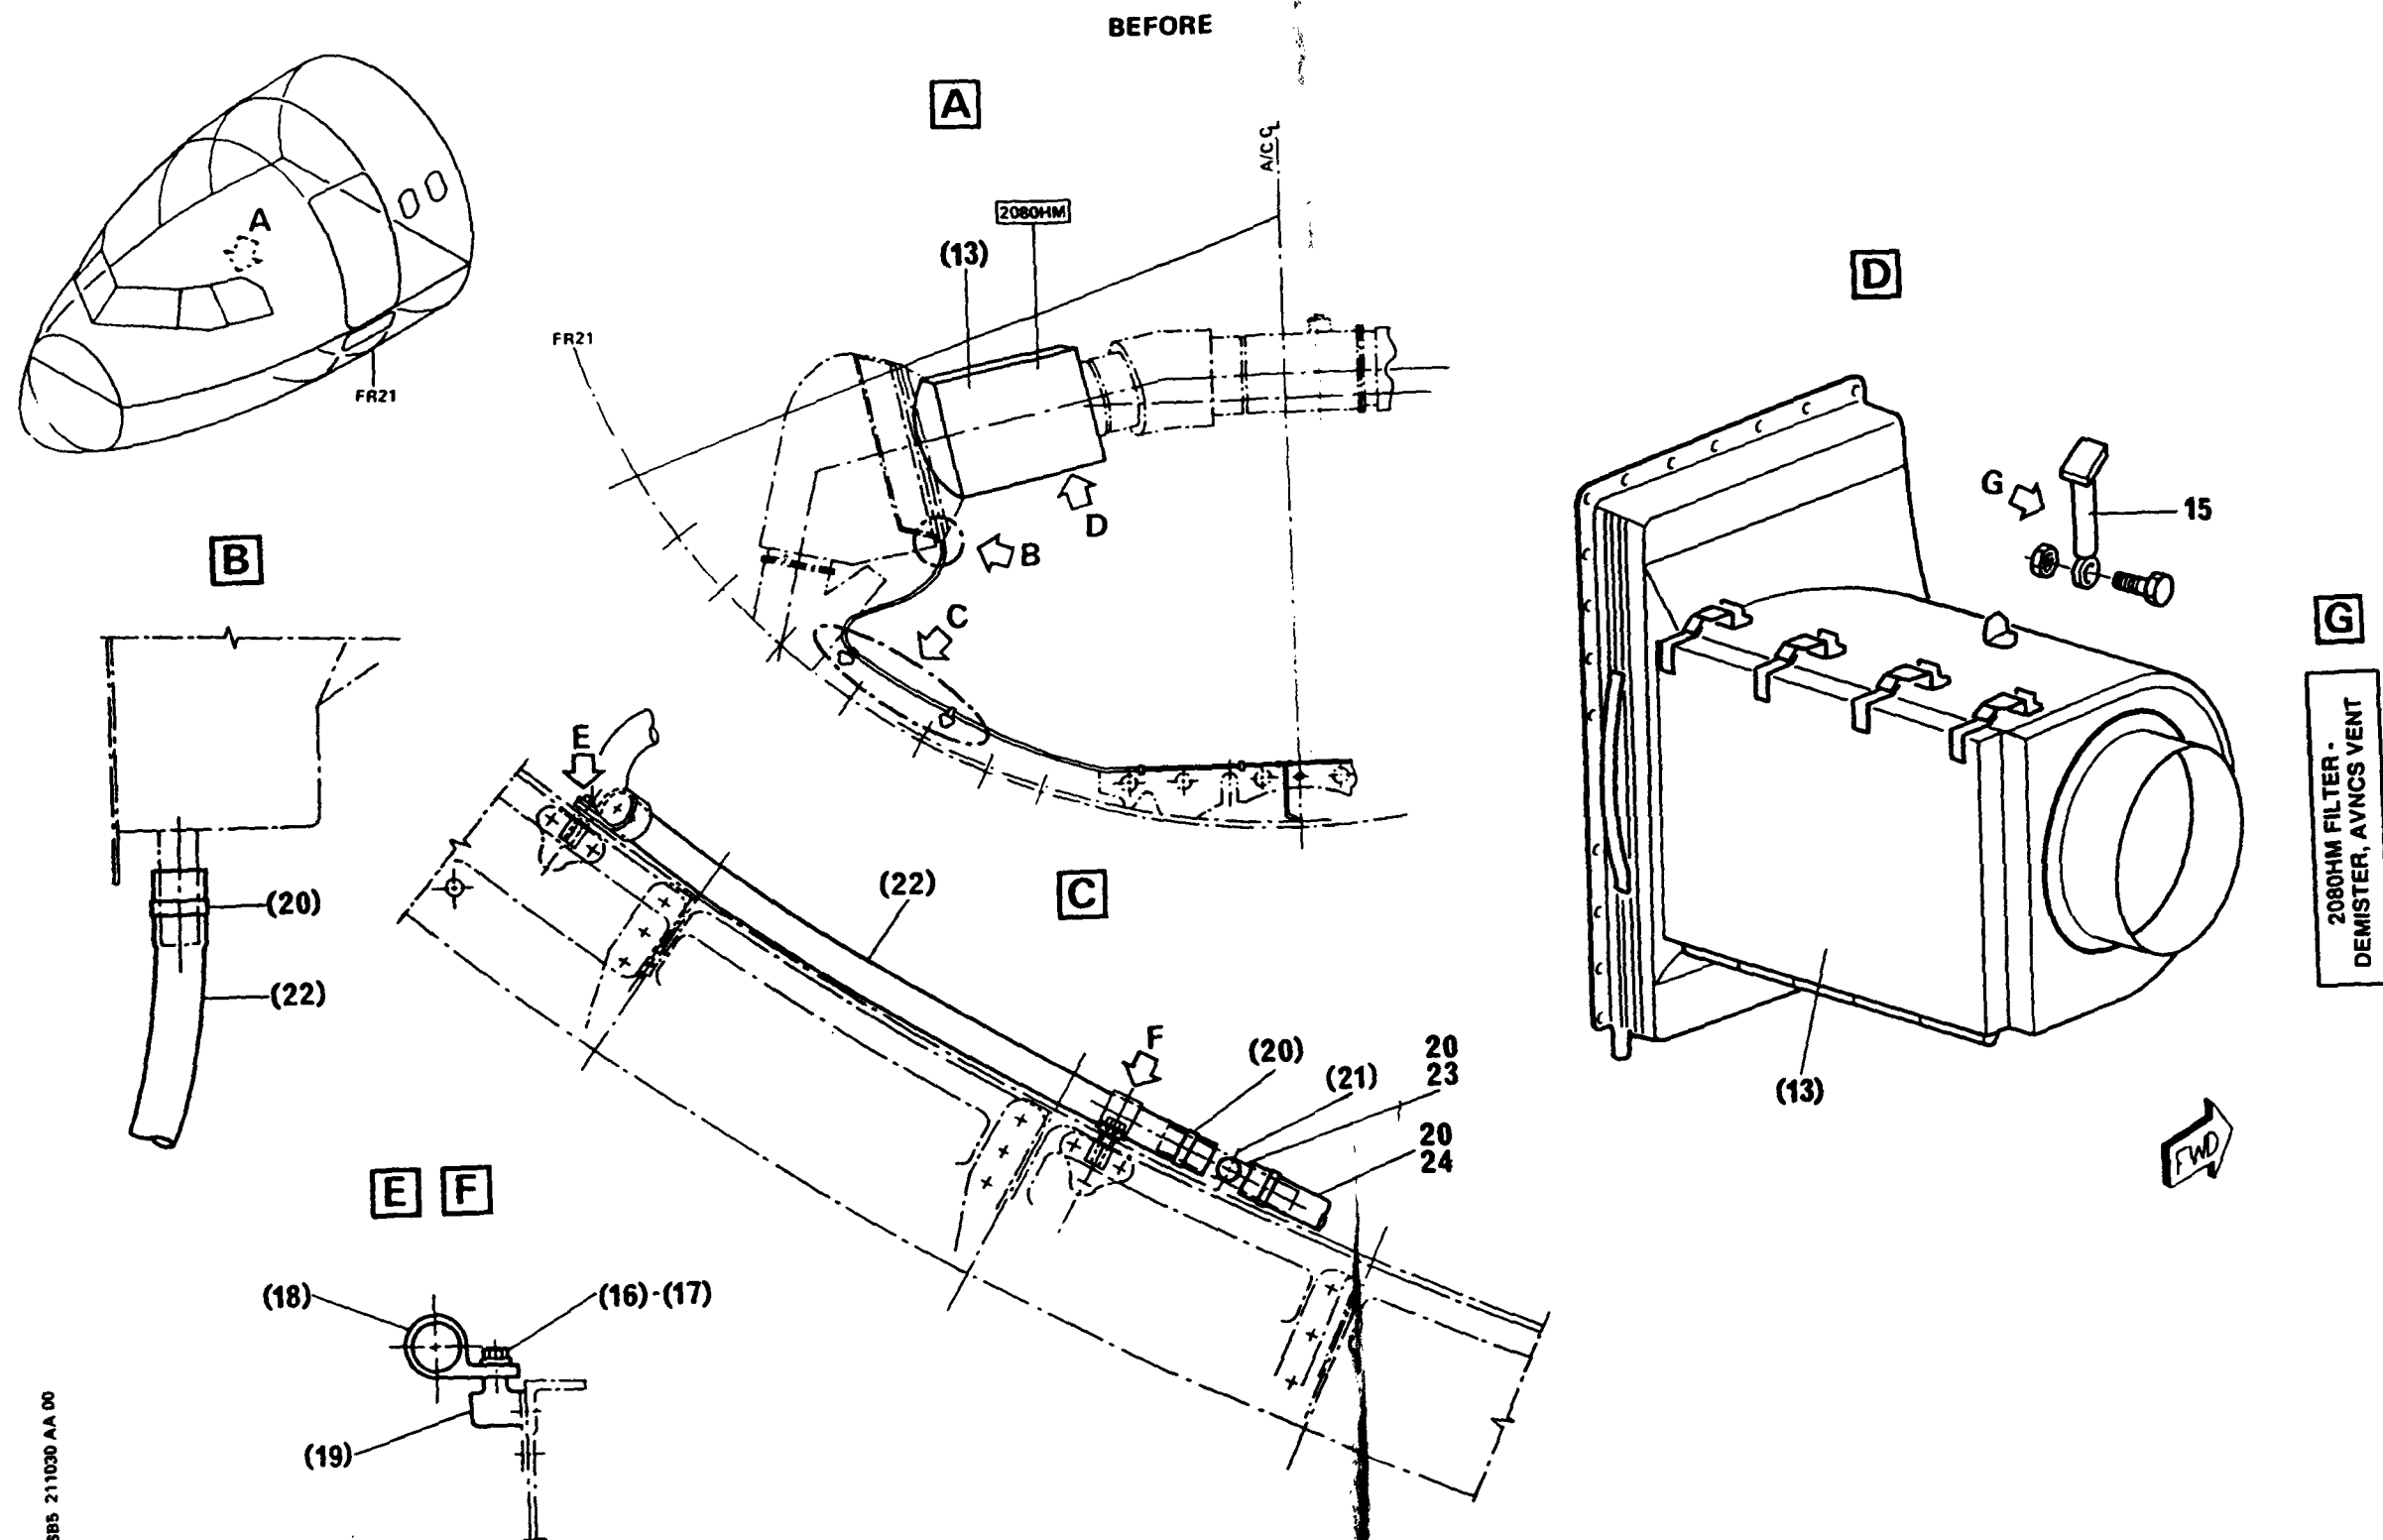
Avionics Ventilation System  
Removal of Demister Filter Assembly with its Drain System  
Figure 1, Sheet 1 of 2

Removal of demister filter assembly (2080HM) with its drain system

1 demister filter assembly (2080HM) Item (13)

2 screws	Item (16) (discard)
2 washers	Item (17) (discard)
2 clamps	Item (18) (discard)
2 supports	Item (19) (discard)
2 clamps	Item (20) (discard)
1 te	Item (21) (discard)
1 hose	Item (22) (discard)
1 hose	Item 23 (retain)
1 hose	Item 24 (retain)
2 clamps	Item 20 (retain)
