S.B. No. A320-21-1003
Mod. No. 20831/P1160

TITLE : AIR CONDITIONING, EQUIPMENT VENTILATION - INSTALL AIR COOLING FANS
WITH MUFFLERS.

SERVICE BULLETIN No. : A320-21-1003

TITLE : AIR CONDITIONING - EQUIPMENT VENTILATION - INSTALL AIR COOLING FANS WITH MUFFLERS.

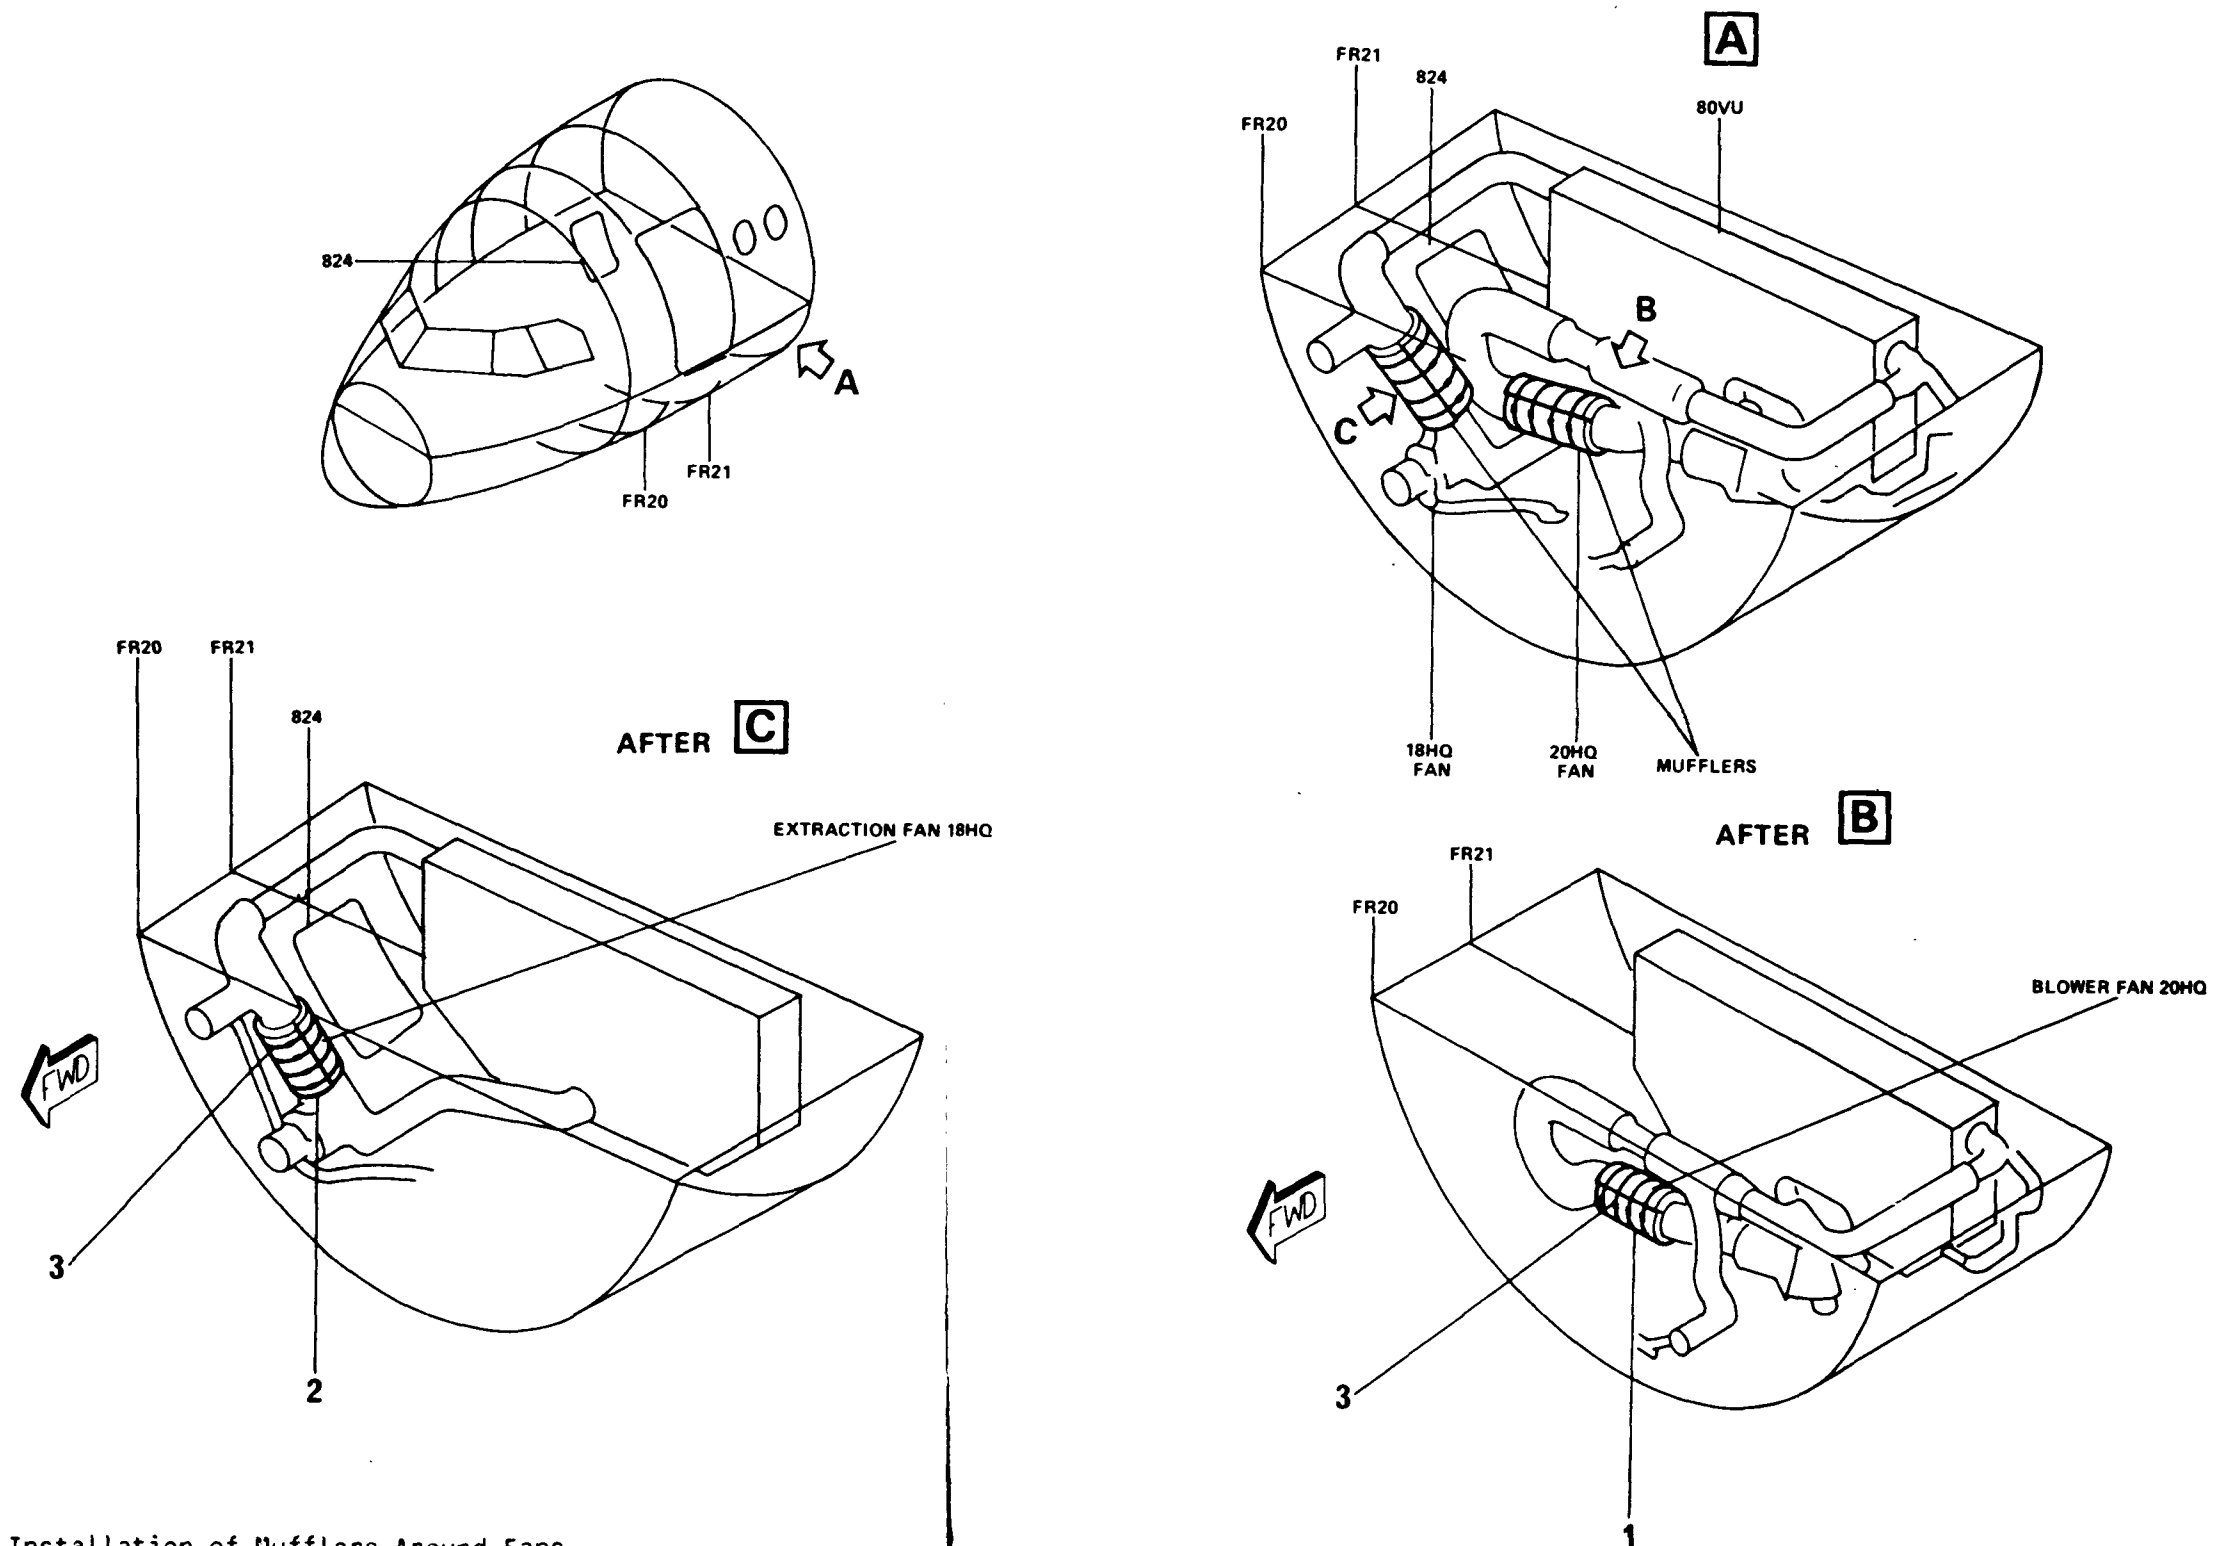
Installation of Mufflers Around Fans
Figure 1

In Avionics compartment in zone 128 between FR20 and FR21 on Electric Fan 20HQ and 18HQ.

- (2) Install the mufflers
Ref. Fig. 1

- (a) On blower fan 20HQ
 - 1 EVT3454-600-01 Item 1
 - 4 clamps TY29M Item 3

- (b) On extract fan 18HQ
 - 1 EVT3454-600-02 Item 2
 - 4 clamps TY29M Item 3
