SERVICE BULLETIN CHANGE NOTICE

S.B. No. A320-21-1017 REV.

TITLE : AIR CONDITIONING - AVIONICS VENTILATION - INSTALL A CHECK VALVE
AT AIR INLET.

SERVICE BULLETIN No. : A320-21-1017

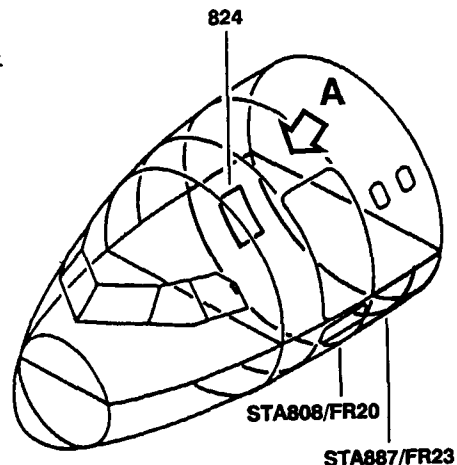
It has been found on in-service aircraft that the untimely opening of the air inlet valve on take-off or in-flight could lead to the compression of some blowing circuit ducts due to the cabin pressure differential (ΔP). Therefore, a check valve is added to the air inlet to protect the circuit. The structure of the ducting installed between the air inlet valve and the check valve is reinforced. Accomplishment of this Service Bulletin is used to protect the blowing circuit against the action of the cabin pressure differential (ΔP).
