MODIFICATION NO: 20837K1857

**T I T L E : AIR-CONDITIONING - TRIM AIR PRESSURE REGULATING VALVE - INSTALL
COLOR MARKINGS**

SERVICE BULLETIN NO: A320-21-1026
PAGE: 7/8

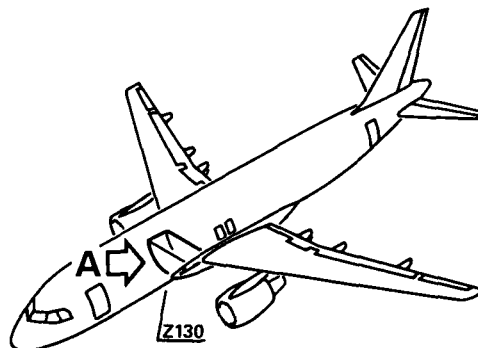
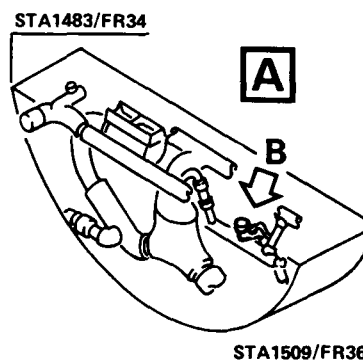
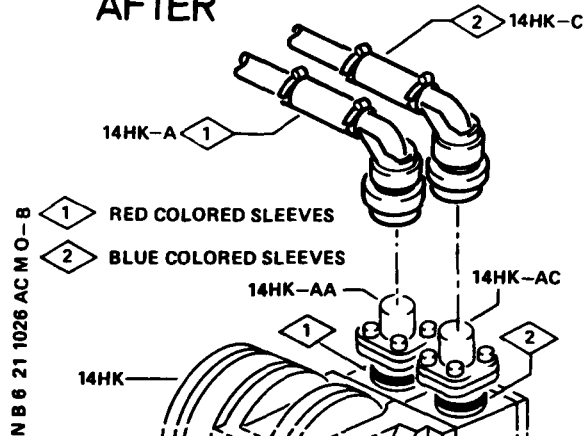
In-service experience has shown that the electrical connectors 14HK-A and 14HK-C of the Trim-Air Pressure-Regulating Valve could be mixed up by mishandling although the connectors are different in type.

This leads to damaged pins in the sockets of the Trim-Air Pressure-Regulating Valve (TAPRV) which results in malfunction of the system. To clearly identify the connections and to avoid an unscheduled replacement of the valve, it is recommended to mark the connectors and the sockets with colored sleeves.

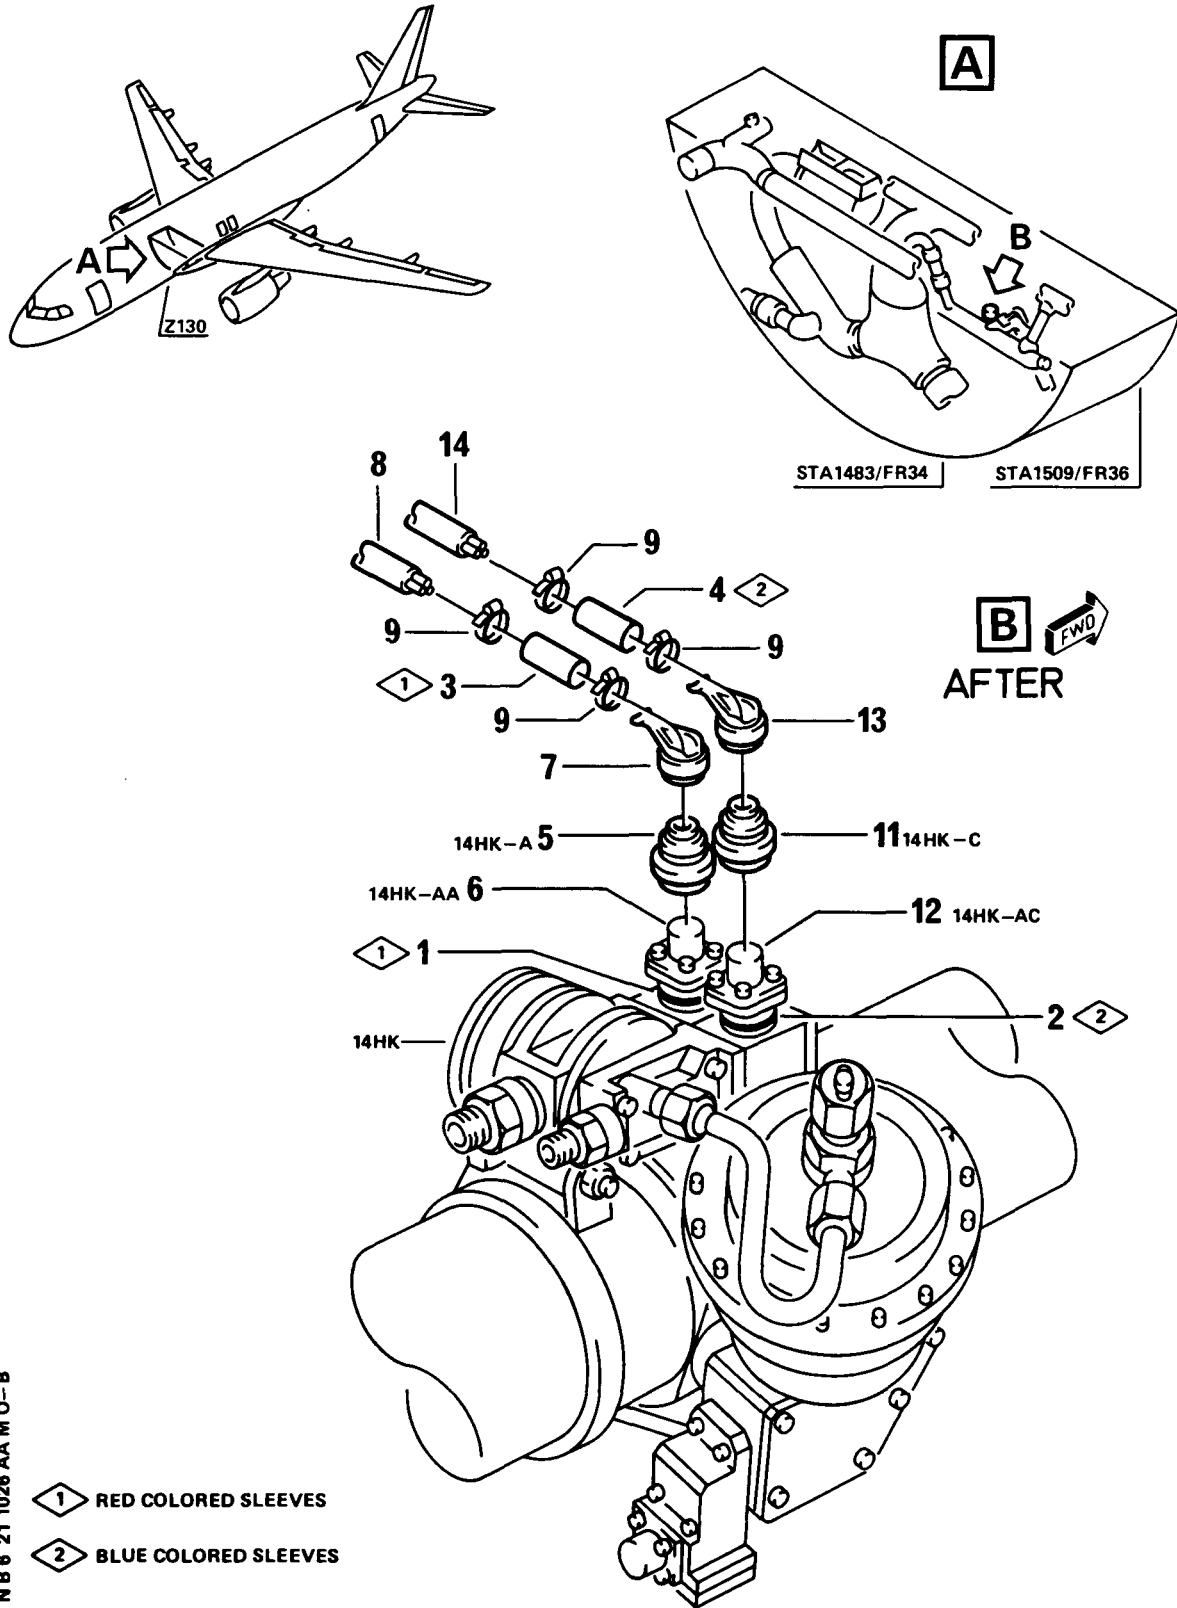
Identification of the Connectors and
the Sockets of the TAPRV
Figure 1

In-service experience has shown that the electrical connectors 14HK-A and 14HK-C of the Trim-Air Pressure-Regulating Valve could be mixed up by mishandling although the connectors are different in type. This leads to damaged pins in the sockets of the Trim-Air Pressure-Regulating Valve (TAPRV) which results in malfunction of the system.

- (1) Identify, with red sleeves, the connector, 14HK-A, and the socket, 14HK-AA, of the TAPRV, 14HK, their location is between FR34 and FR36.
 - (a) Disconnect from the socket, 14HK-AA, item 6:
1 connector, 14HK-A, item 5.

- (b) Cut the red thermofit sleeve, NSA937211-008D, item 1, to a length of 8 mm \pm 1 mm (0.31 in. \pm 0.04 in.).
- (c) Attach to the socket, 14HK-AA, item 6:

- 1 red thermofit sleeve, item 1.
- (d) Heat shrink the red thermofit sleeve, item 1.
- (e) Remove and retain from the cable bundle, item 8:
 - 1 connector 14HK-A, item 5,

- 1 backshell, item 7.
- (f) Attach to the cable bundle, item 8:
 - 1 red sleeve, NSA937201MA1001, item 3, with
 - 2 cable ties, NSA935401-03, item 9.
- (g) Install on the cable bundle, item 8:

- the retained backshell, item 7,
 - the retained connector, 14HK-A, item 5
 - as shown on lines 1, 2 and 3 of Figure 2.
- (h) Connect to the socket, 14HK-AA, item 6:

- 1 connector, 14HK-A, item 5.
- (2) Identify, with blue sleeves, the connector, 14HK-C and the socket, 14HK-AC, of the TAPRV, 14HK.
 - (a) Disconnect from the socket, 14HK-AC, item 12:

- 1 connector, 14HK-C, item 11.
 - (b) Cut the blue thermofit sleeve, NSA 937211-008H, item 2, to a length of 8 mm \pm 1 mm (0.31 in. \pm 0.04 in.).
 - (c) Attach to the socket, 14HK-AC, item 12:

- 1 blue thermofit sleeve, item 2.
 - (d) Heat shrink the blue thermofit sleeve, item 2.

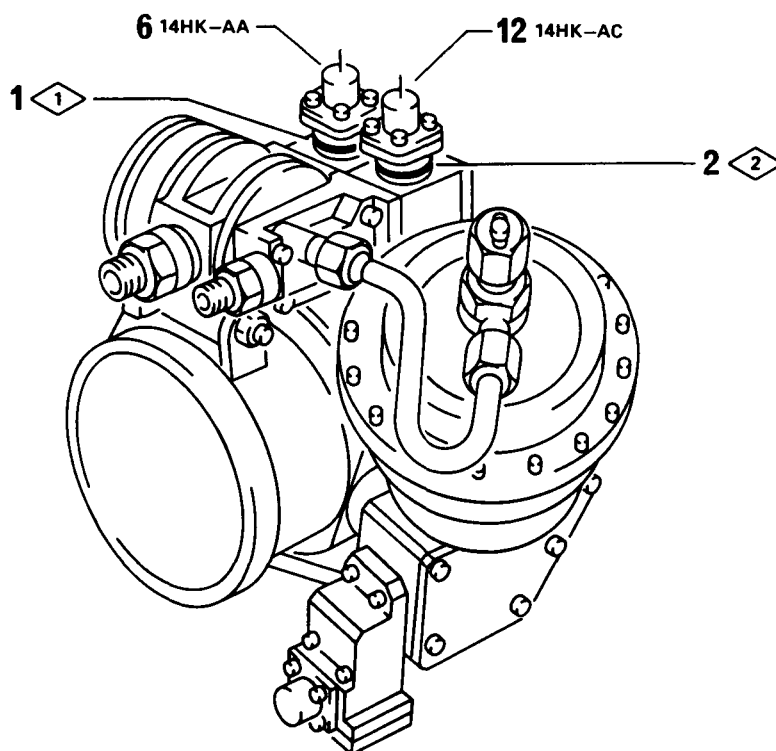
Identification of the Sockets of the TAPRV
Figure 3

- 1 RED COLORED SLEEVE , LENGTH 8 ± 1 mm (0.31 ± 0.04 in.)
- 2 BLUE COLORED SLEEVE , LENGTH 8 ± 1 mm (0.31 ± 0.04 in.)

(a) Identify, with a red thermofit sleeve, the socket, 14HK-AA, of the TAPRV.

1 Cut the red thermofit sleeve, NSA937211-008D, item 1, to a length of 8 mm \pm 1 mm (0.31 in. \pm 0.04 in.).2 Attach to the socket, 14HK-AA, item 6:

(b) Identify, with a blue thermofit sleeve, the socket, 14HK-AC, of the TAPRV.

1 Cut the blue thermofit sleeve, NSA937211-008H, item 2, to a length of 8 mm \pm 1 mm (0.31 in. \pm 0.04 in.).2 Attach to the socket, 14HK-AC, item 12:
