S.B. No. A320-21-1023 REV.

TITLE : AIR CONDITIONING - IMPROVED ADIRU DRAINAGE.

SERVICE BULLETIN No. : A320-21-1023

TITLE : AIR CONDITIONING - IMPROVE ADIRU DRAINAGE

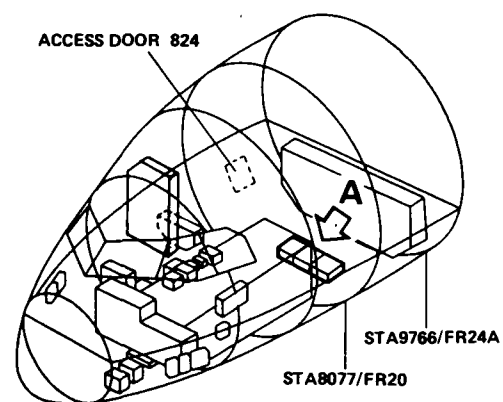
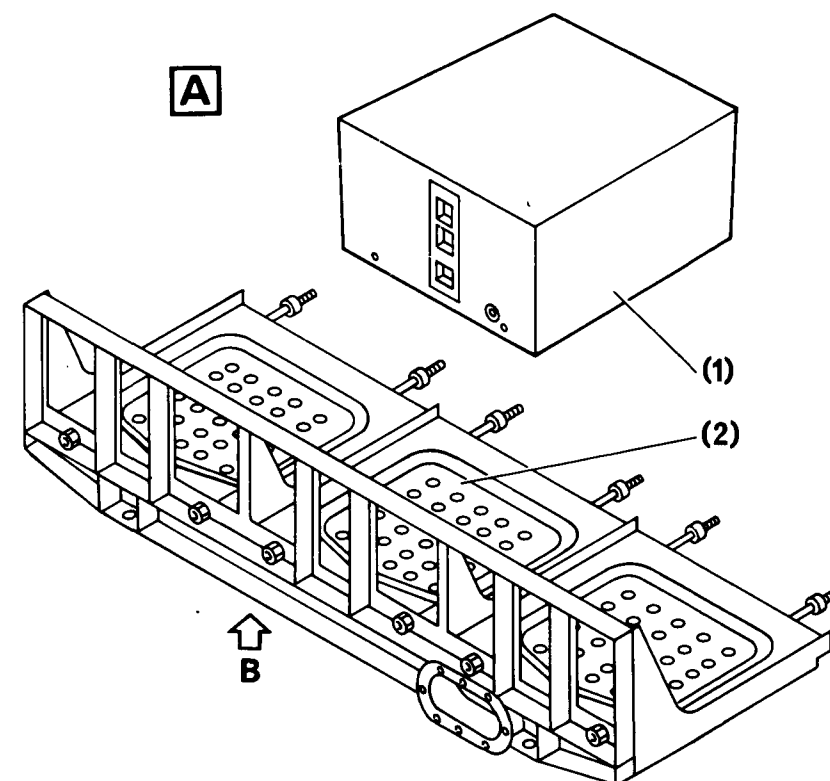
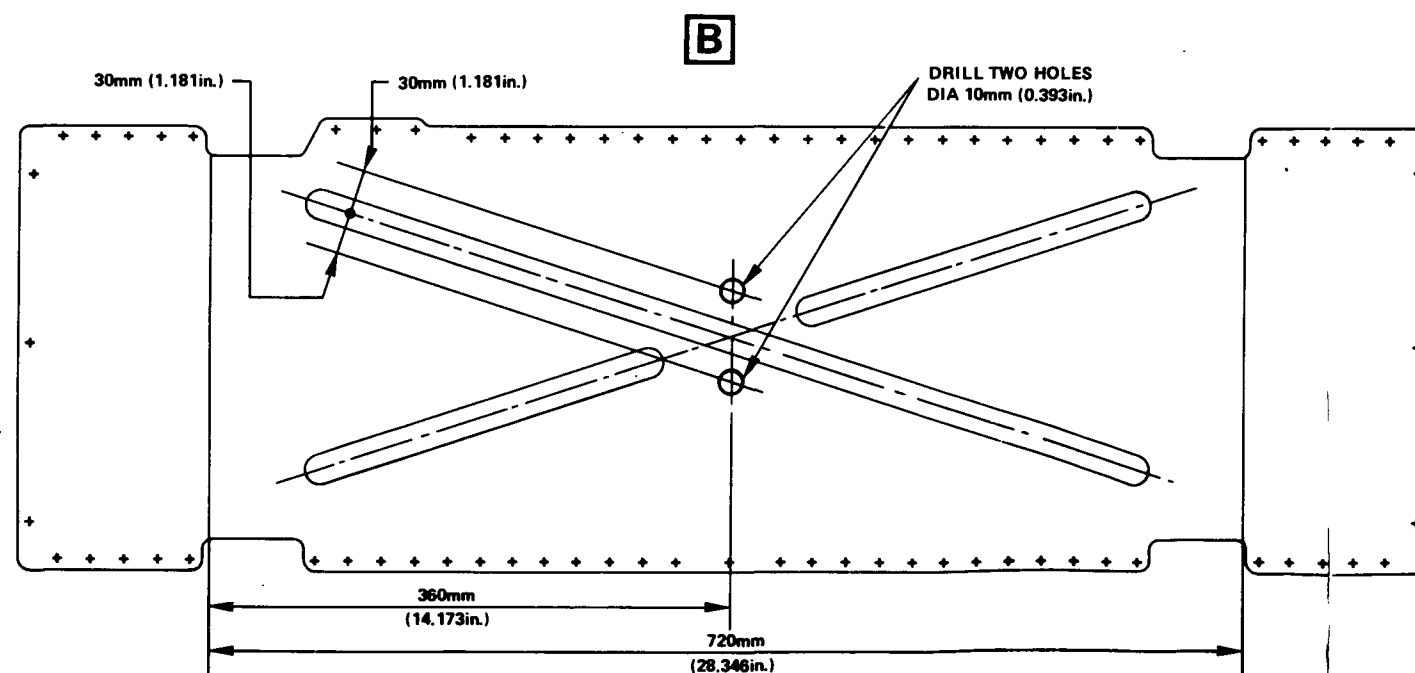
Drilling of 2 Drainage Holes in Lower Plate of ADIRUs Support
Figure 1

Water was found on the lower plate of the ADIRUs support. This water comes from the avionics equipment ventilation system in ground configuration during rainy weather (air taken from outside the aircraft) and can collect under the ADIRUs, sometimes leading to ADIRU malfunctions.

Drill 2 drainage holes in the lower plate of the ADIRUs support.

- (2) Drill 2 holes in the lower plate.
 - (a) Mark and drill 2 holes 10 mm (0.39 in.) dia.
 - (b) Clean the work area with Material No. 11-003 (Ref. CLM).
 - (c) After the drilling, deburr the holes and renew the protective finish (Ref. AMM 51-23-11) with Materials No. 13-002, 16-001 and 16-002 (Ref. CML).
