A319/A320/A321

S.B. No. A320-21-1019 REV.
Mod. No. 20327/P01104

TITLE : AIR CONDITIONING - COCKPIT - REPLACE AIR DUCT.

SERVICE BULLETIN No. : A320-21-1019

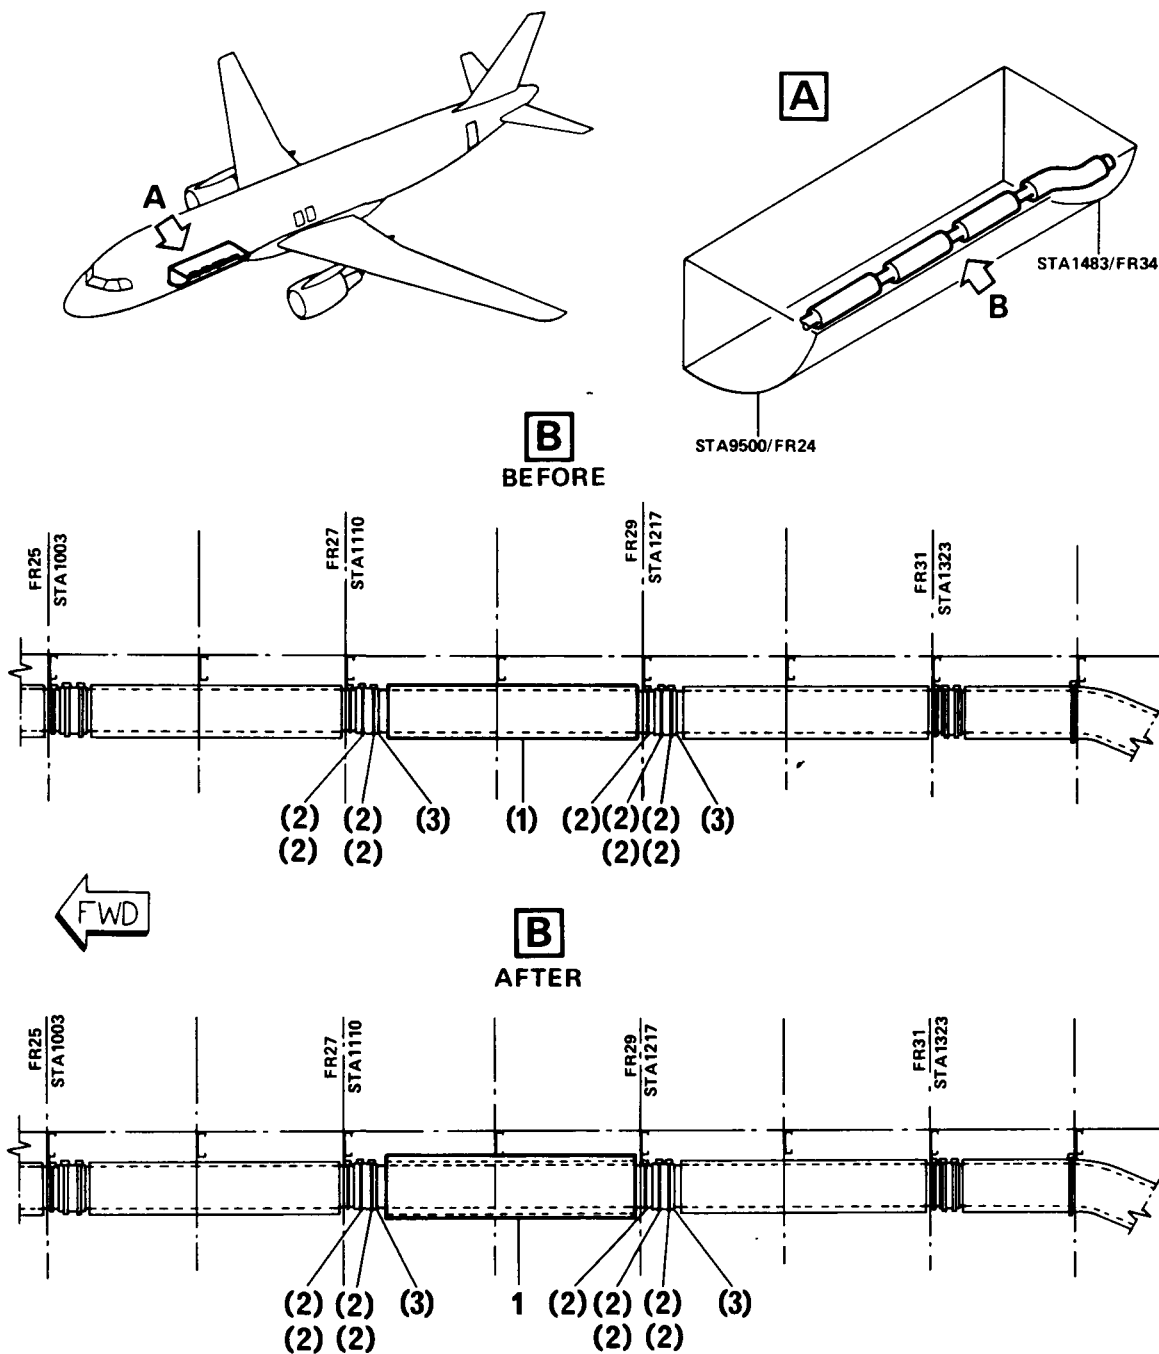
**Installation of New Silenced Duct
Figure 1**

In order to reduce noise caused by air generation and in this way improve the acoustic comfort of the cockpit, this Service Bulletin proposes replacing the existing basic duct of the air conditioning system by a silenced duct, between frames 27 to 29.

- (1) Remove the left lateral panel 131HW between the frames 27 to 30
(re-used)
- (2) Remove the basic air conditioning duct that is in the aircraft

9 clamps	Item (2)	(retain)
2 sleeves	Item (3)	(retain)
1 duct	Item (1)	(Ref. NOTE)

NOTE : If necessary, it will be possible to re-use the duct
Item (1) because this duct has the same Part No. as the
ducts that are in the aircraft and that are installed
between the frames 25 to 27 and the frames 29 to 31.

- (3) Install the new silenced duct

1 duct D2121097000000	Item 1	
2 sleeves	Item (3)	(retained at removal)
9 clamps	Item (2)	(retained at removal)
