SERVICE BULLETIN CHANGE NOTICE

S.B. No. A320-21-1013 REV.

MOD. No. 21110/P1441

TITLE : AIR CONDITIONING - COCKPIT VENTILATION INSTALL A GRILL IN AIRDUCT.

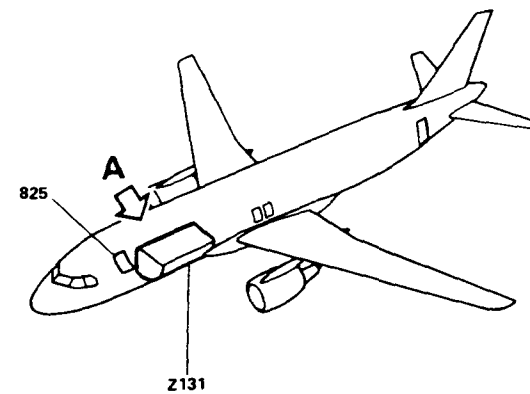
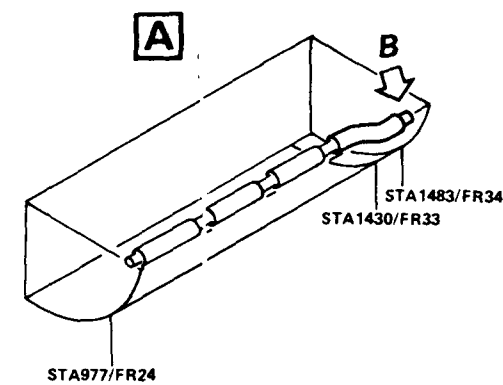
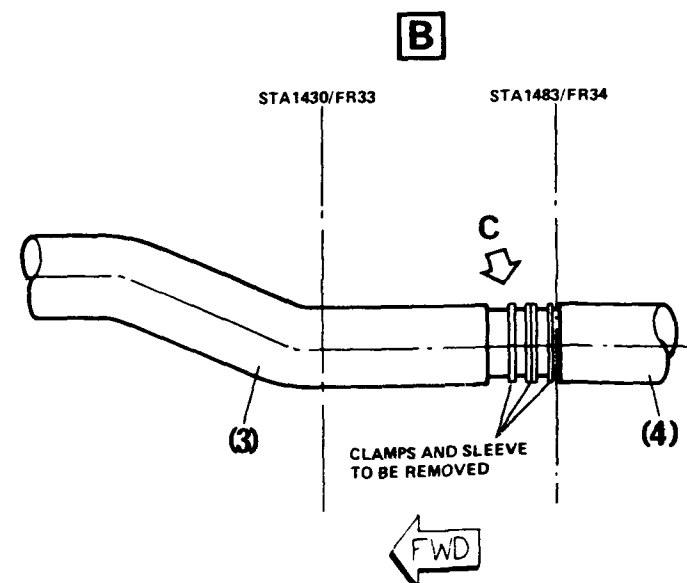
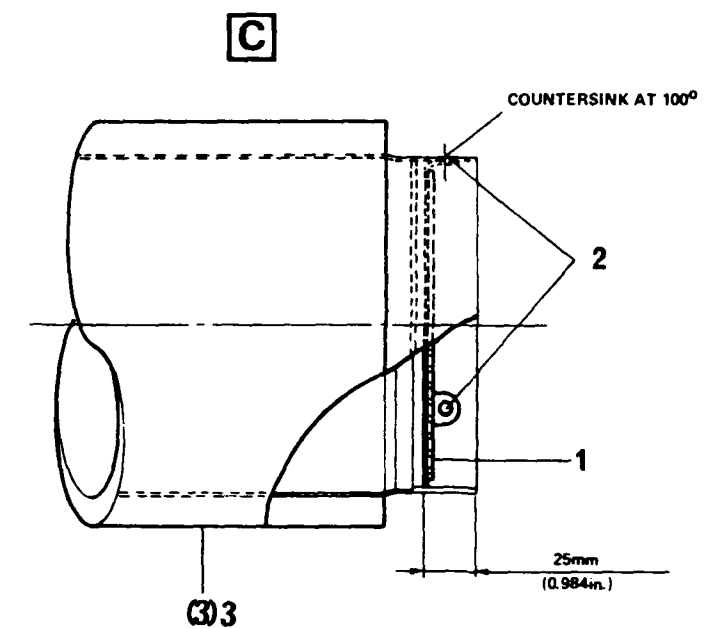
Installation of Grill  
Figure 1

Prevent projection of ice particles through the flight deck outlets. Whese ice chips are generated by the air conditioning packs and should be melted within the mixing unit. With existing system configuration some ice particles are not completely melted and can reach the flight deck air distribution outlets.

In forward cargo compartment, in zone 131 between STA1430/FR33 and STA1483/FR34, installation of a grill at end of flight compartment air conditioning duct.

(1) Remove clamps and flexible sleeves between ducts Items (3) and (4).

(2) Install grill on duct Item (3).

Matchdrill to 2.4 mm (0.094 in.) dia., countersink and attach with :

3 rivets ASNA2051DCJ02412 Item 2.

- (3) On ducts Items (3) and (4), install clamps and flexible sleeves retained during removal.
- (4) Part Number of Modified Item  
D2121031500000 becomes D2121031500200.
- (5) Install sidewall Panels 131MW, 131PW (Ref. AMM 06-41-53).
