737

Service Bulletin

Number: 737-21-1186
Original Issue: April 17, 2012
Revision 1: April 23, 2015
ATA System: 2130

SUBJECT: AIR CONDITIONING - Control Cabin Conditioned Air Distribution System - Inspection of the Metal Clamp Installed on Hoses to the Air Conditioning Temperature Sensor, Gasper Air Outlet and Diffuser

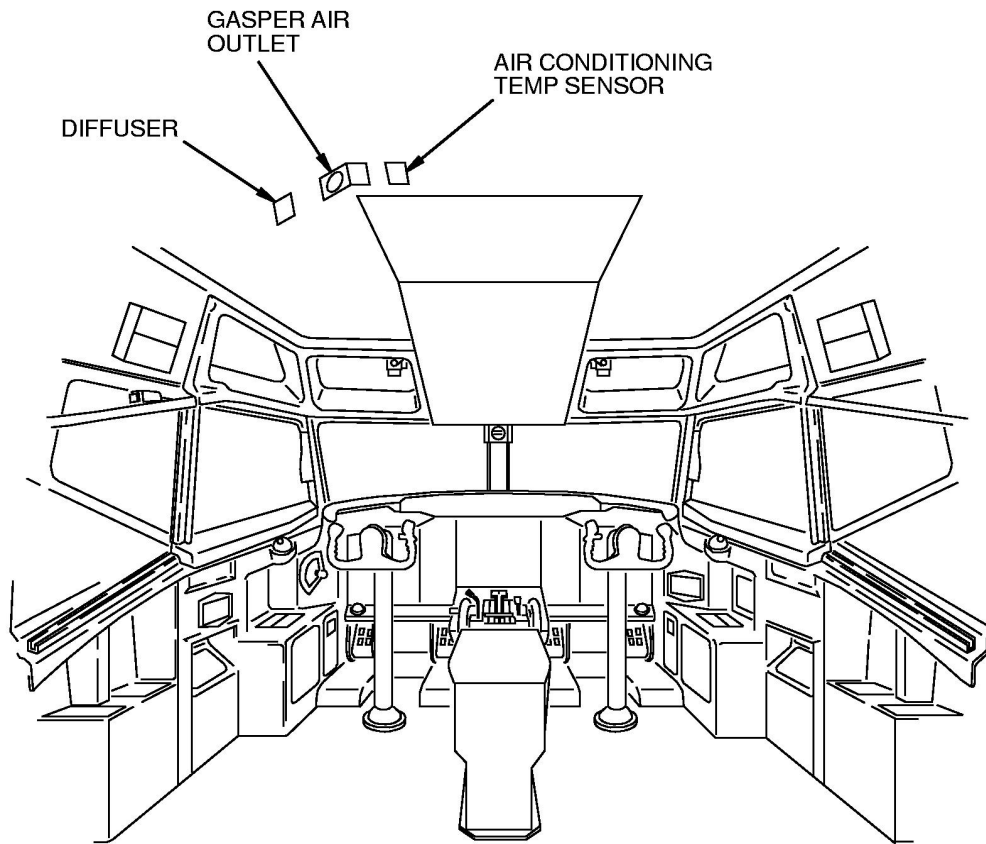
GROUP 1-2:

GAIN ACCESS TO THE AIR CONDITIONING TEMPERATURE SENSOR, GASPER AIR OUTLET AND THE DIFFUSER ON THE LEFT SIDE OF THE CONTROL CABIN, DO A GENERAL VISUAL INSPECTION (GVI) OF HOSES FOR METAL CLAMPS OR IMPROPERLY INSTALLED PLASTIC TIE STRAPS. REMOVE AND REPLACE METAL CLAMPS OR IMPROPERLY INSTALLED PLASTIC TIE STRAPS WITH PROPERLY INSTALLED PLASTIC TIE STRAPS. DO A GVI OF ADJACENT WIRE BUNDLES FOR DAMAGE OR CHAFING AND REPAIR THE DAMAGE. CLOSE ACCESS TO THE AIR CONDITIONING TEMPERATURE SENSOR, GASPER AIR OUTLET AND THE DIFFUSER ON THE LEFT SIDE OF THE CONTROL CABIN.

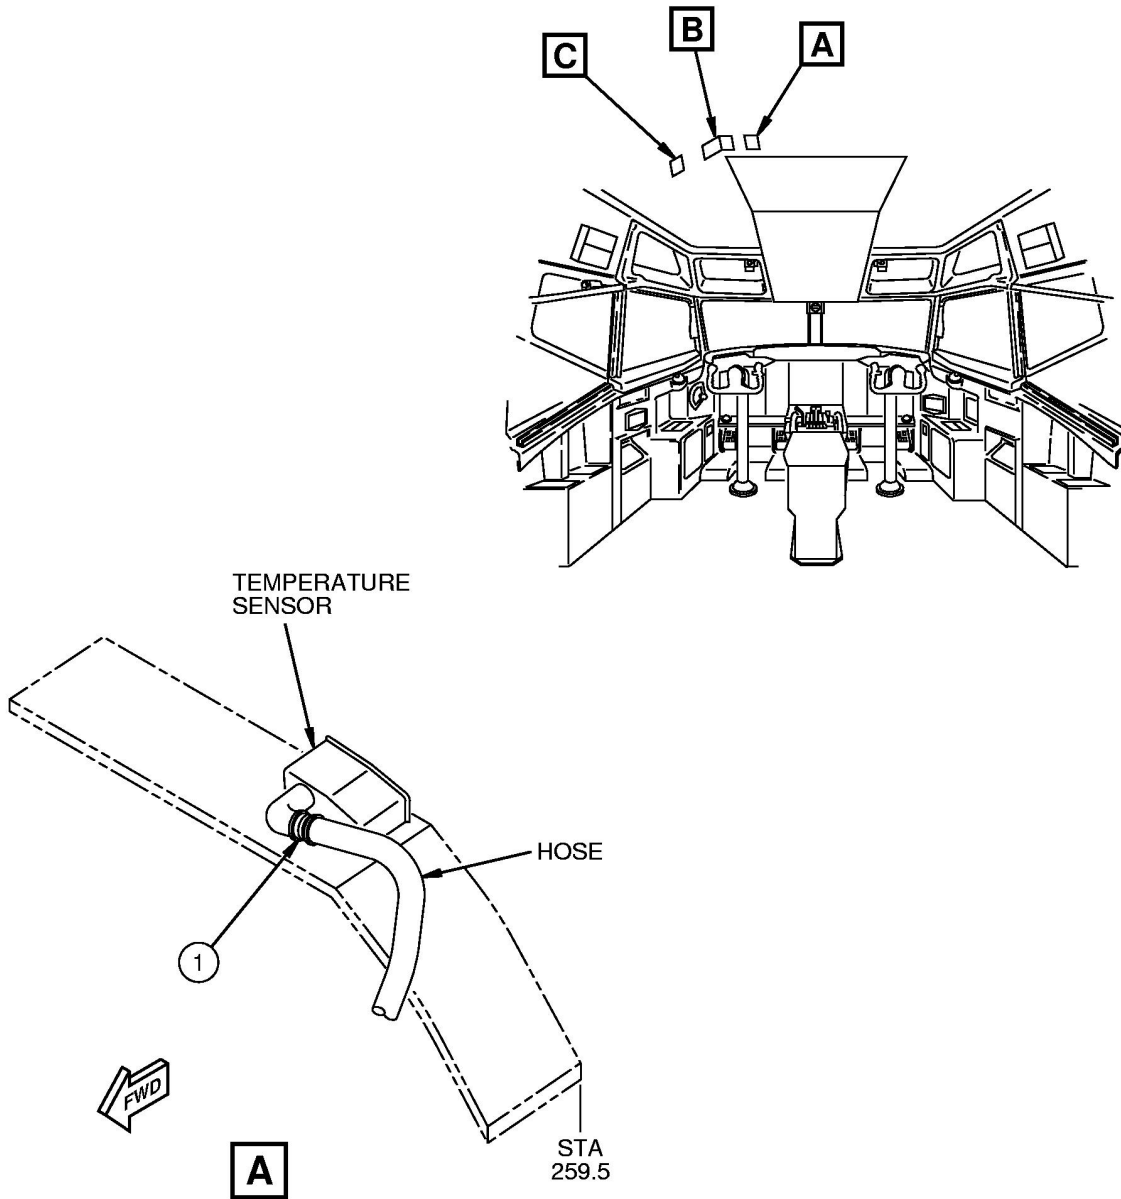
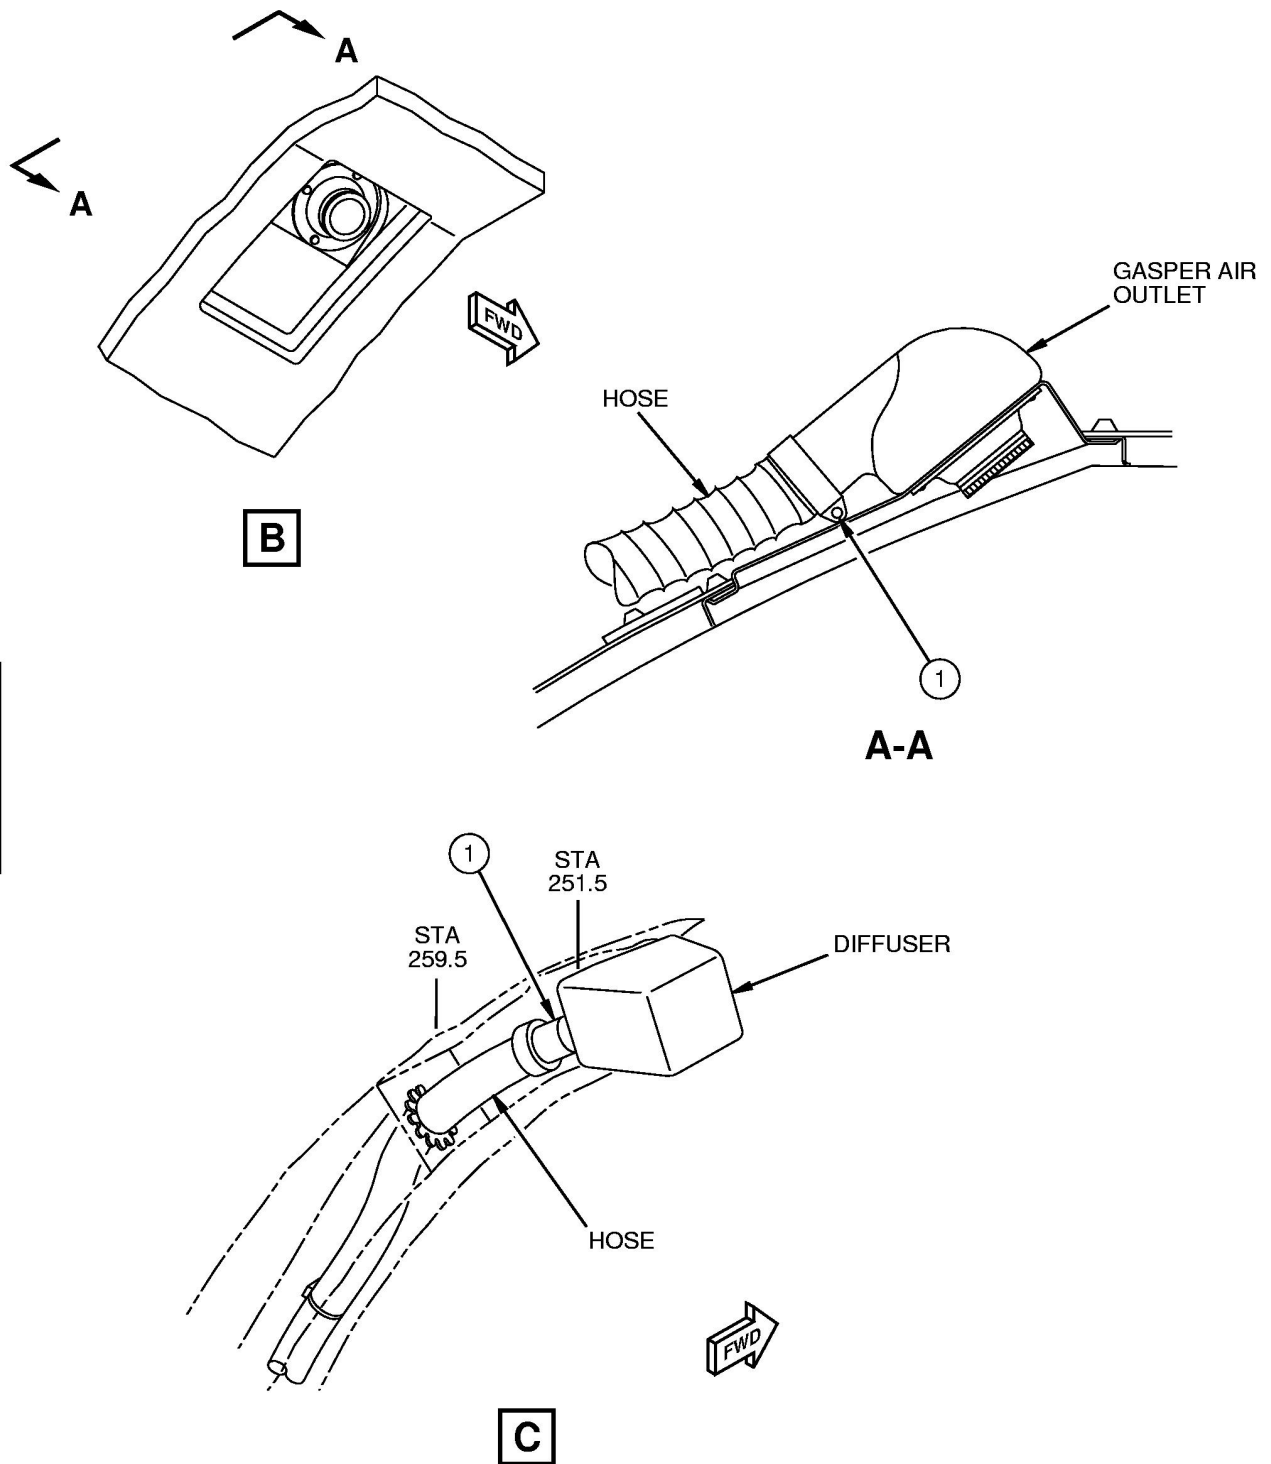
**FIGURE 1: HOSE GENERAL VISUAL INSPECTION
(SHEET 1 OF 3)**

Operators have informed Boeing of chafed wire bundles caused by metal clamps installed on hoses to the Air Conditioning Temperature Sensor, Gasper Air Outlet and the Diffuser on the left side of the Control Cabin at STA 259.5. A metal clamp or improperly installed plastic tie strap can cause chafing of the wire bundles.

Step	Task	Name	Identification	Qty	More Data
1	Inspect	Metal Clamp or Plastic Tie Strap	-	-	(a) (b)
(a) Do a General Visual Inspection (GVI) of hoses for metal clamps or improperly installed plastic tie straps.					
(b) An improperly installed plastic tie strap has the head pointed in any direction, except towards the panel. The correct installation is head of plastic tie strap towards the panel.

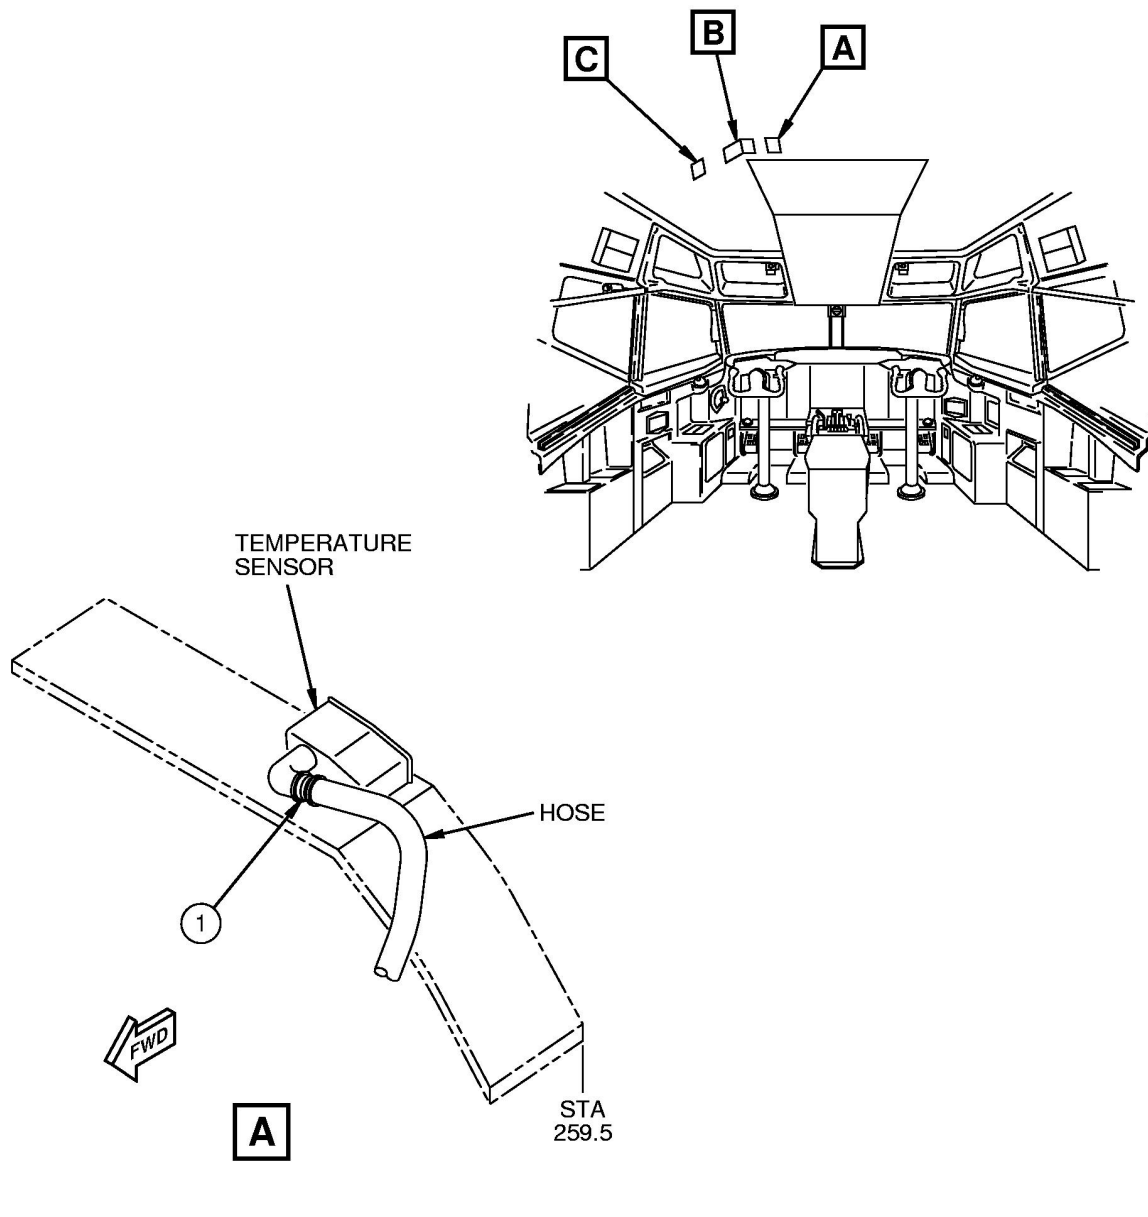
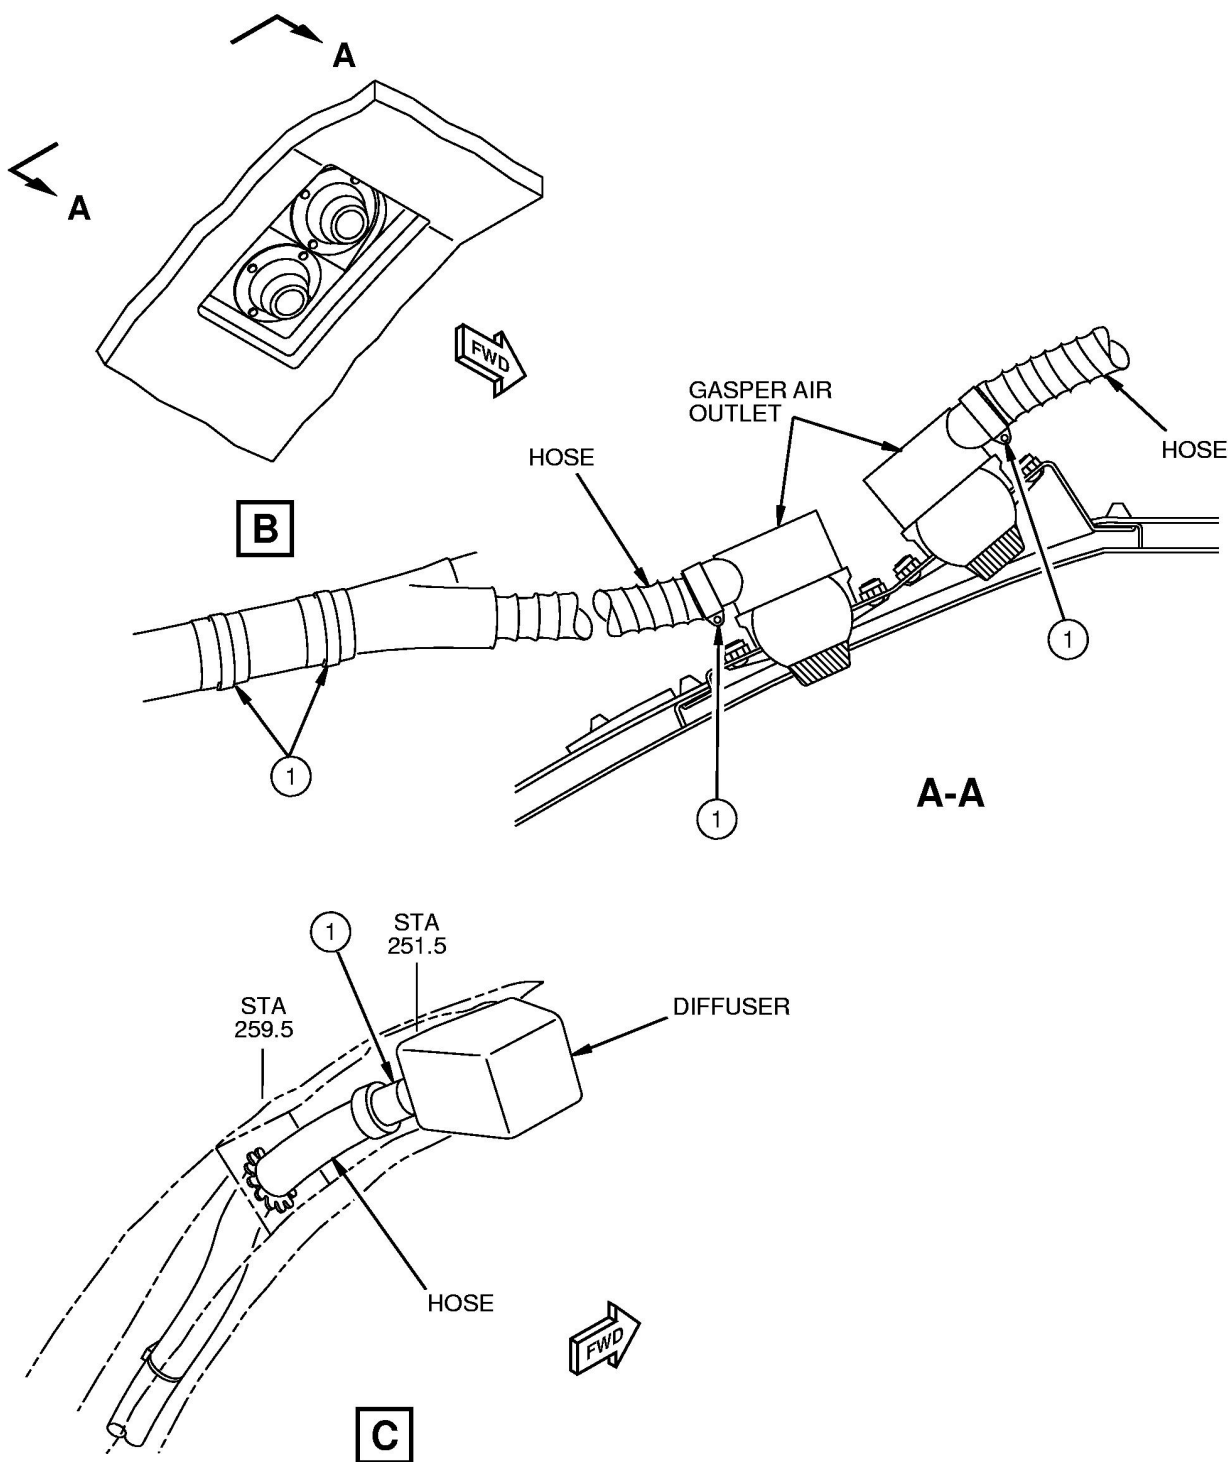
**FIGURE 3: HOSE GENERAL VISUAL INSPECT
(SHEET 1 OF 3)**

Step	Task	Name	Identification	Qty	More Data
1	Inspect	Metal Clamp or Plastic Tie Strap	-	-	(a) (b)
(a) Do a General Visual Inspection (GVI) of hoses for metal clamps or improperly installed plastic tie straps.					
(b) An improperly installed plastic tie strap has the head pointed in any direction, except towards the panel. The correct installation is head of plastic tie strap towards the panel.
