737

Service Bulletin

Number: 737-24-1214
Original Issue: May 12, 2015
ATA System: 2421

SUBJECT: ELECTRICAL POWER - AC Generation System - Power Feeder Wire Bundle Support Installation

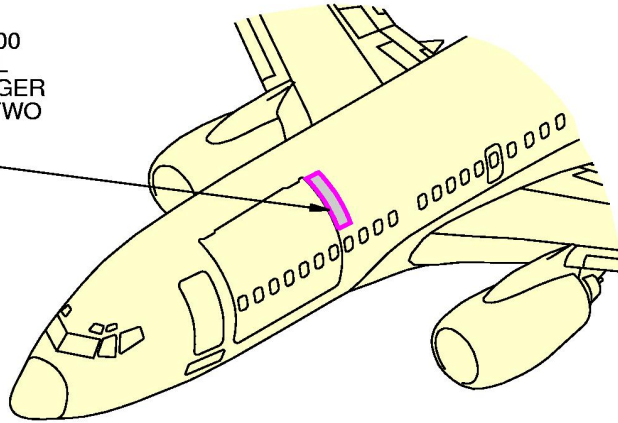
This service bulletin provides instructions on installing two additional wire support stringer clip assemblies for wire bundle W4722 located in main deck cargo area between stations 500 and 500A. It will prevent for wire bundle from rubbing on the overhead stowage bin sidewall. If this service bulletin is not accomplished, it may lead to wire bundle damage resulting in potential loss of Auxiliary Power Unit (APU) power channel.

IN MAIN DECK CARGO
AREA BETWEEN STA 500
AND STA 500A, INSTALL
WIRE SUPPORT STRINGER
CLIP ASSEMBLIES AT TWO
LOCATIONS FOR WIRE
BUNDLE W4722

Get access to wire bundle W4722 located next to main deck cargo door between stations 500 and 500A. Install wire support stringer clip assemblies at locations S-6L and S-7L. Close access.
