SERVICE BULLETIN CHANGE NOTICE

S.B. No. A320-21-1027

TITLE: AIR CONDITIONING - FLOW CONTROL AND INDICATING - IMPROVE THE
VENTING OF THE PRESSURE PORT

**A320**
SERVICE BULLETIN
REVISION TRANSMITTAL SHEET

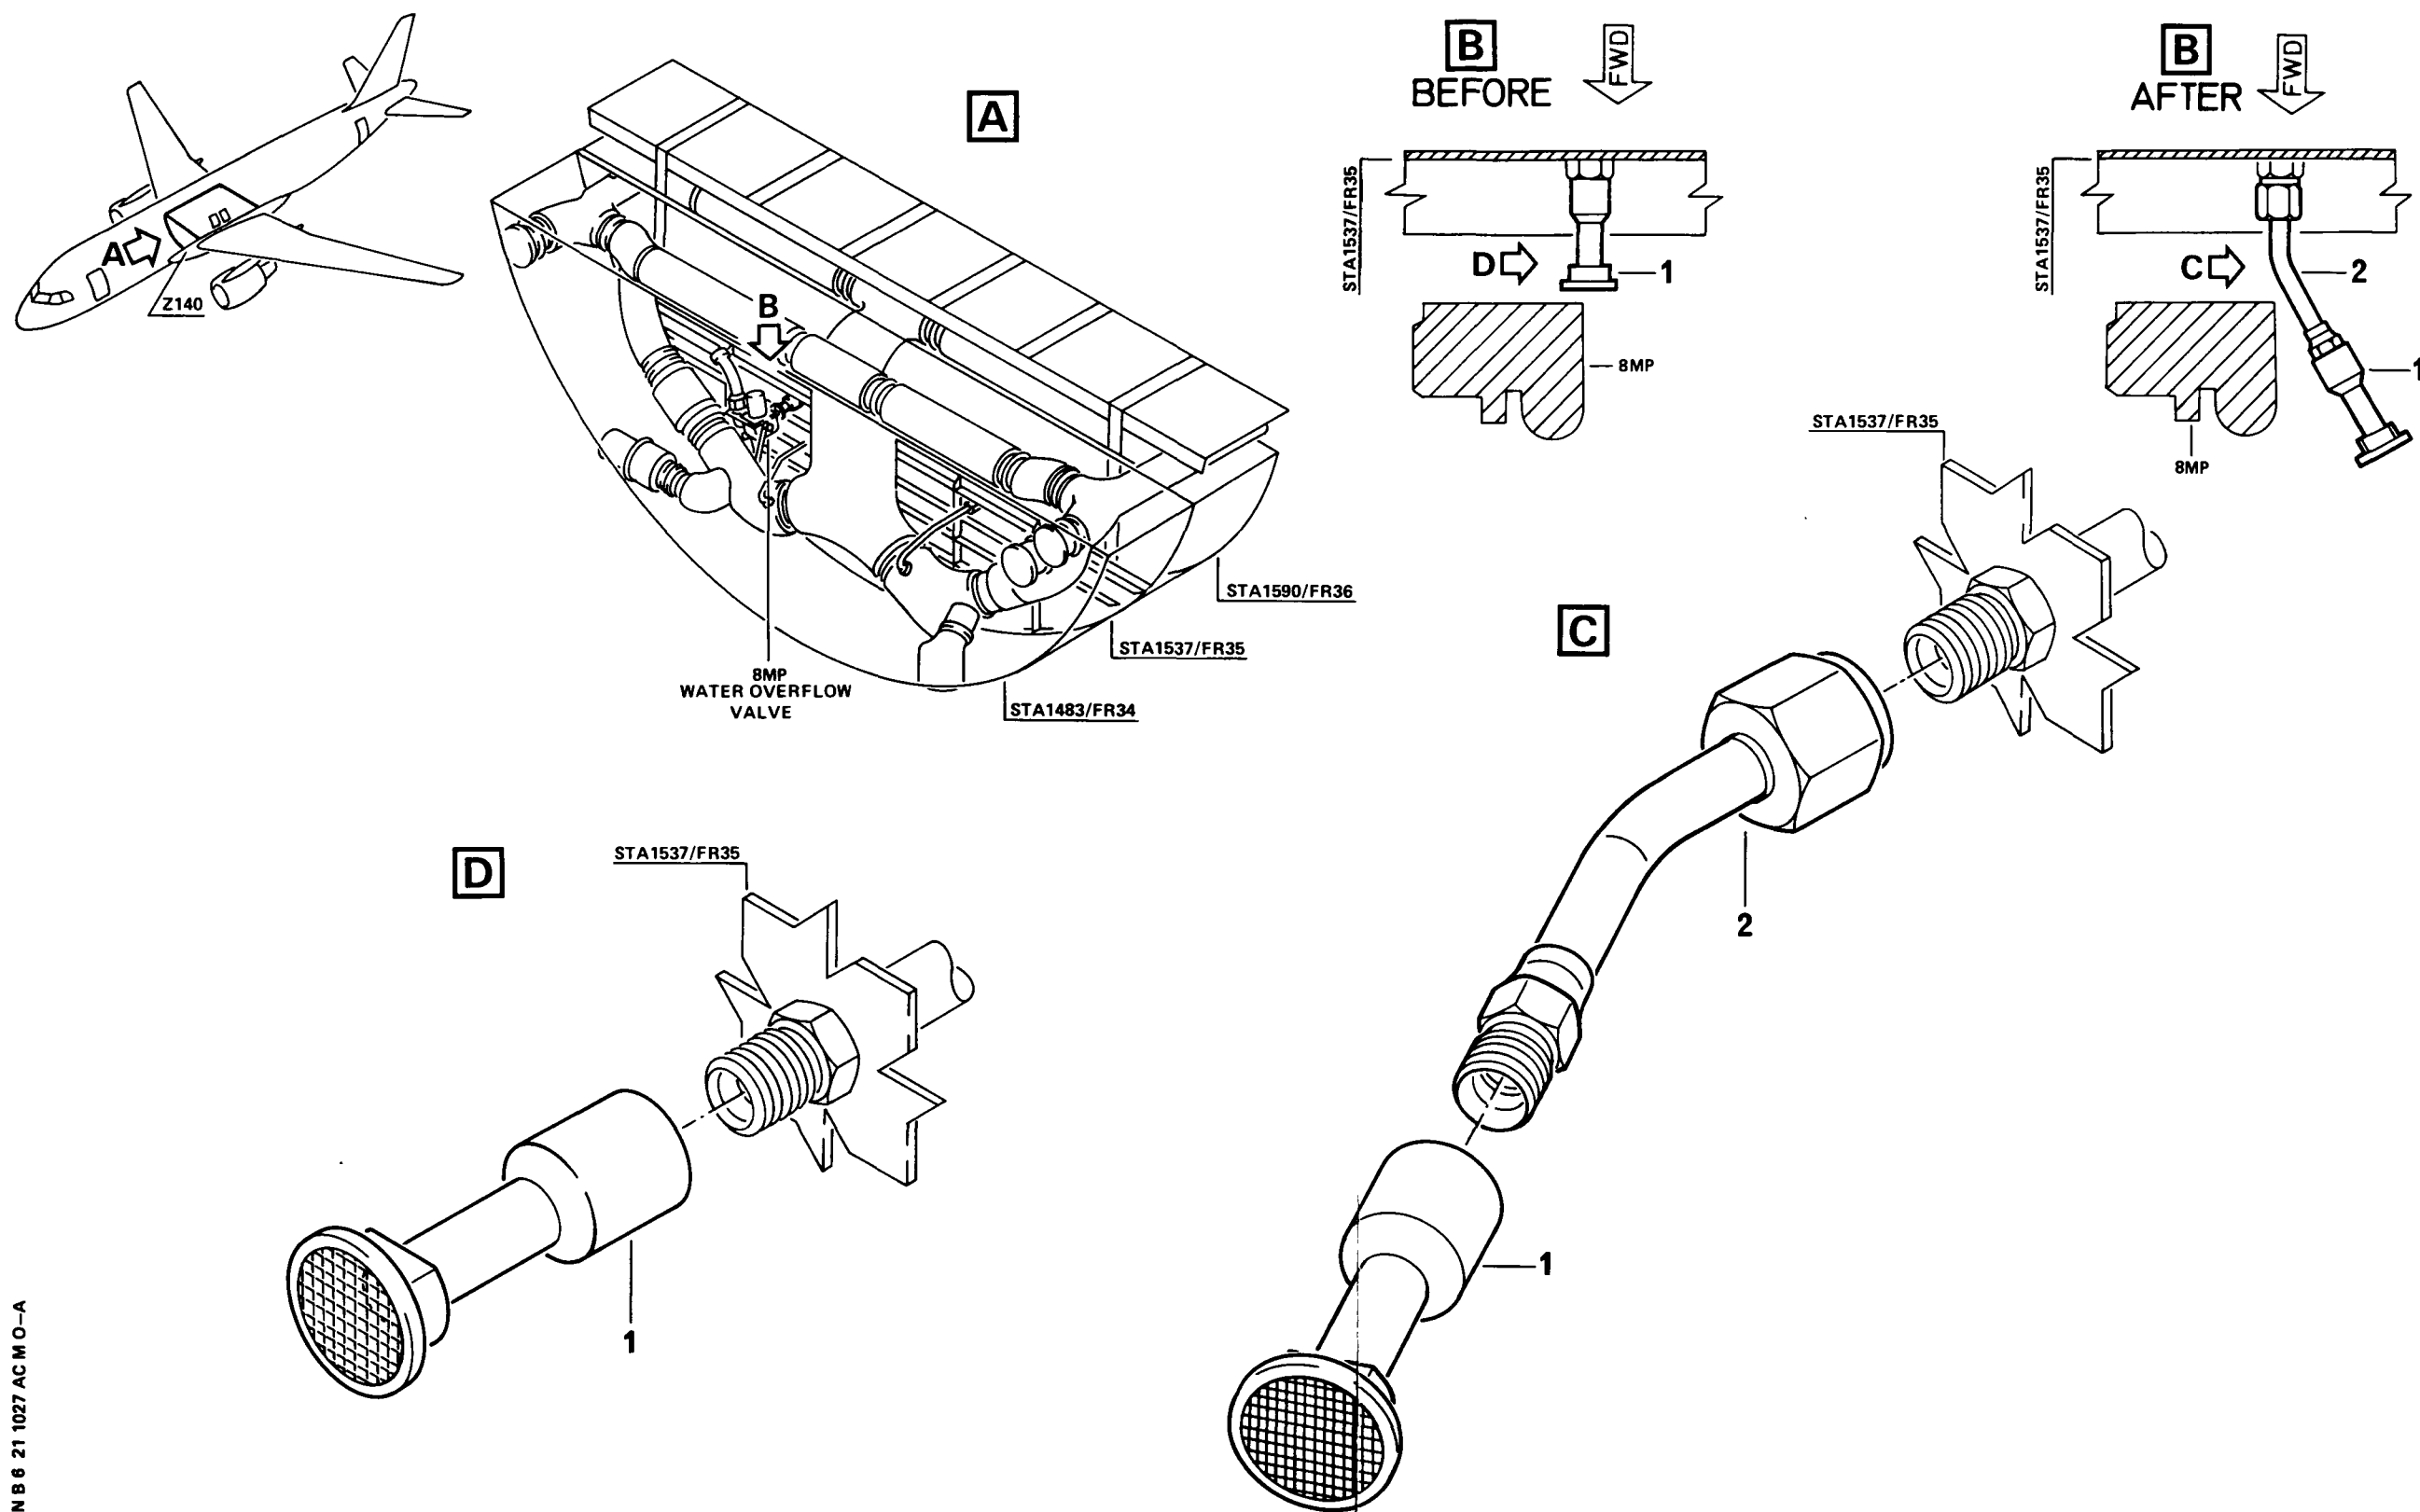
Installation of the Tube Assembly for the Pressure Port
Figure 1

It was found that correct venting of the pressure port for the pneumatic regulation of the flow control valve 'pack 2' is not fully ensured, due to the very close water overflow valve, which is installed with Mod. No. 21003.

- (a) Remove and retain the pressure port D2127412800000, item 1.
- (b) Install the new tube assembly D2127413500000, item 2, as shown.
- (c) Install the retained pressure port, item 1, on the tube assembly, item 2, as shown.
