S.B. No. A320-21-1015  
Mod. No. 21224/P01532

TITLE : AIR CONDITIONING - AVIONICS EQUIPMENT VENTILATION - REDUCE  
LEVEL OF VIBRATION AT WALL HEAT EXCHANGER.

SERVICE BULLETIN

MODIFICATION No. 21224/P01532

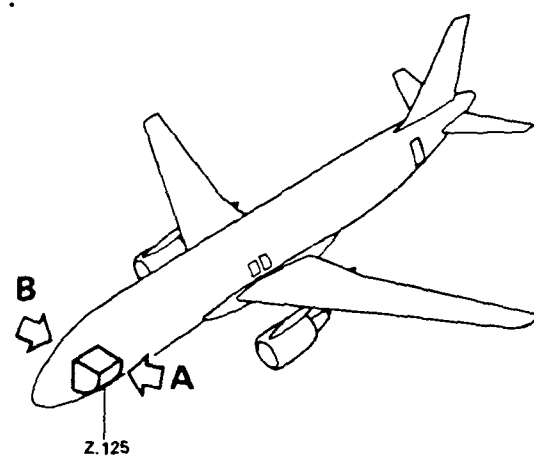
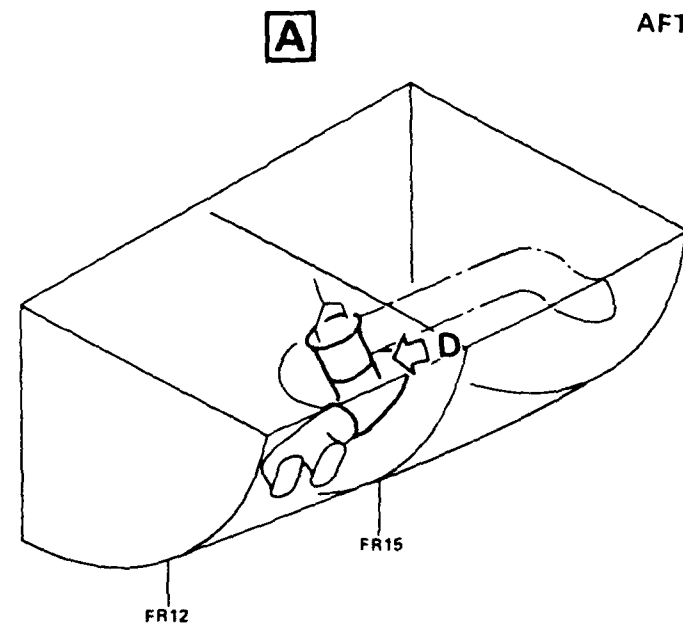
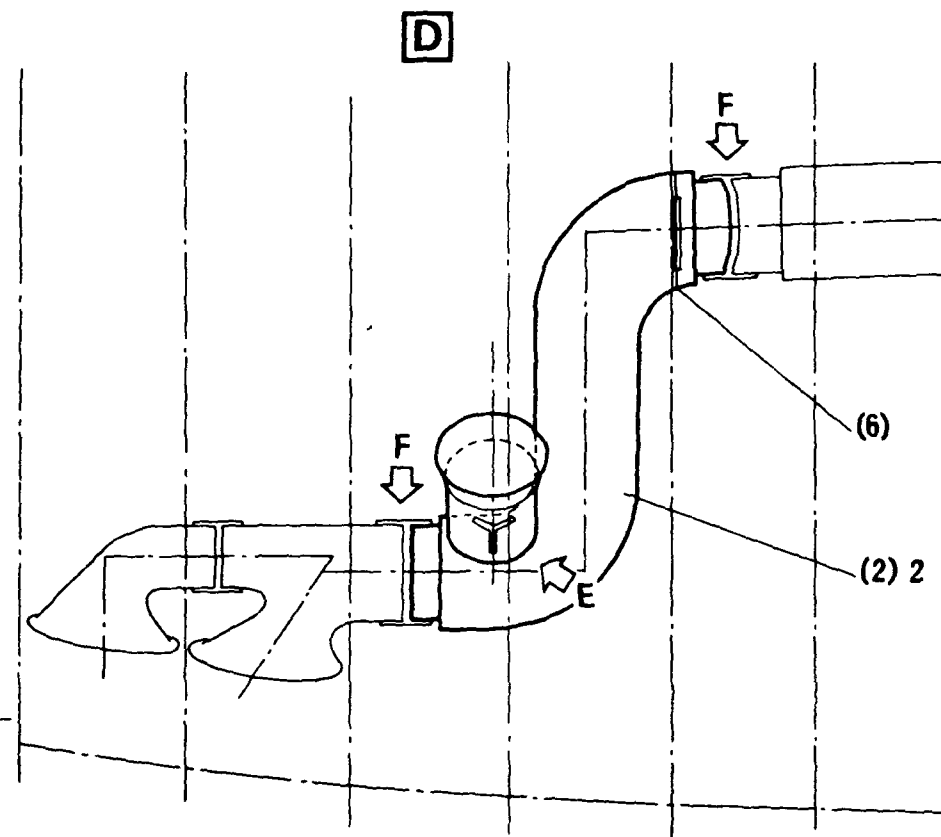
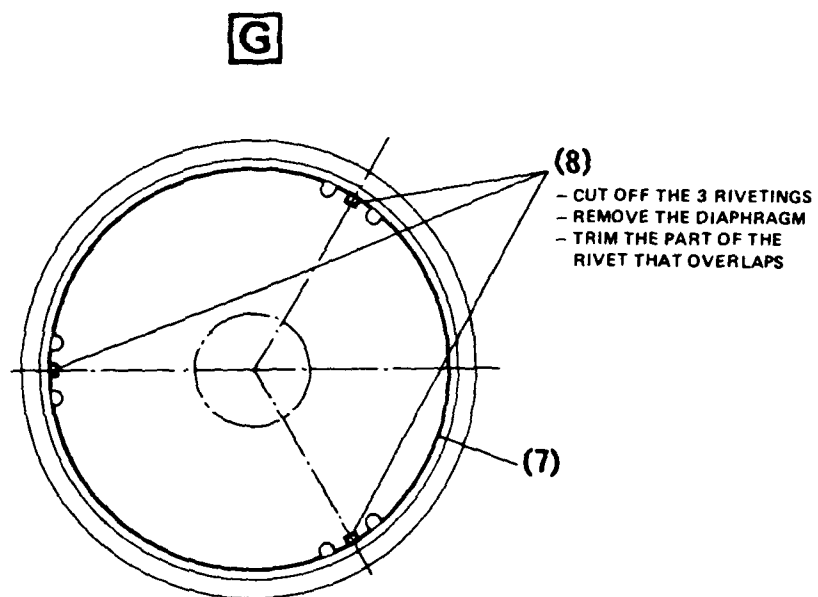
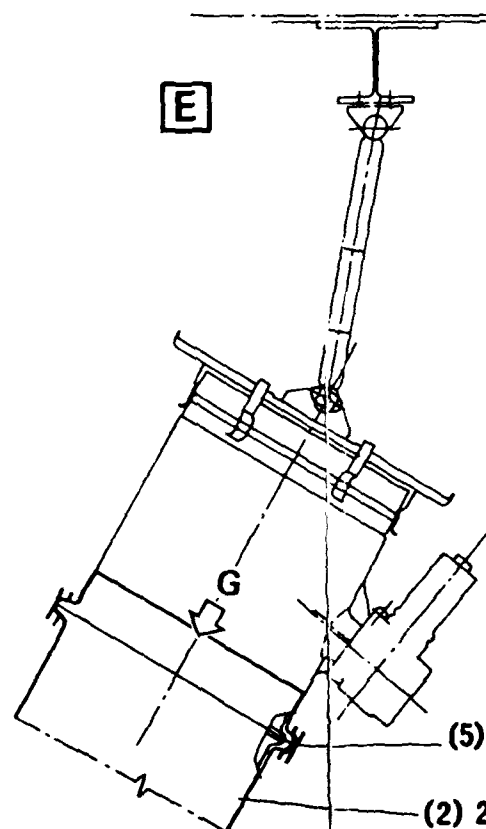
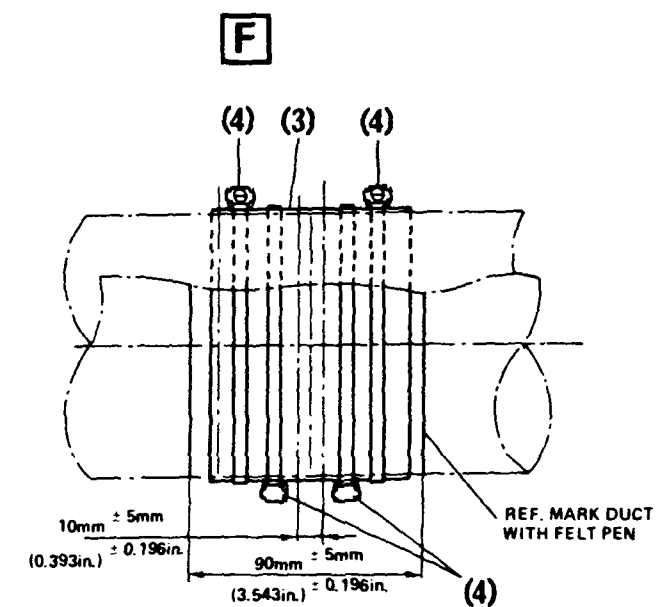
Modification of Duct-Blowing in Avionics Compartment  
Figure 1, Sheet 1 of 2

- (2) In avionics compartment, zone 125, modification of blowing duct  
Refer to Figure 1 Sheet 1 of 2

(a) Remove :

1 Blowing Duct	Item (2) (retained)
----------------	---------------------

2 sleeves	Item (3) (retained)
3 Clamps	Item (4) (retained)
1 Clamp	Item (5) (retained)
1 Clamp	Item (6) (retained)

### 3 Rivets

Item (8) (discard)

1 diaphragm

Item (7) (discard)

1 modified Blowing Duct 02191017900200 Item 2

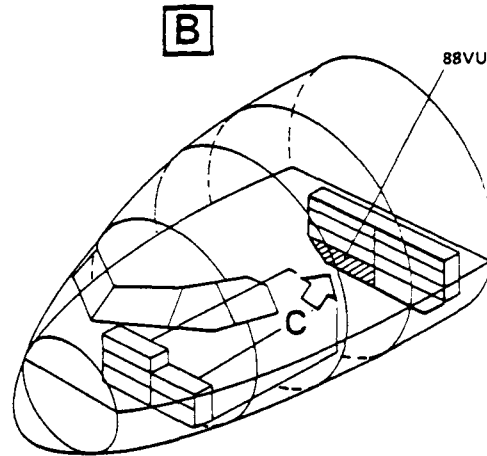
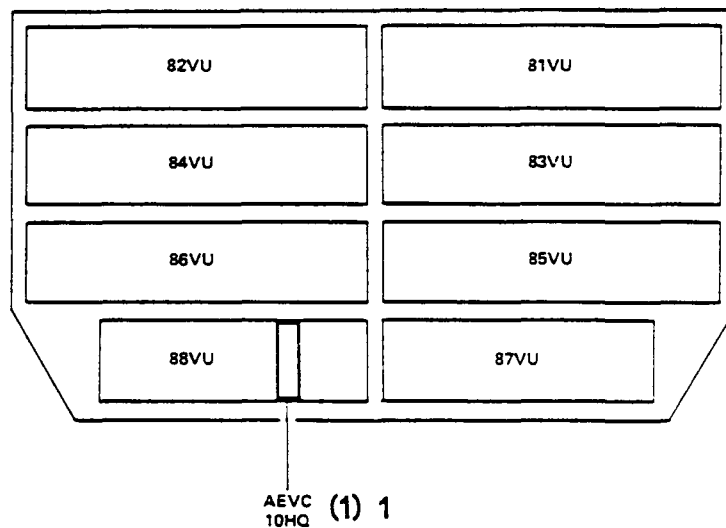
At Shelf 88VU of Electronics Rack 80VU, Replacement of Avionics Equipment  
Ventilation Computer (A.E.V.C.) 10HQ  
Figure 1, Sheet 2

- (1) At shelf 88VU of electronics rack 80VU replacement of Avionics Equipment Ventilation Computer (A.E.V.C.) 10HQ.  
Refer to AMM 21-26-34, P. Block 401

(a) Remove :

1 A.E.V.C. (10HQ)	Item (1)
-------------------	----------

(b) Install :

1 A.E.V.C. (10HQ) 87292325V03 Item 1 modified as per instructions of CROUZET Service Bulletin No. 87292325-21-001.
