SERVICE BULLETIN
SUMMARY

ATA SYSTEM: 21

**TITLE: AIR CONDITIONING - AVIONICS EQUIPMENT VENTILATION -
OPTIMIZE VENTILATION OF T3CAS INSTALLED IN 82VU**

MODIFICATION No.: 152526K15298

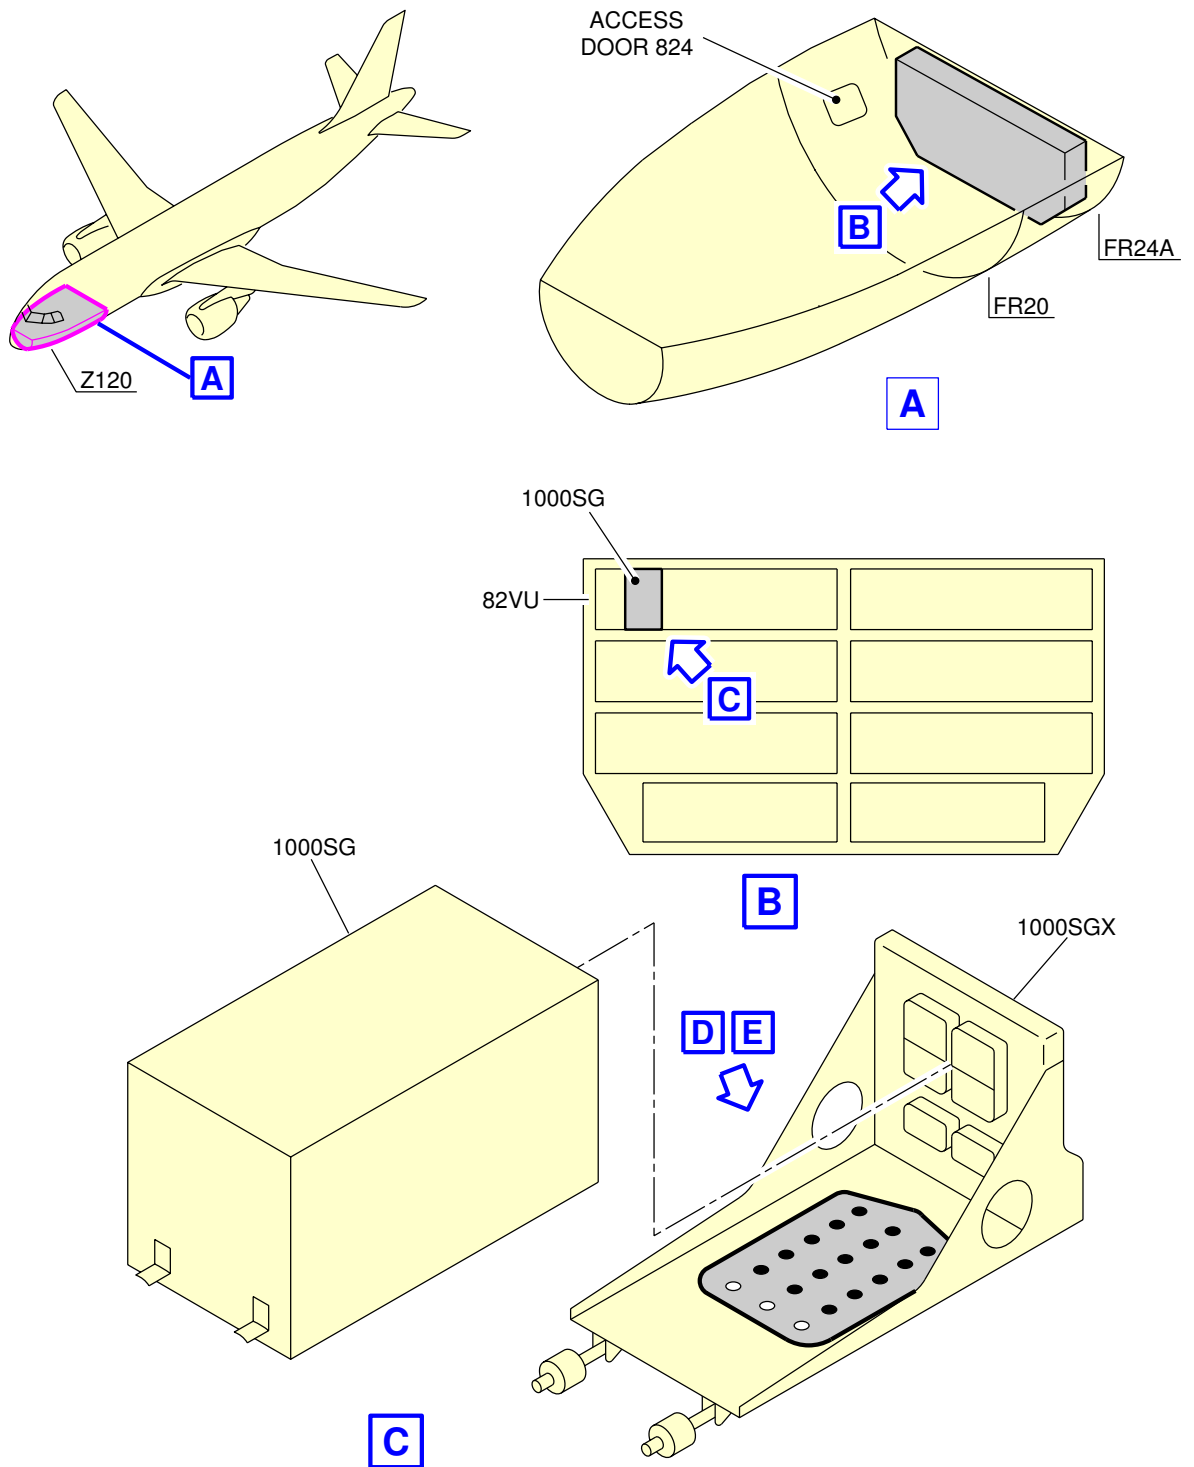
Figure A-GBAAA - Sheet 01
Modify the Cover of ventilation holes

Investigations have shown, that the T3CAS computer is not sufficiently cooled by air. The reason for the insufficient air cooling is the non optimized position of the open ventilation holes.

- (a) To close the ventilation holes at the avionic rack 1000SGX, install as shown on [Fig. A-GBAAA Sheet 01](#), View C and [Fig. A-GBAAA Sheet 02](#), E 'AFTER':
- 3 Cover NSA939511-03 Item 1
- (b) To open new ventilation holes at the avionic rack 1000SGX, remove as shown on [Fig. A-GBAAA Sheet 01](#), View C and [Fig. A-GBAAA Sheet 02](#), View E 'AFTER':
- 3 Cover NSA939511-03 Item (1) Discard
