SERVICE BULLETIN
SUMMARY

**TITLE: AIR CONDITIONING - AVIONICS EQUIPMENT VENTILATION -
UPGRADE TRU VENTILATION DUCT**

A318/A319/A320/A321

MODIFICATION No.: 150334P11623

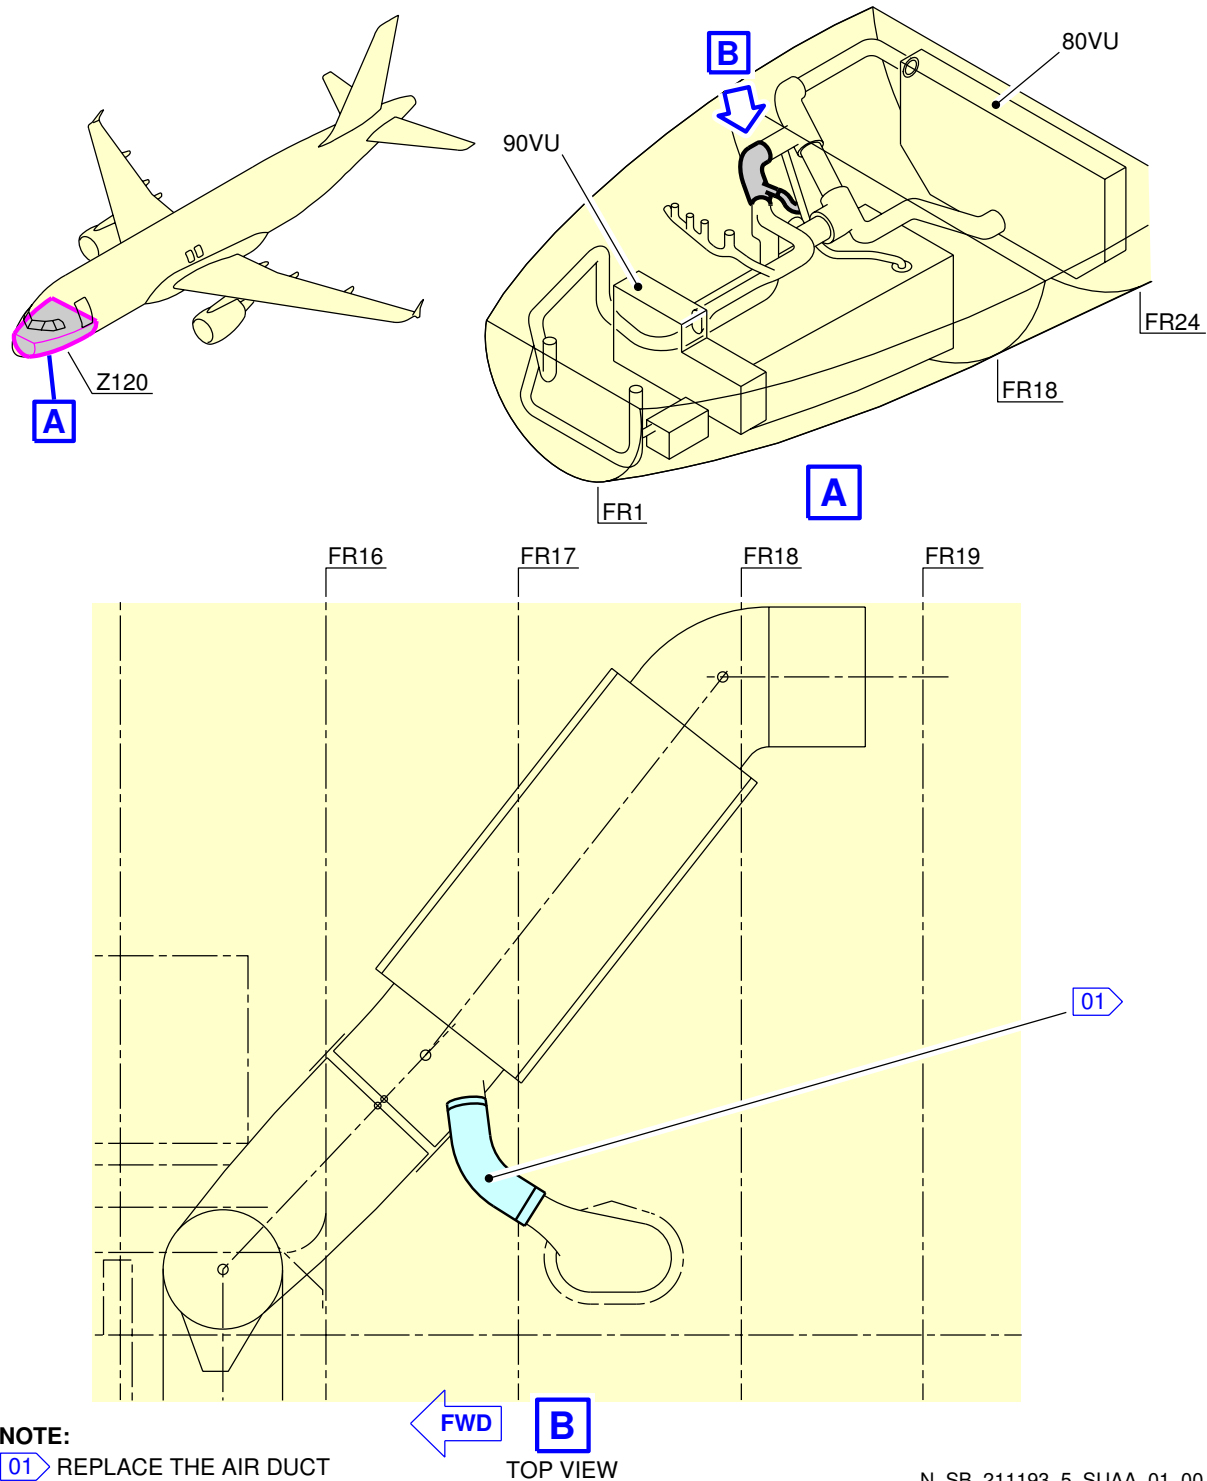
Figure A-FSUAA - Sheet 01

On aircraft post modification No. 37052P10052 (ELECTRICAL POWER - DC MAIN GENERATION - INTRODUCE AN ADDITIONAL TRU (4TH) TO COVER IFE NEEDS ON SINGLE AISLE CORPORATE JET), it has been highlighted that the hose located between the air extraction of the fourth Transformer Rectifier Unit (TRU) and the avionic air extraction pipe is too short.

This Service Bulletin proposes replacing the existing hose PN ABS1114B028D180 by new hose with PN ABS1114B028D210, 30mm longer.

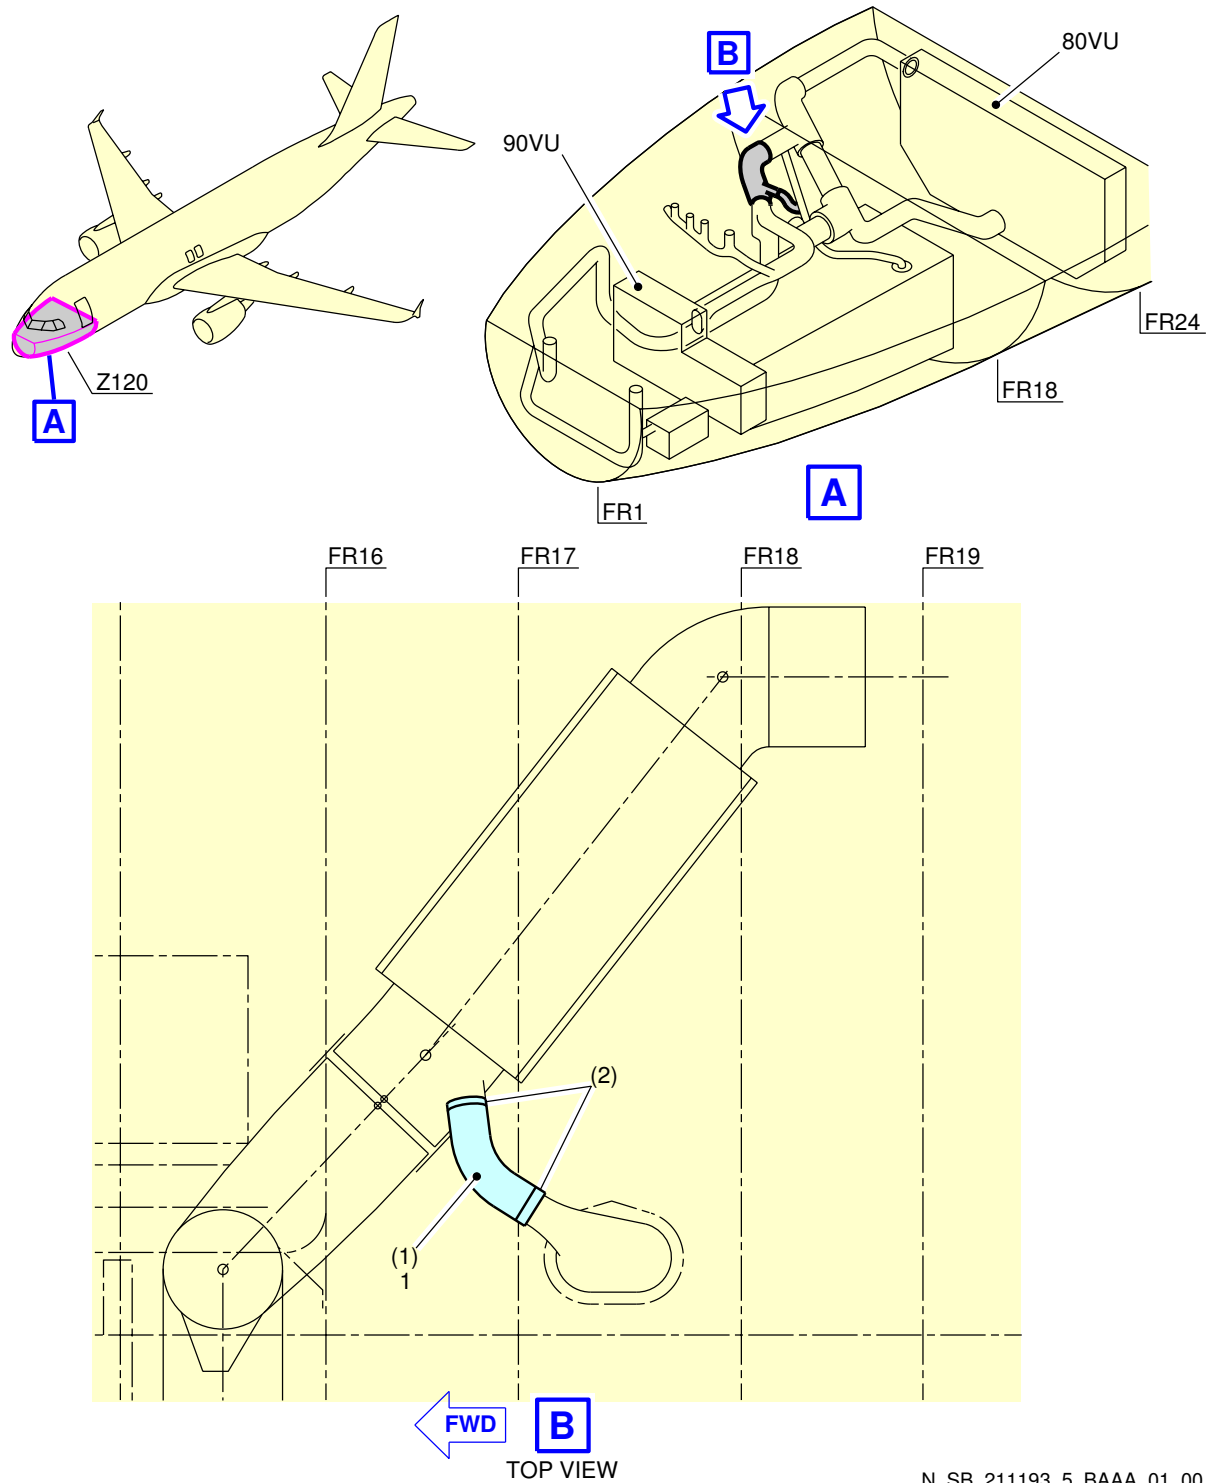
Figure A-FBAAA - Sheet 01
Replacement of the Transformer Rectifier Unit (TRU) Ventilation Hose.

On aircraft post modification No. 37052P10052 (ELECTRICAL POWER - DC MAIN GENERATION - INTRODUCE AN ADDITIONAL TRU (4TH) TO COVER IFE NEEDS ON SINGLE AISLE CORPORATE JET), it has been highlighted that the hose located between the air extraction of the fourth Transformer Rectifier Unit (TRU) and the avionic air extraction pipe is too short.

This Service Bulletin proposes replacing the existing hose PN ABS1114B028D180 by new hose with PN ABS1114B028D210, 30mm longer.

- (a) Remove :

1	Hose	ABS1114B028D180 Item (1)	Discard
---	------	--------------------------	---------

(b) Install :

2	Clamp	Item (2)	Retained at removal
---	-------	----------	---------------------
