**A320/A321**

SERVICE BULLETIN
REVISION TRANSMITTAL SHEET

TITLE : AIR CONDITIONING - PRESSURIZATION CONTROL - IMPROVE CONTROL
PANEL 25VU.

SERVICE BULLETIN No. : A320-21-1066

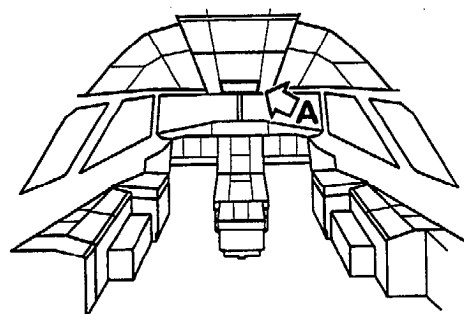
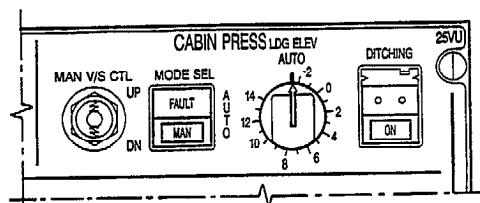
PANEL 25VU

Operators have reported that inadvertent operation and unintentional selections of landing field elevation have occurred.

This Service Bulletin proposes replacing, on the panel 25VU, the existing LDG ELEV AUTO potentiometer by an electrically and mechanically interchangeable potentiometer and the associated control knob by a knob with a different shape. The new potentiometer includes the following characteristics :

- a travel reduced from 360° to 300°
- a depressed position allowing no rotation and corresponding to the AUTO mode.

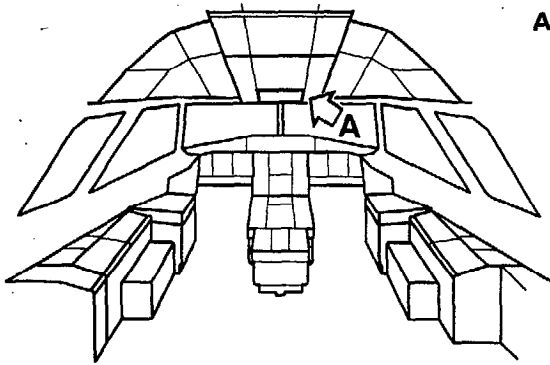
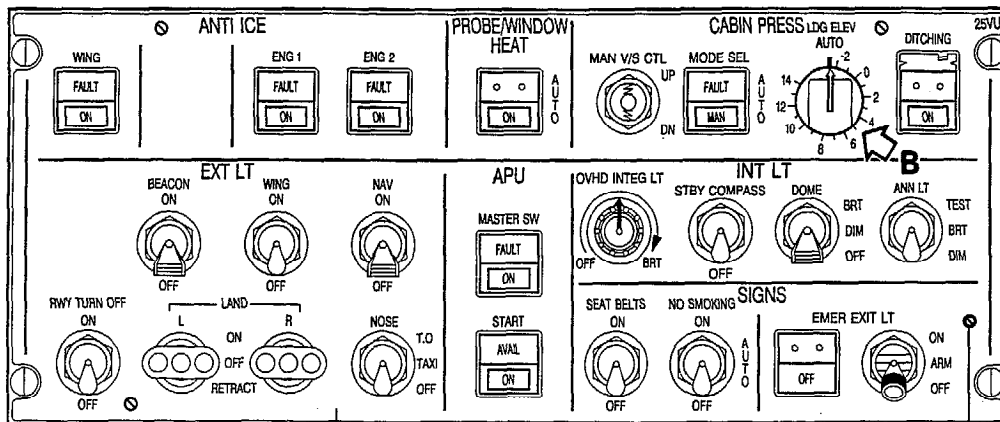
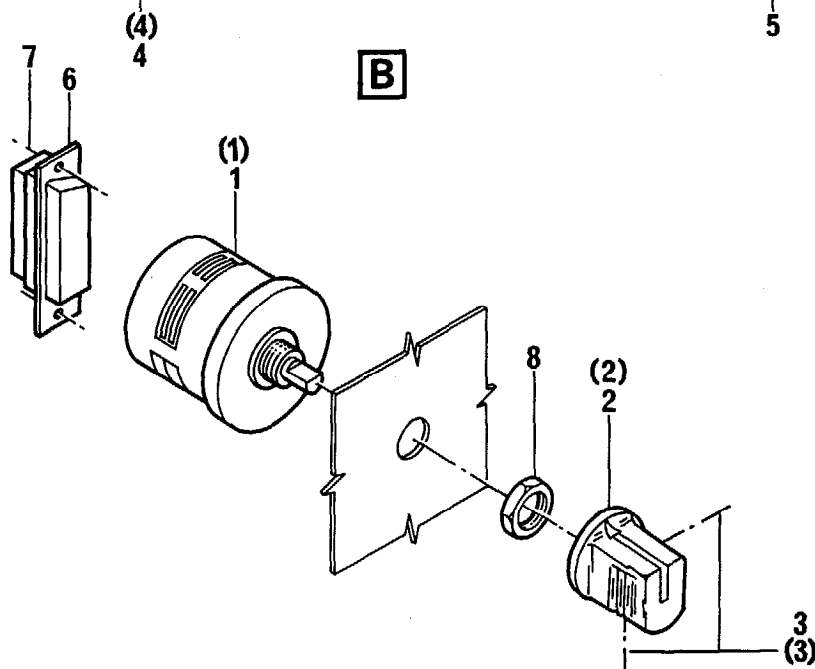
Modification to Equipment in Panel 25VU
Figure 1

Operators have reported that inadvertent operation and unintentional selections of Landing field elevation have occurred.

Separate AUTO mode from 14,000 ft position to prevent confusion between AUTO and MANUAL modes.

- (a) Remove from the panel 25VU :

2 screws	Item (3) (discard)
1 control knob	Item (2) (discard)

1 nut	Item (8) (discard)
1 selector	Item (1) (discard)

1 selector	9027-20010	Item 1
1 nut		Item 8

1 control knob	ABS0078-01	Item 2
2 screws	DIN916M3X3A2-70	Item 3
