SERVICE BULLETIN

TITLE : AIR CONDITIONING - INTRODUCE SOME IMPROVEMENTS TO AVOID WATER
CONDENSATION IN THE COCKPIT.

SERVICE BULLETIN No. : A320-21-1902

REVISION No. : 1 - Feb 18/92

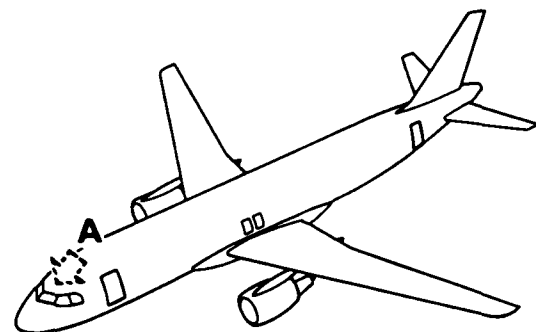
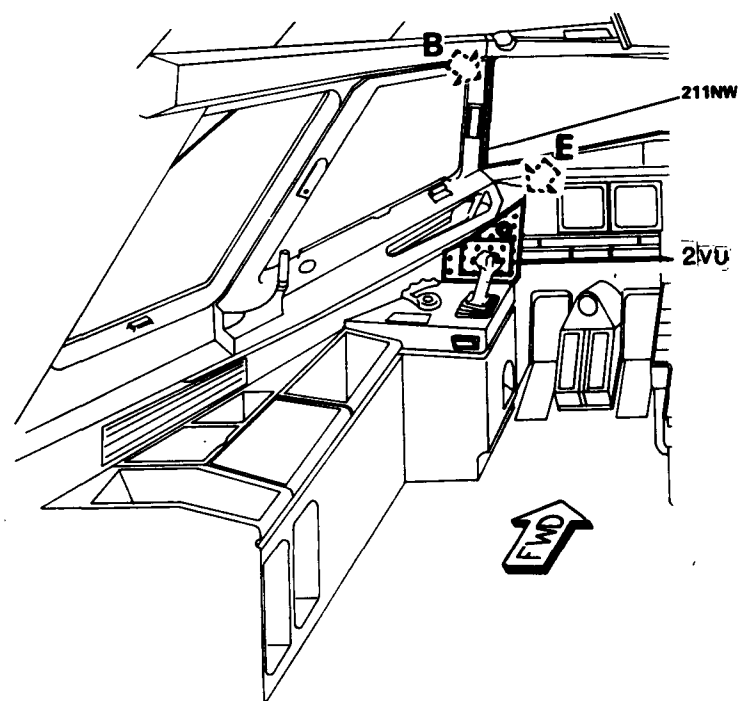
Apply Self-Adhesive Foam Pieces on Left Lining in Cockpit
Figure 1 Sheet 1 of 3

Operators report damage and nuisance due to condensed water ;
several locations have been identified mainly on the front panel
and side walls of the cockpit. This is experienced during long
flights (4 hours and more).

B. MODIFICATION**(1) Apply self adhesive foam pieces on left lining in cockpit**

Refer to figure 1 sheet 1 of 3, 2 and 3

- (a) Cut-out 6 pieces of self-adhesive foam as per shop sketches No. C 000075, C 000076, C 000077 and figure 1 sheet 3.

- (b) On lining panels 211NW, 211PW, 8DG1 and 2VU apply self-adhesive foam pieces as per shop sketches No. C 000075, C 000076, C 000077 and figure 1 sheet 3.

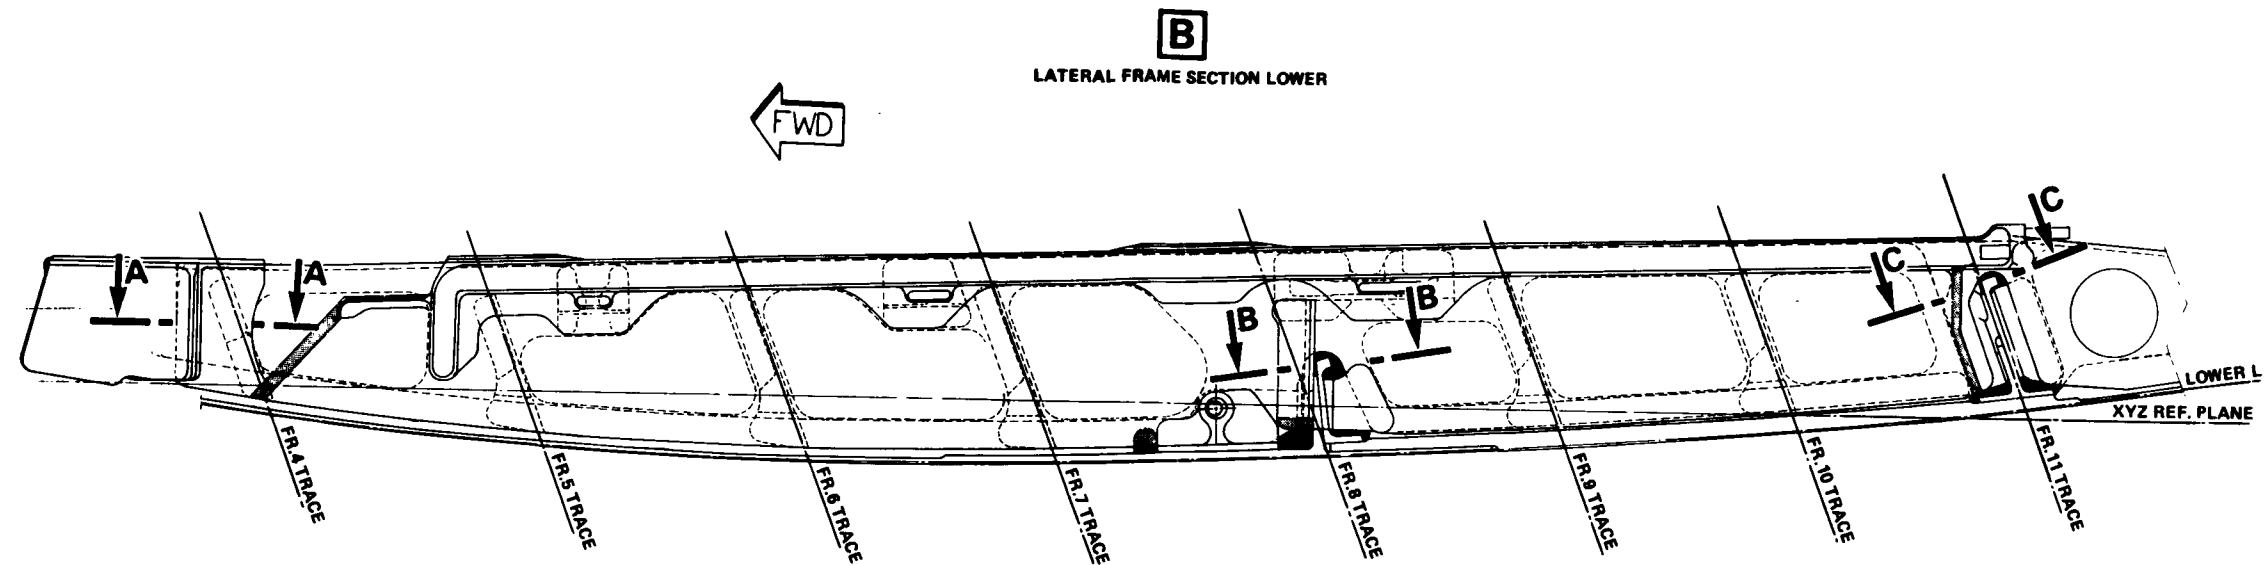
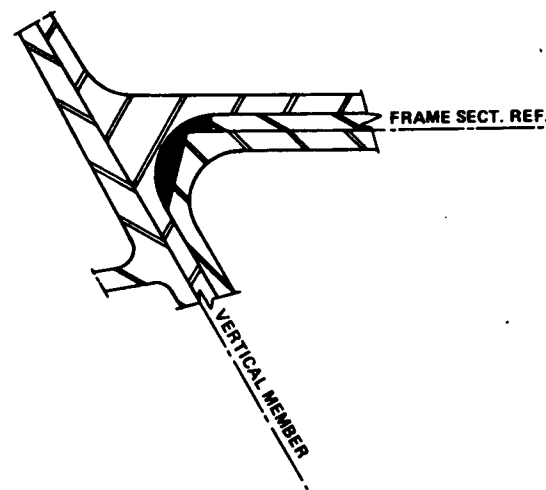
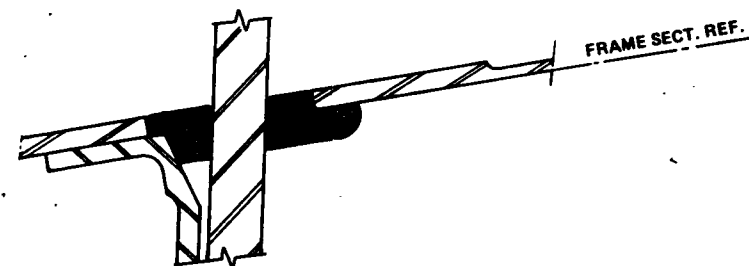
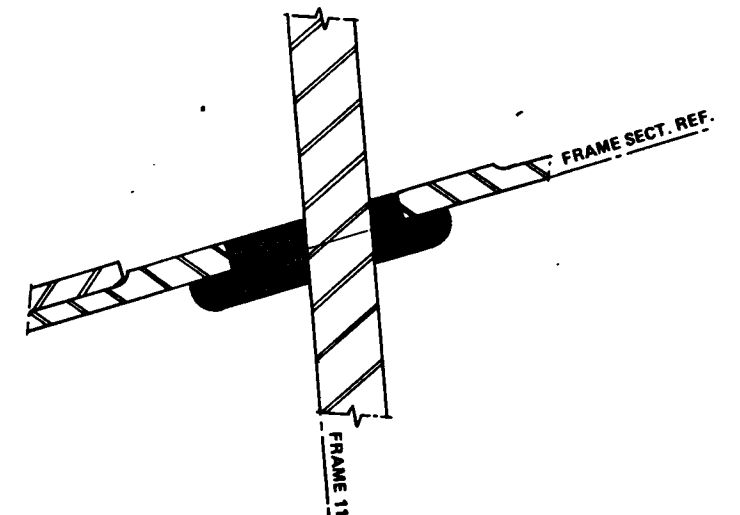
Gaps to be Sealed on Lower and Upper Left Lateral Frames in the Cockpit
Figure 2 Sheet 2

GAPS TO BE SEALED WITH MAT. No. 09 - 019
AND MAT. No. 05 - 013

Refer to figure 2 sheet 1 of 3, 2 and 3.

- (a) Before sealing gaps, blank off bottom gaps using adhesive tape Mat. No. 05-015.
- (b) With a brush, apply a coat of release agent Mat. No. 05-013 and let dry.
- (c) Seal gaps using sealing compound Mat. No. 09-019.
- (d) After drying of sealing compound, remove the adhesive tape.

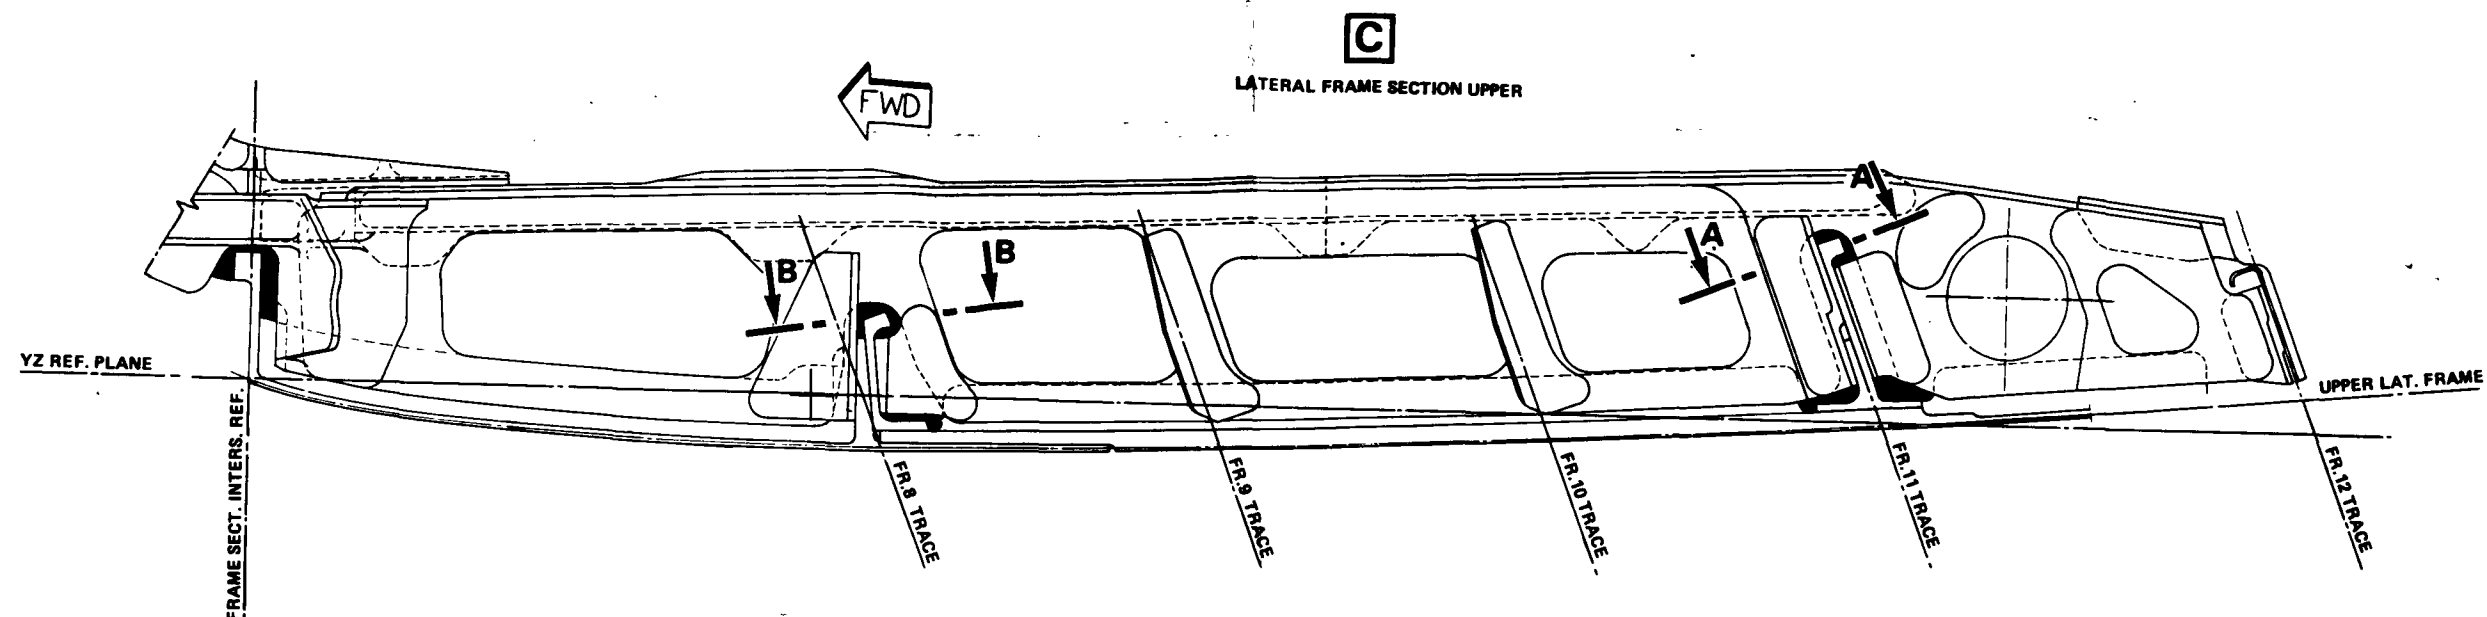
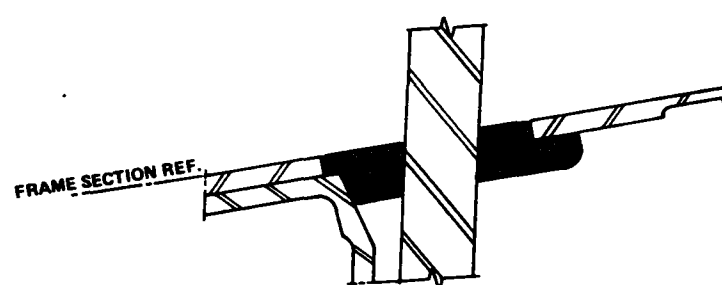
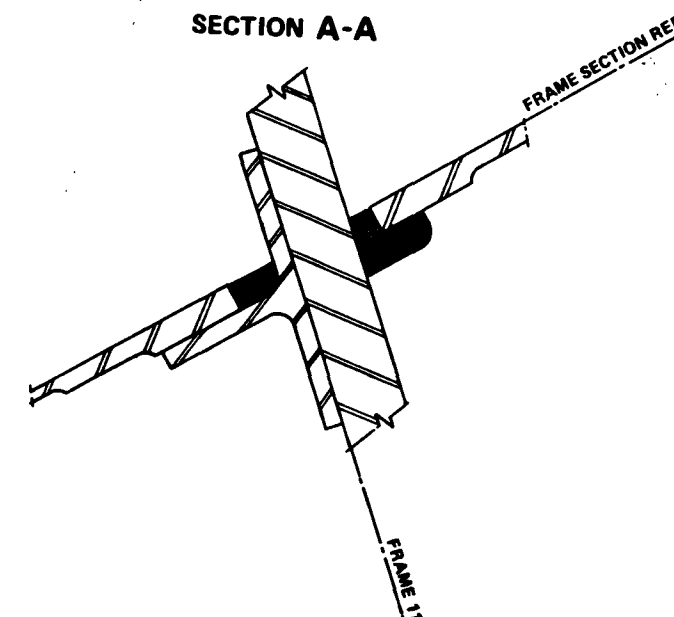
Gaps to be Sealed on Lower and Upper Left Lateral Frames in the Cockpit
Figure 2 Sheet 3

GAPS TO BE SEALED WITH MAT. No. 09 - 019
AND MAT. No. 05 - 013
