TITLE : AIR CONDITIONING ELECTRICAL INSTALLATION - PROVIDE PROTECTIONS  
AGAINST WATER CONTAMINATION OF ELECTRICAL HARNESS.

MODIFICATION No. 24291P3789

This page transmits Revision No. 1 of Service Bulletin No. A320-21-1097.  
No more work is necessary to do this Revision.

SERVICE BULLETIN No. : A320-21-1097

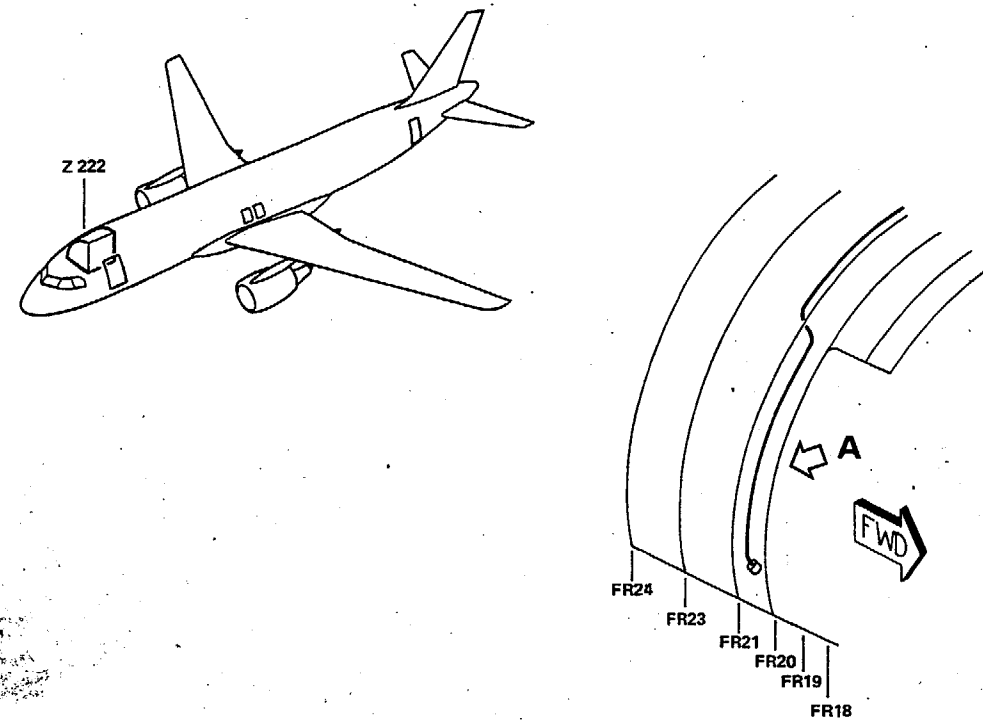
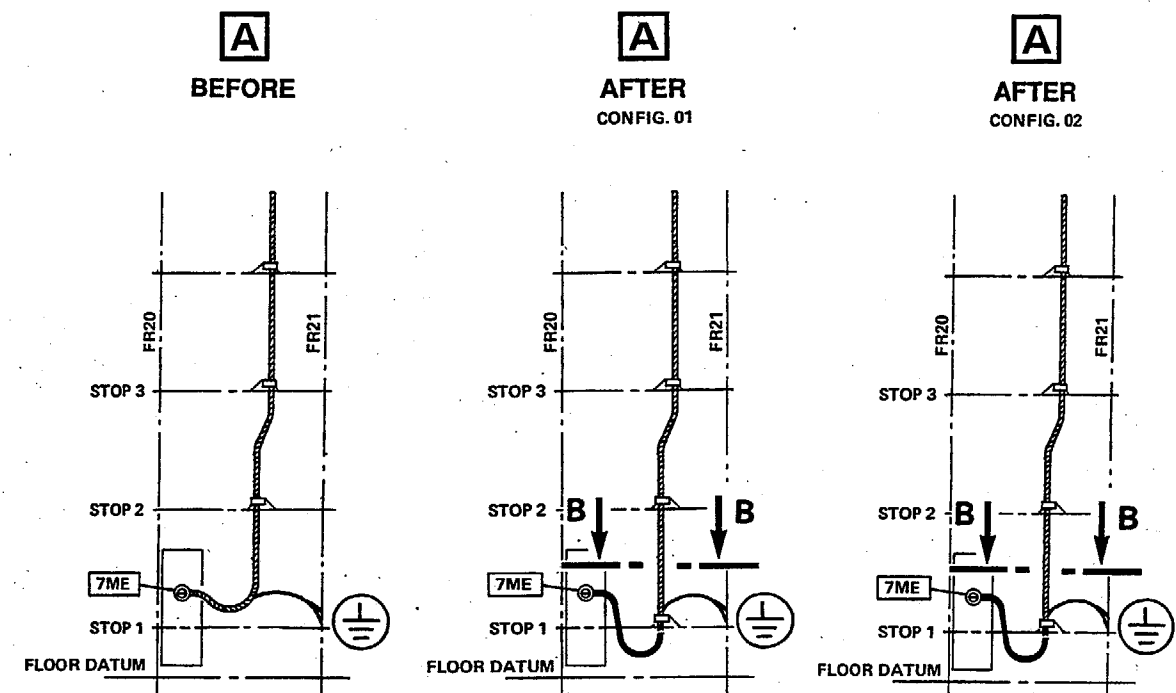
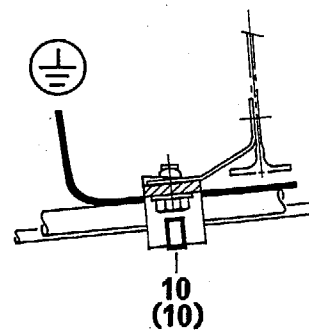
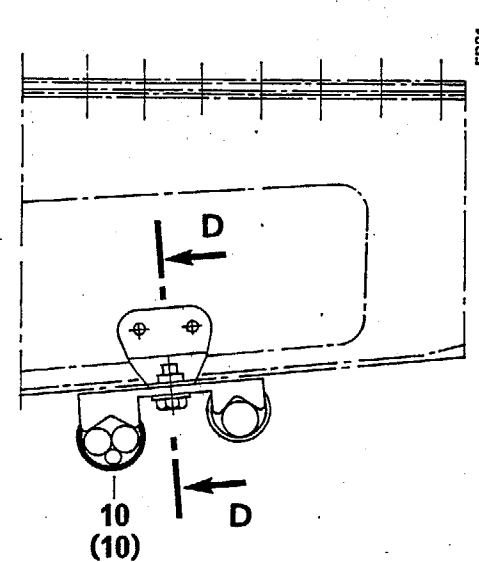
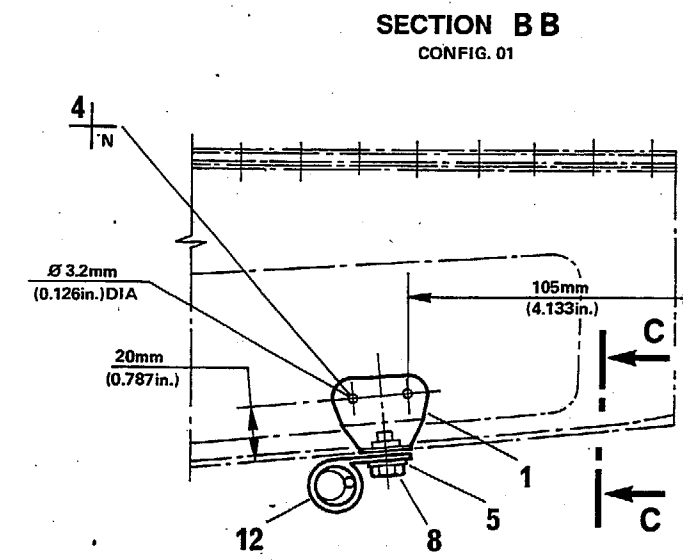
Modification of the Routing of the Vacuum Cleaner  
Figure 1

- (1) Modify the routing of the vacuum cleaner between FR20 and FR21.
- (2) Install a drip pan between FR23 and FR24 on the cabin ceiling.
- (3) Provide a drain hole on the L furnishings harness conduit at the cabin floor.

- (1) Modify the routing of the vacuum cleaner between FR20 and FR21.

Refer to Figure 1

- (a) Remove the components which prevent the removal of the  
insulation blanket.
- (b) Remove the insulation blanket between FR20 and FR21  
(Refer to AMM 25-80-00, P. Block 201).
- (c) Installation of the new bracket :
  - 1 Apply sealant Mat. No. 09-018 between the brackets Item 1  
and the stop 1.
  - 2 Put in position :  
1 bracket D5391375200000 Item 1
  - 3 Drill to a dia. of 3.2 mm (0.126 in.)

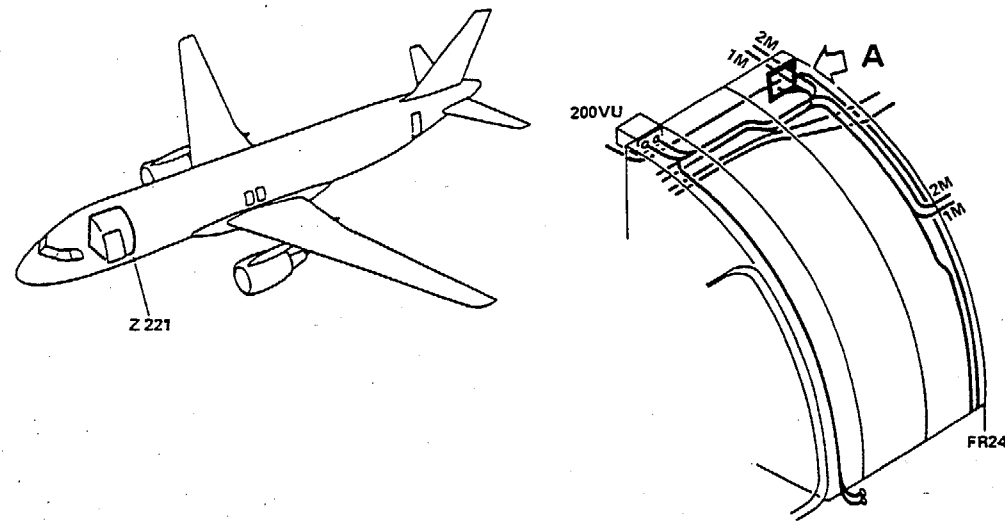
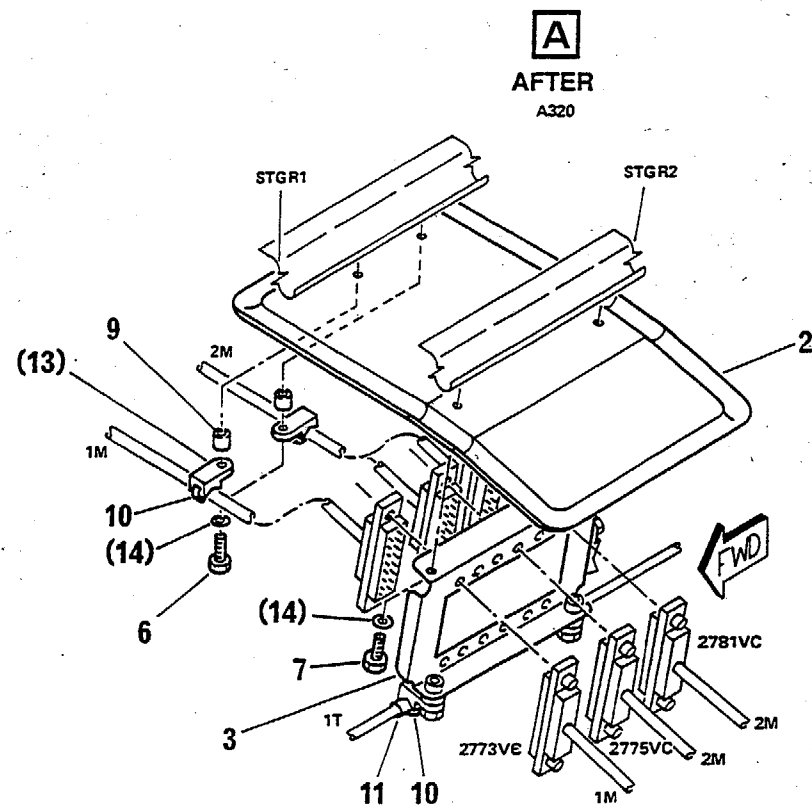
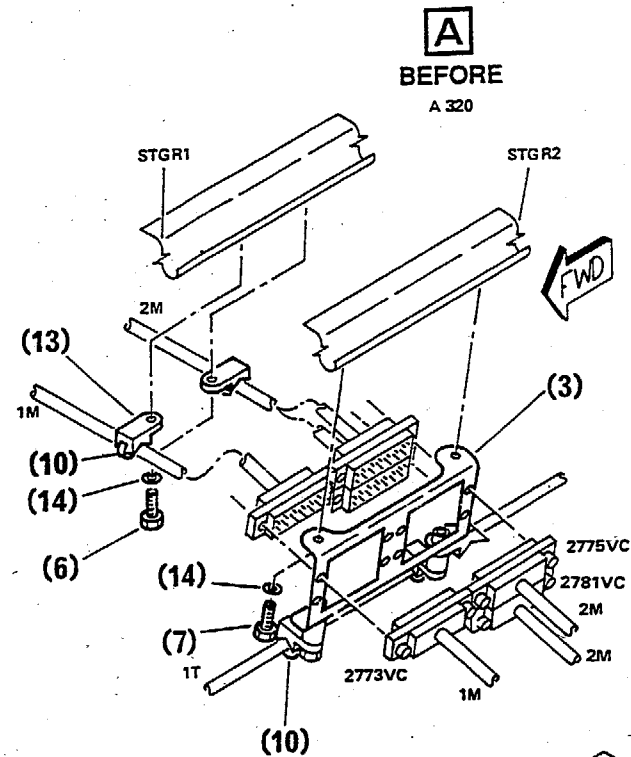
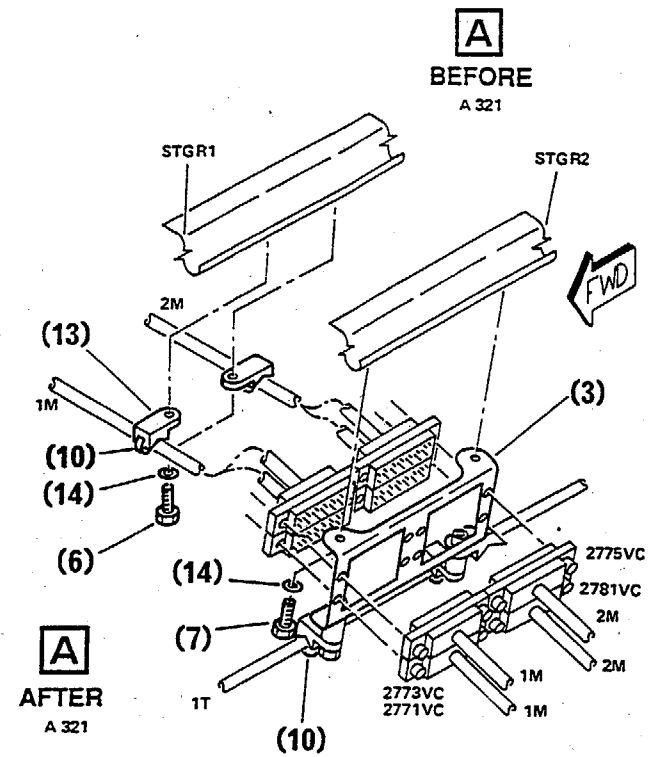
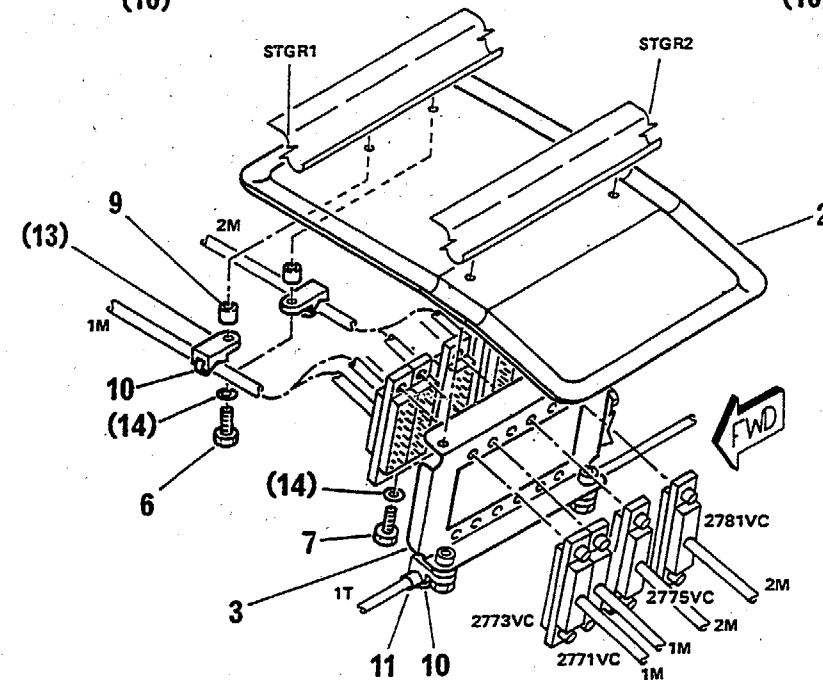
Installation of a Drip Pan between FR23 and FR24  
Figure 2

Operators have reported electrical connector damage in the forward galley area due to water condensation ingress between FR21 and FR24.

(2) Install a drip pan between FR23 and FR24 on the cabin ceiling.

Refer to Figure 2

4 cable ties	Item (10) (discard)
2 screws	Item (6) (discard)
2 screws	Item (7) (discard)
4 washers	Item (14) (retain)
2 supports	Item (13) (retain)
1 plate assy	Item (3) (discard)

1 plate	D9241239020000	Item 2
1 plate assy	D9241239200000	Item 3
2 spacers	NSA5527-03-06	Item 9
2 supports		Item (13)
4 washers		Item (14)
2 screws	NAS1096-3-16	Item 6
2 screws	NAS1096-3-8	Item 7
2 bobbins	NSA935510-02	Item 11
4 cable ties	NSA935401-04	Item 10
