A320

SERVICE BULLETIN

T I T L E : AIR CONDITIONING — PACK 1 AND 2 — INSPECT THE RAM AIR INLETS

SERVICE BULLETIN No. : A320-21-1040

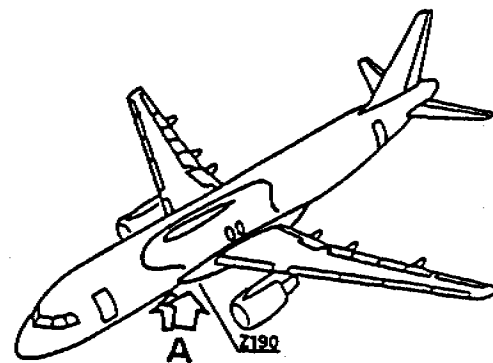
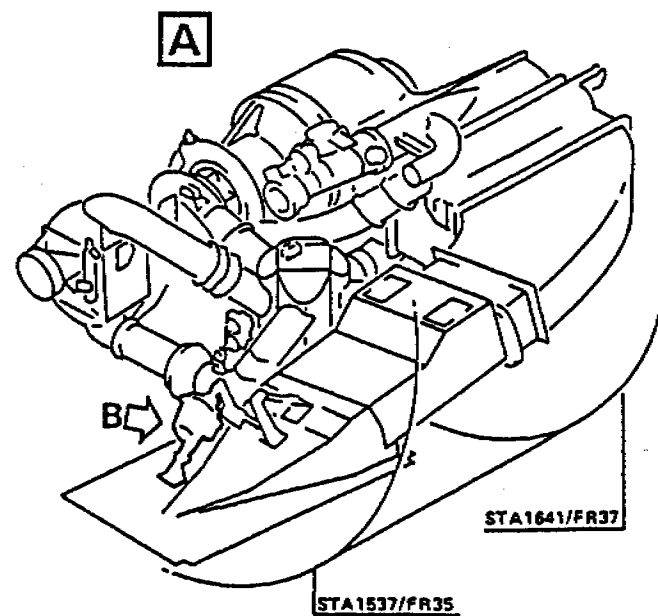
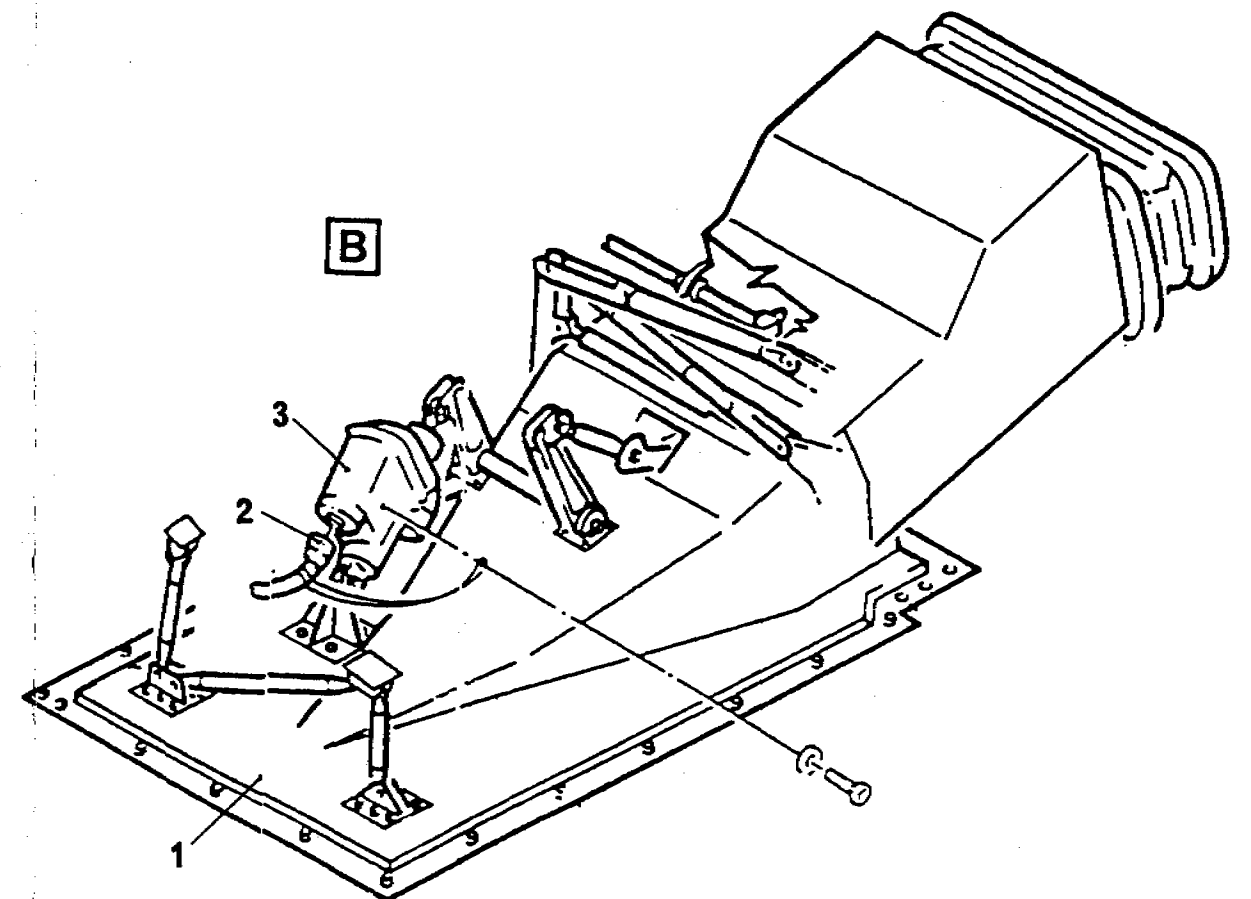
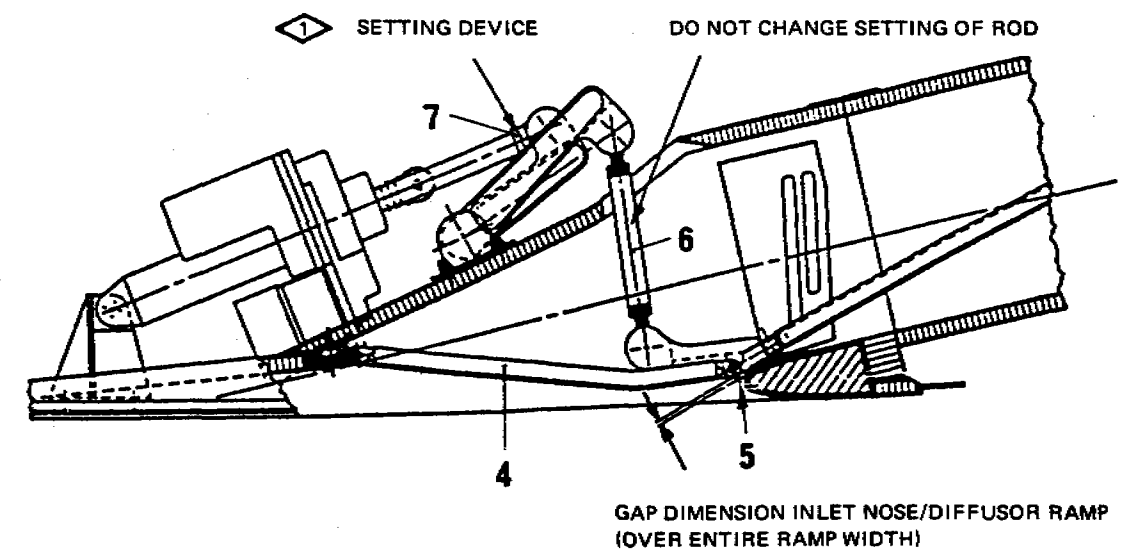
Inspection of Ram Air Inlet
Figure 1

During servicing of the air cooling system, the fan of the air cooling machine was found to be ruptured. Tests have shown that the fan stress level was extreme when the ram air inlet was closed (linked to reduced fan flow) during take-off and landing.

- (f) Check the gap between the inlet nose, item 5 and diffuser ramp, item 4:

$$\text{GAP} = 0.8 \text{ mm} + 0.6 \text{ mm}, -0.5 \text{ mm} \\ (0.0314 \text{ in.} + 0.0236 \text{ in.}, - 0.0196 \text{ in.})$$

- If the play of the diffuser ramp is more than 1 mm (0.04 in.), replace the respective component.

- (g) If the gap is out of tolerance, adjust as described in AMM 21-61-51, P. Block 401.

NOTE: Do not change the settings of the rod, item 6.

NOTE: Do not turn out the eye-end of the setting device, item 7 more than 6 mm (0.236 in.).

CAUTION: DO NOT TURN-OUT THE
EYE END OF THE ROD
MORE THAN 6mm(0.236in.)
