737

Service Bulletin

Number: 737-24-1205
Original Issue: March 25, 2014
Revision 2: July 22, 2015
ATA System: 2400

SUBJECT: ELECTRICAL POWER - Standby Power System - Replacement of the M9 Static Inverter Terminal Lugs

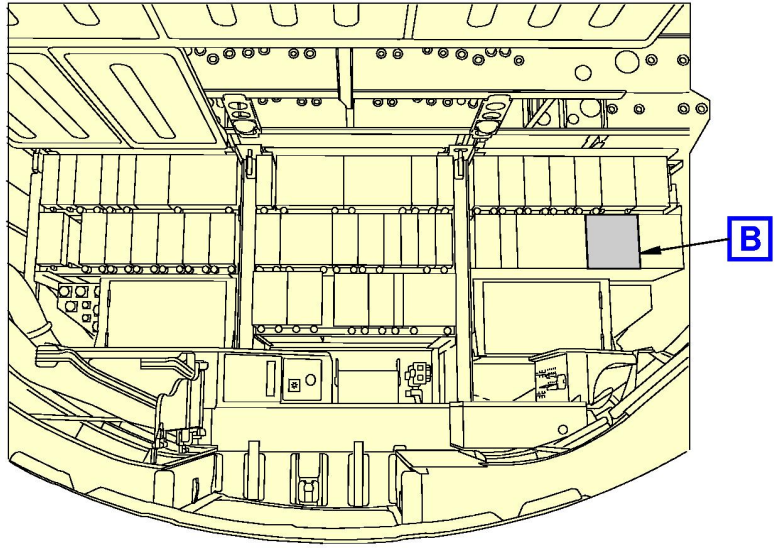
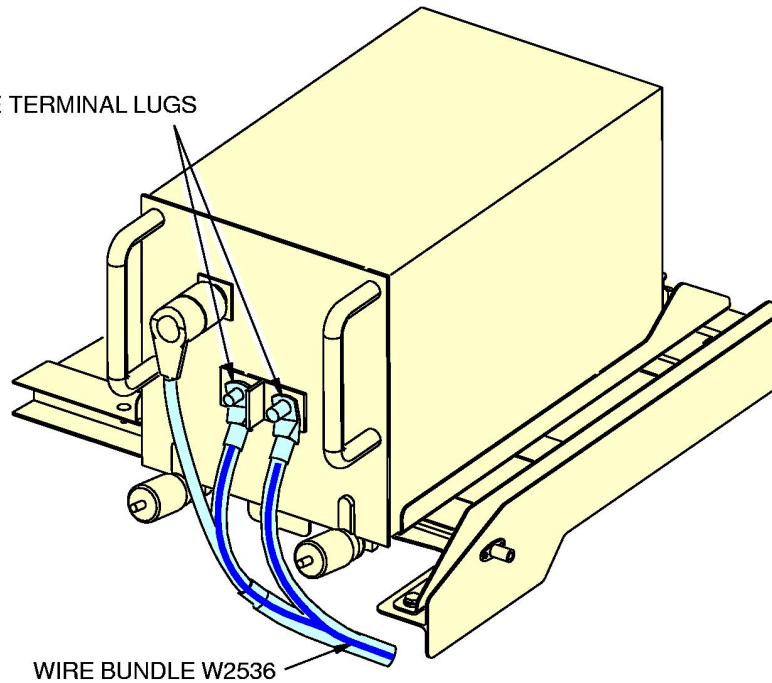
Boeing received reports from operators that 737NG airplanes that have the existing M9 static inverter terminal lugs were found to be cracked.

Get access to the main equipment center. At the E2-2 electronics shelf, replace the terminal lugs at the M9 static inverter. Do a test.

REPLACE THE TERMINAL LUGS

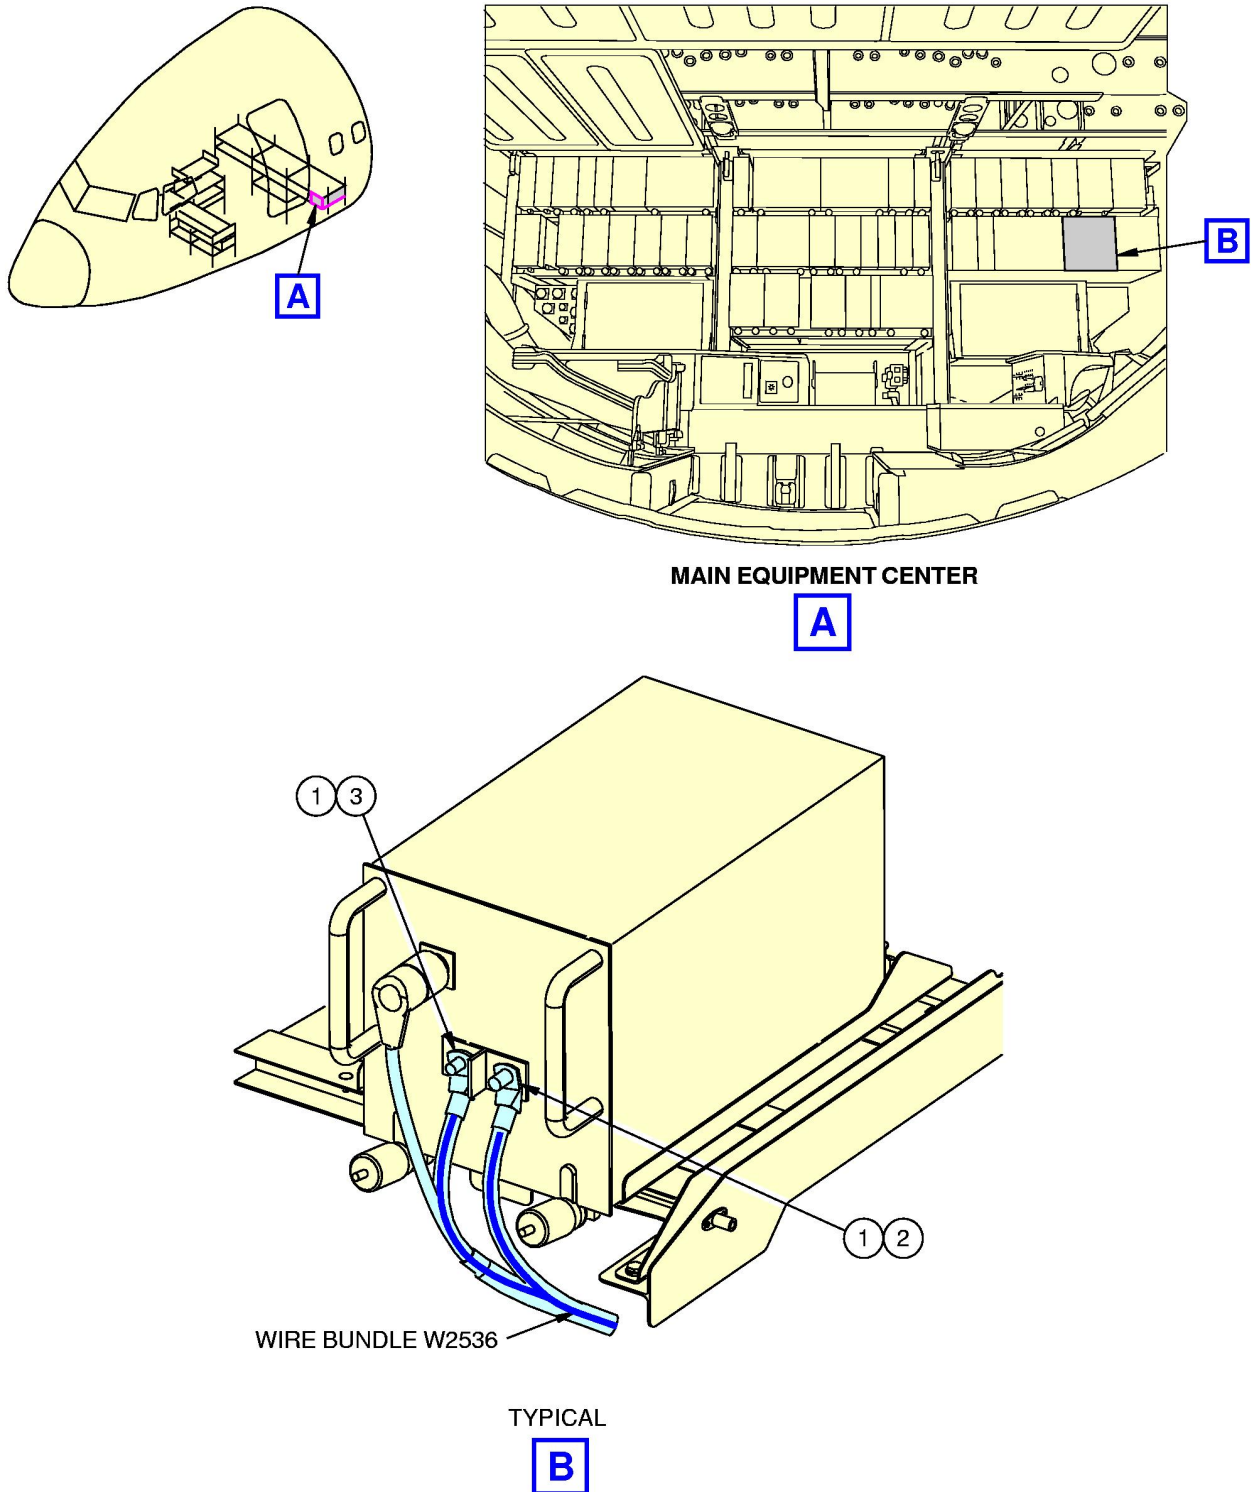
FIGURE 1: MAIN EQUIPMENT CENTER - M9 STATIC INVERTER UNIT - TERMINAL LUG REPLACEMENT (SHEET 1 OF 2)

Boeing received reports from operators that 737NG airplanes that have the existing M9 static inverter terminal lugs were found to be cracked.

1. Remove electrical power from the airplane. Refer to 737-600/700/800/900 AMM 24-22-00 as an accepted procedure.
2. Replace the terminal lugs at M9 static inverter, in accordance with FIGURE 1.
3. Restore the electrical power to the airplane. Refer to 737-600/700/800/900 AMM 24-22-00 as an accepted procedure.
4. Do the M9 static inverter installation test. Refer to 737-600/700/800/900 AMM 24-34-21 as an accepted procedure.
5. Put the airplane back to a serviceable condition.

Step	Task	Name	Identification	Qty	More Data
1	Remove	NUT	-	2	Remove the terminal block cover, if installed.
	Remove	WASHER	-	4	
	Remove	TERMINAL LUG	-	2	(a)
2	Install (New)	TERMINAL LUG	BACT12M8-3	1	(b) (c) (e)
	Install (New)	WASHER	NAS1149F0416P	1	(b)
	Install (New)	NUT	BACN10JC4CD	1	(b) (d)
3	Install (New)	TERMINAL LUG	BACT12M8-4	1	(b) (c) (f)
	Install (New)	WASHER	NAS1149F0516P	1	(b)
	Install (New)	NUT	BACN10JC5CD	1	Install the terminal block cover, if removed. (b) (d)

(a) Cut the wires as close to the end of the terminal lugs as possible.					
(b) This part is operator supplied.					
(c) Refer to SWPM 20-30-11 as an accepted procedure.

(d) Refer to SWPM 20-30-00 as an accepted procedure.					
(e) The terminal lug BACT12M8-3 for the wire W2536-0513-08. Refer to 737-600/700/800/900 WDM 24-34-11 as an accepted procedure.

(f) The terminal lug BACT12M8-4 for the wire W2536-0506-08. Refer to 737-600/700/800/900 WDM 24-34-11 as an accepted procedure.
