A318/A319/A320/A321

TITLE : AIR CONDITIONING - INSTALL IMPROVED CLAMP ON BELLOWS AT PACK OUTLET AND
BETWEEN PACK OUTLET CHECK VALVE AND MIXER UNIT.

MODIFICATION No. : 35038K9698

SERVICE BULLETIN No. : A320-21-1155

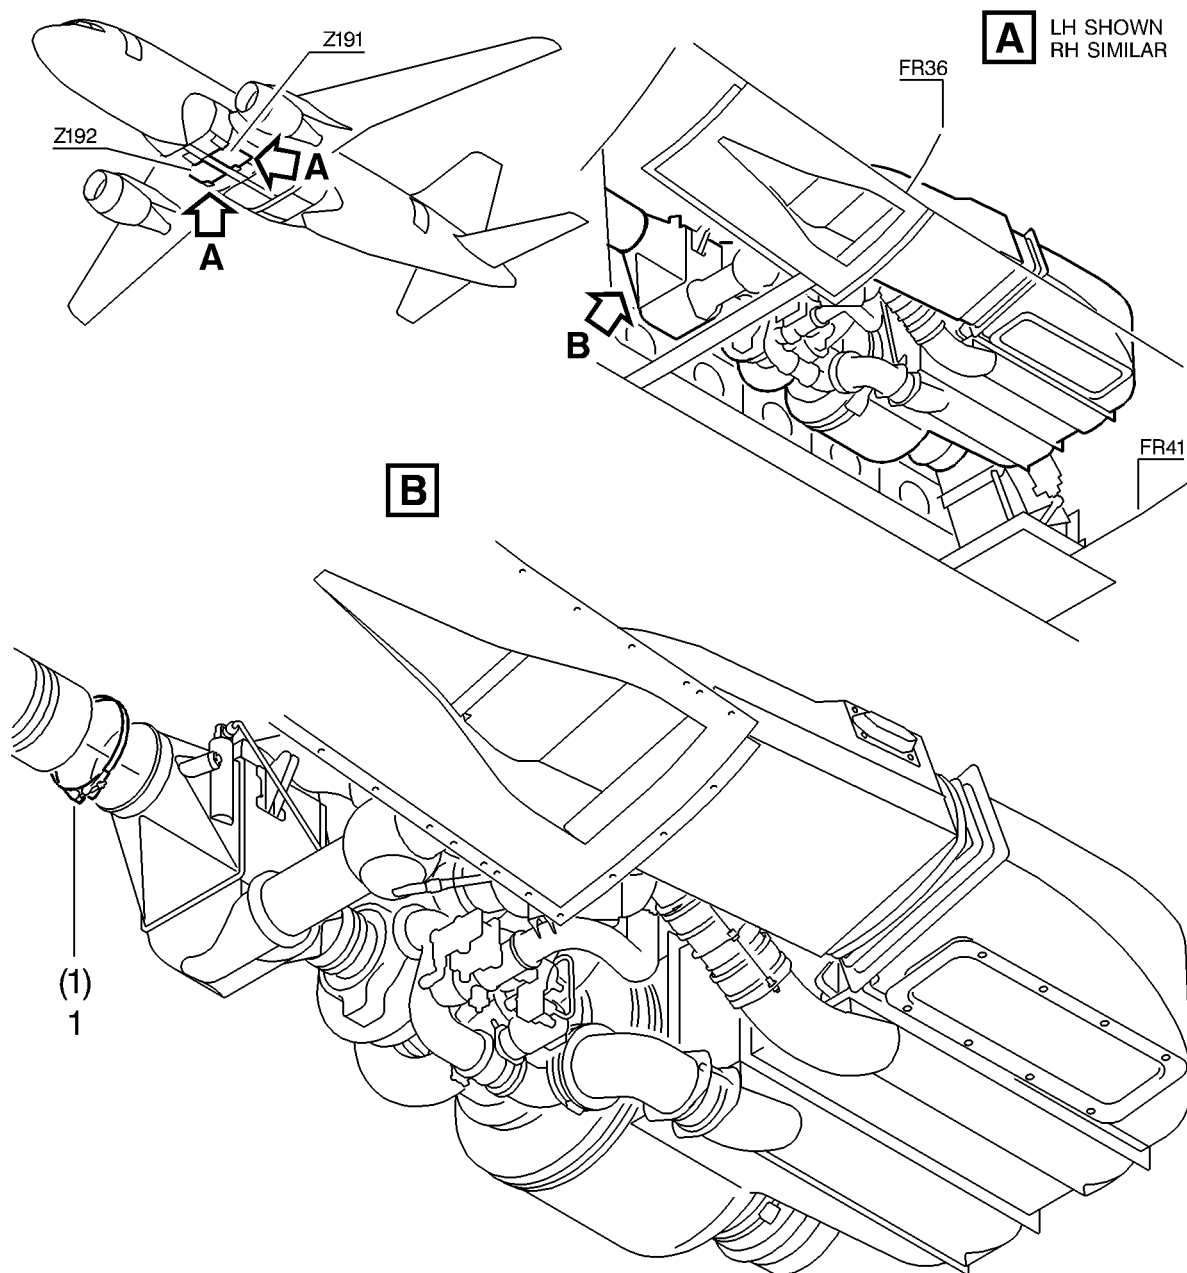
Figure 1 Sheet 1
Replace the Clamps at Air-Conditioning Pack Outlets

Operators have reported some cases of rupture of the quick disconnect clamps used for the bellows which connect the condensers of the air conditioning packs with the outlet ducts and the pack outlet check-valves with the mixer unit. As a result of these clamp ruptures the bellows come completely off, the pack air blows into the pack bay, the pack outlet valve closes and the aircraft is supplied only with pack air from the remaining pack. In one case a depressurization of the cabin was reported as the result of a failed pack outlet-valve flap-position or broken flap due to heavy oscillation of flap.

- (a) Replace the quick-disconnect clamp of the bellow at the air-conditioning condenser outlet duct of the LH pack 10HM at FR36.

Refer to Figure 1

1 Remove as shown in Sheet 1 , Detail B :

1 clamp NSA5532-612 Item (1) Discard

2 Clean the work area with cleaning agent (Mat No. 11-026) .

3 Install as shown in Sheet 1 , Detail B :

1 clamp NSA5532C612 Item 1

4 Torque tighten the clamp to between 0.28m.daN (24.78lbf.in) and 0.38m.daN (33.63lbf.in).

- (b) Replace the quick-disconnect clamp of the bellow at the air-conditioning condenser outlet duct of the RH pack 11HM at FR36.
